71-183-2019

Construction job site of sewer installation project.

Spotter Crushed between Excavator Bucket and Trench Box

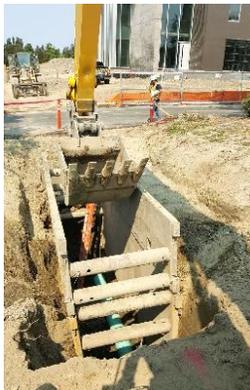
View from excavator cab. The spotter was in the trench to the right in the operator's blind spot.

- Pre-plan a job task to ensure safety of the crew. For example, in this case the task could have been accomplished by having only one spotter/signal person and no one in the trench.
- Ensure all ground workers are aware of the excavator's swing areas and blind spots when hoisting materials and stay outside of these areas.
- Before hoisting materials, review and confirm communication signals between the equipment operator and workers on foot.
