Parking Lot Attendant Falls Three Stories Off Manlift

Industry: Parking Lots and Garages

Release Date: January 18, 2011

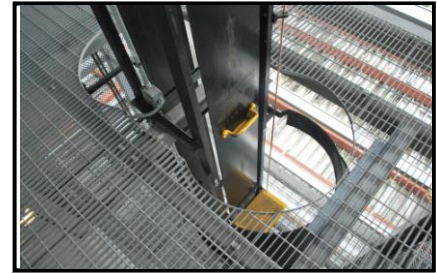
The victim was using the manlift to descend from the 5th floor of a parking garage. A manlift is a power-driven platform lift used to transport people between floors. Riding the manlift involves stepping onto a 1-2 square foot platform and grabbing a handhold. The manlift moves at approximately 75 feet per minute (less than 1 mile per hour). To get off the lift, a rider steps onto an adjacent platform. The company's training for manlift use normally involves verbal instruction by a supervisor followed by trainees viewing a video demonstrating safe operation of the equipment. In this case, the victim's training consisted of a demonstration of how to ride the lift followed by a ride with the supervisor present. The victim was uncomfortable with using the manlift.

View of manlift coming up to landing

On the day of the incident, the worker's second day on the job, the victim was rushing to return to the main floor to help customers. As the victim stepped onto the lift platform with one foot, the shoelace of his other foot snagged on the metal grate used for the landing surface. The manlift continued to descend while the victim was hanging by his shoelace from the fifth floor. When his shoelace broke, he fell thirty feet to the second floor. The injuries initially added significant personal stress to his life since he needed others to assist him with simple everyday tasks. A year after the incident the victim continues to have leg and back pain; he can no longer participate in sports. His fear of heights has worsened and he is uncomfortable riding in elevators.

- Belt manlifts installed between July 1, 2004, and January 1, 2008 must meet American Society of Mechanical Engineers (ASME) A90.1-1997 requirements. All belt manlifts installed after January 1, 2008 must meet ASME A90.1-2003 requirements. See WAC 296-96-11001.
- All belt manlifts must have emergency stop devices that are located within easy reach of the "up" and "down" run of the belt. See WAC 296-96-11066.
- Establish, supervise, and enforce effective rules that lead to a safe and healthy work environment. See WAC 296-800-11035.

- Employees should be physically and mentally able to perform work tasks. If employees are uncomfortable using any equipment or machinery, they should not do so until training or skill issues are addressed.
- Employers should ensure that all employees are trained on how to recognize and minimize hazards associated with any equipment they will be using.
- Employers should strongly consider not using these manlifts due to their inherent hazards.
