INCIDENT FACTS

71-168-2018

Siding Contractor Falls 23 Feet from Apartment Balcony

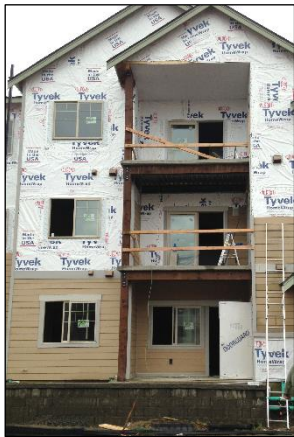
Apartment building where siding contractor fell from the third story balcony.

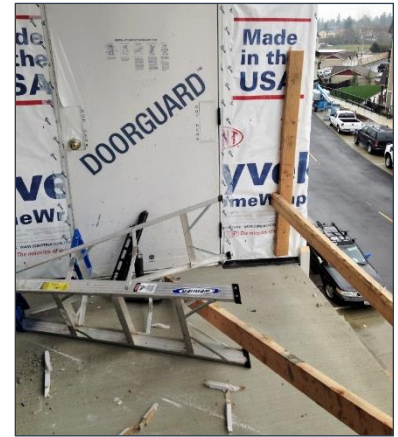
Investigators determined that the temporary guardrails on the balcony, and many others throughout the five building development, were improperly installed by a framing contractor. The original guardrails on the incident balcony had been removed by a siding contractor and his employees so that they could install moisture barriers on the building exterior. When they replaced the guardrails, they also did so improperly. The project general contractor did not ensure that the guardrails were installed and maintained in a safe manner.

Incident scene on a third floor balcony of apartment building under construction.

- General contractors should convey firm expectations for using fall protection to employees and subcontractors before the job starts. During the job they should visit sites to monitor for compliance and take corrective action.
- All contractors should ensure that appropriate fall protection is used by workers.
- Consider using safer alternatives to ladders for working at height, such as a mobile baker scaffold with guardrails or a portable lift platform.
