Siding Contractor Falls 23 Feet from Apartment Balcony

REPORT #: 71-168-2018s

REPORT DATE: March 12, 2018

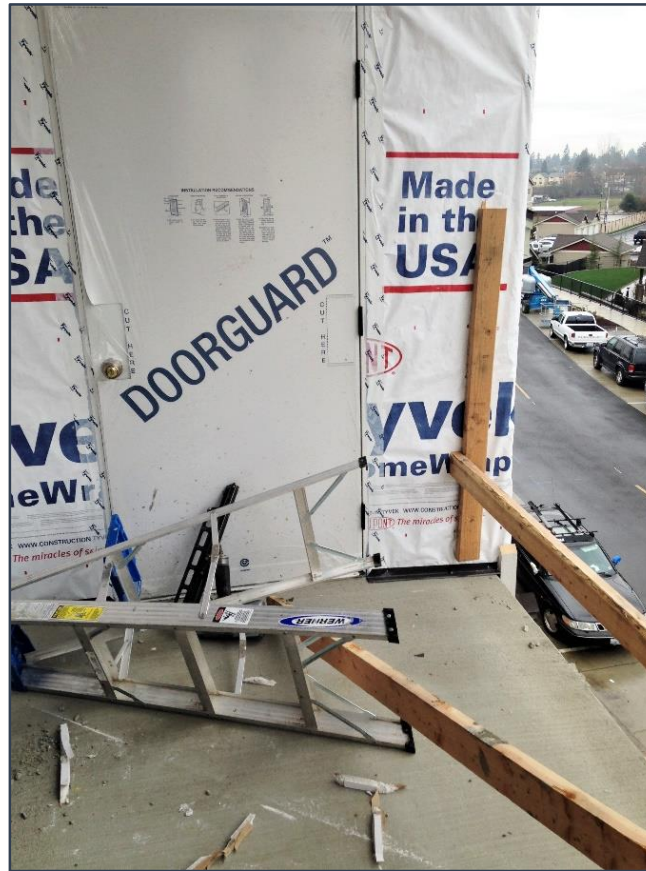
Investigators determined that the temporary guardrails on the balcony, and many others throughout the five building development, were improperly installed by a framing contractor.

The original guardrails on the incident balcony had been removed by a siding contractor and his employees so that they could install moisture barriers on the building exterior. When they replaced the guardrails, they also did so improperly.

Photo 1. Incident scene on a third floor balcony of the apartment building under construction. The sider who was standing on the stepladder put one foot on top of the temporary wooden railing. As he did so, the railing came loose and he fell 23 feet to a sidewalk below.

- General contractors have a responsibility to ensure the safety of their worksite, not only for their employees, but also for subcontractors and their employees. See [WRD 27.00](#)
- Develop a written fall protection work plan including each area of the work place where the employees are assigned and where fall hazards of 10 feet or more exist.
See [WAC 296-155-24611\(2\)](#)

- Ensure that appropriate fall protection is provided, installed, and implemented when employees are exposed to fall hazards of 4 feet or more to the ground or lower level when on a walking/working surface.
See [WAC 296-155-24609](#)
- Conduct walk-around safety inspections of job sites.
See [WAC 296-155-110\(9\)](#)

- General contractors should convey firm expectations for using fall protection to employees and subcontractors before the job starts. During the job they should visit sites to monitor for compliance and take corrective action.
- All contractors should ensure that appropriate fall protection is used by workers. In this incident, for example, an extra guardrail could have been installed or workers could have used a personal fall arrest system.
- Consider using safer alternatives to ladders for working at height, such as a mobile baker scaffold with guardrails or a portable lift platform.

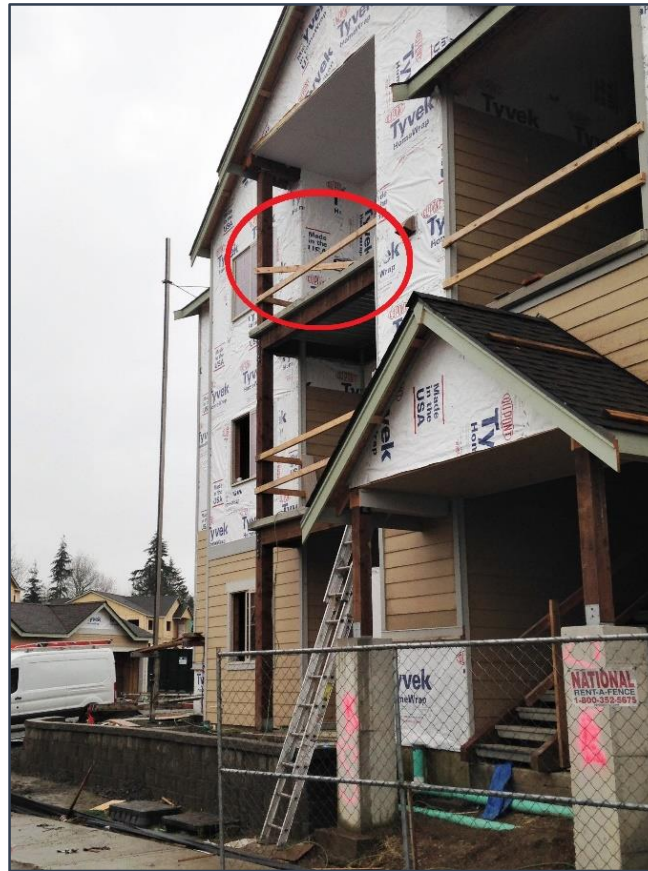
Photo 2. Incident scene showing third floor balcony of the apartment building (circled) where the sider was working. He was standing on an a stepladder, and as he reached above to take measurements for a soffit, he put one foot on top of a temporary wooden railing. The railing came loose and he fell 23 feet to the sidewalk below.

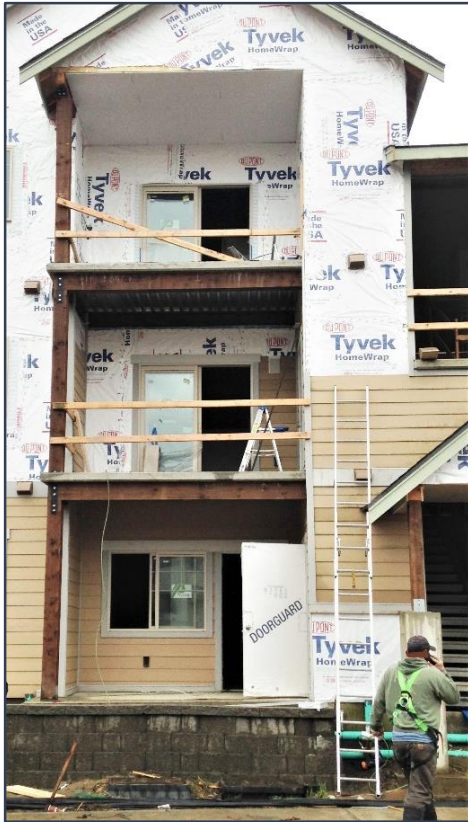
Incident apartment building with temporary wooden balcony railings.
Photo 3 shows the railings shortly after the victim fell from the third floor balcony.
Photo 4 shows the same building with temporary railings installed properly.

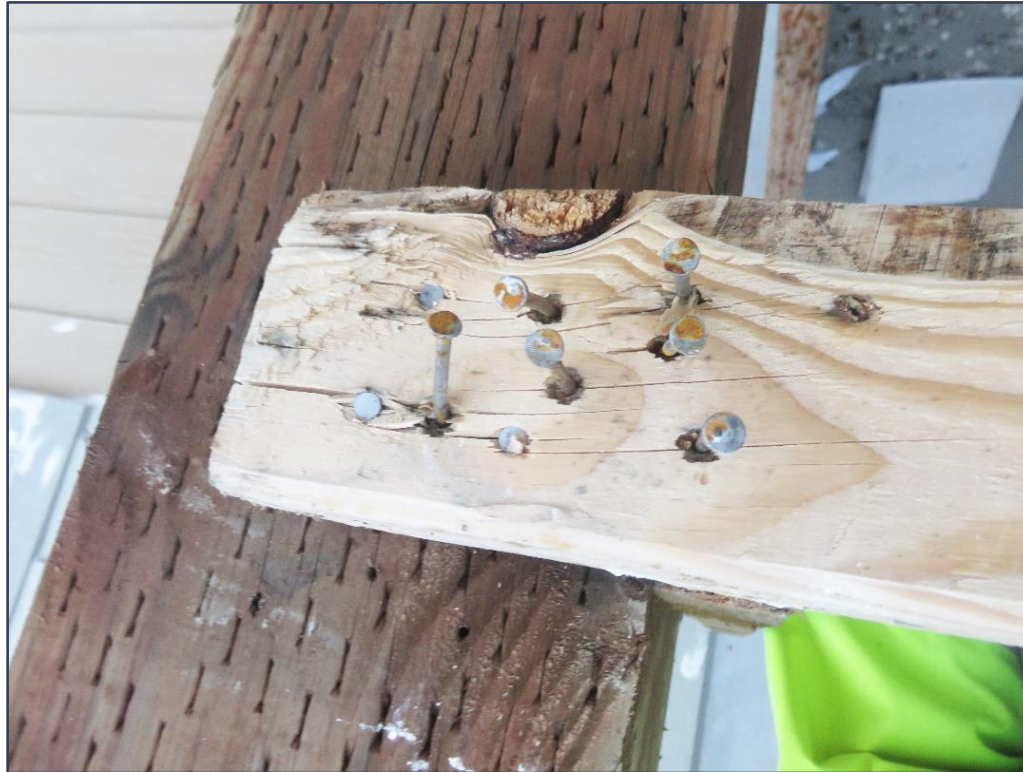
Photo 5. Railing (not incident railing) at job site showing multiple nails. Workers needed to remove railings to install moisture barriers on the building.
