## INCIDENT FACTS

71-240-2023

Trench collapse

## Contractor and Laborer Buried in Trench Collapse

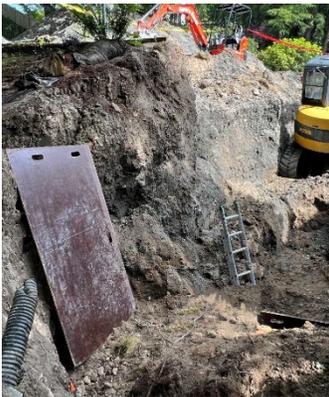
Unbraced steel shoring plate resting against trench wall.

- Trench protection (shoring, shielding, benching, and sloping) was not used.
- There was some shoring equipment on site, but it was not adequate for the trench.
- No safe means of egress from trench.
- The employer had previous safety violations, including having workers in unprotected trenches and no ladder as a means of access and egress in a trench.

- Never enter a trench or excavation that does not have an adequate protective system in place.
- Inspect the trench or excavation before entering.
- Do not assume there will be a warning sign before a cave-in or that you will have time to escape.

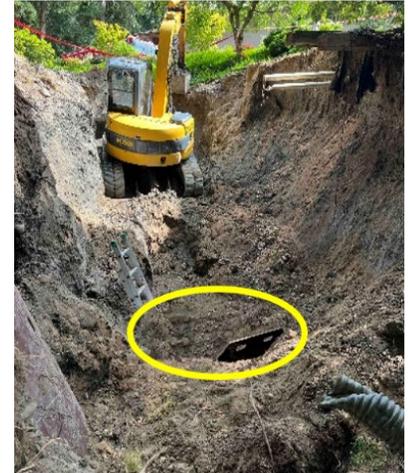
On the morning of the incident, one of the workers used the large excavator to scoop out the collapsed soil. Another worker used a smaller excavator to push the spoils pile back from the trench edge. The contractor and a laborer then used an extension ladder to enter a 10-foot deep ditch in the larger trench. The contractor located the sewer line. He then told the other workers he was going to replace a section of the old line. A few moments later, the trench wall collapsed, burying him and the laborer. The two workers died of asphyxia due to suffocation.

The yellow circle shows the ditch inside the trench where the contractor and laborer were buried.
