Farm Laborer Caught in Hay Baler

Industry: Hay farming

Task: Greasing baler gear box

Type of Incident: Caught in machinery

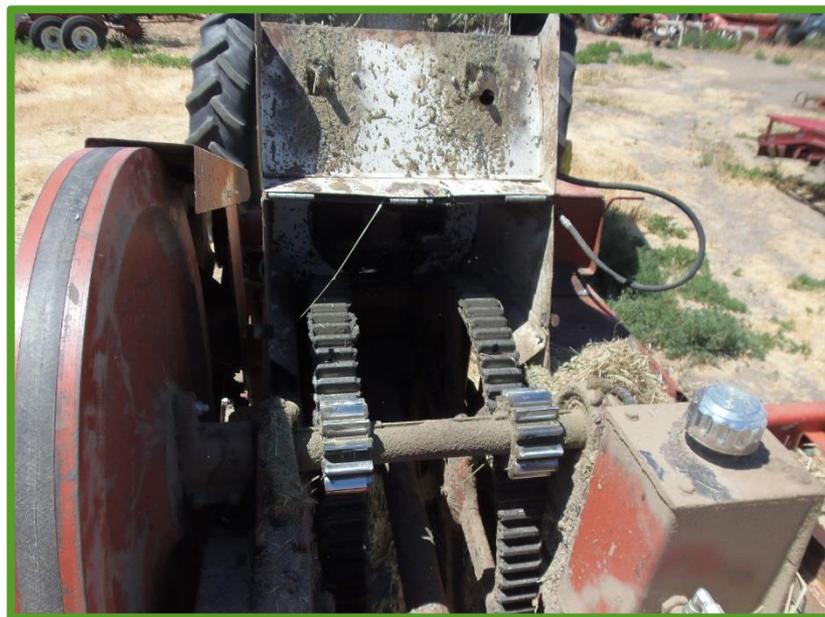
In June of 2016, a 29-year-old hay farm laborer's legs were seriously injured when they were caught in a hay baler's machinery.

On the day of the incident, the laborer had finished baling hay for the day. He then went to do routine maintenance on the baler by greasing its bull gears. These two gears are driven by a flywheel which is powered by the PTO. The gears in turn power the plunger and the feed fork which together produce bales. The manufacturer's specified method of spreading the grease on the gears was to put grease in the luber compartment while hand turning the flywheel and the lube pump crank.

- Equipment operators should familiarize themselves with the manufacturer's operating manuals. These manuals are critical sources of safety information and should be available for reference.
- Repair broken or malfunctioning equipment.
- Do not alter equipment or machinery unless approved and specified by the manufacturer.

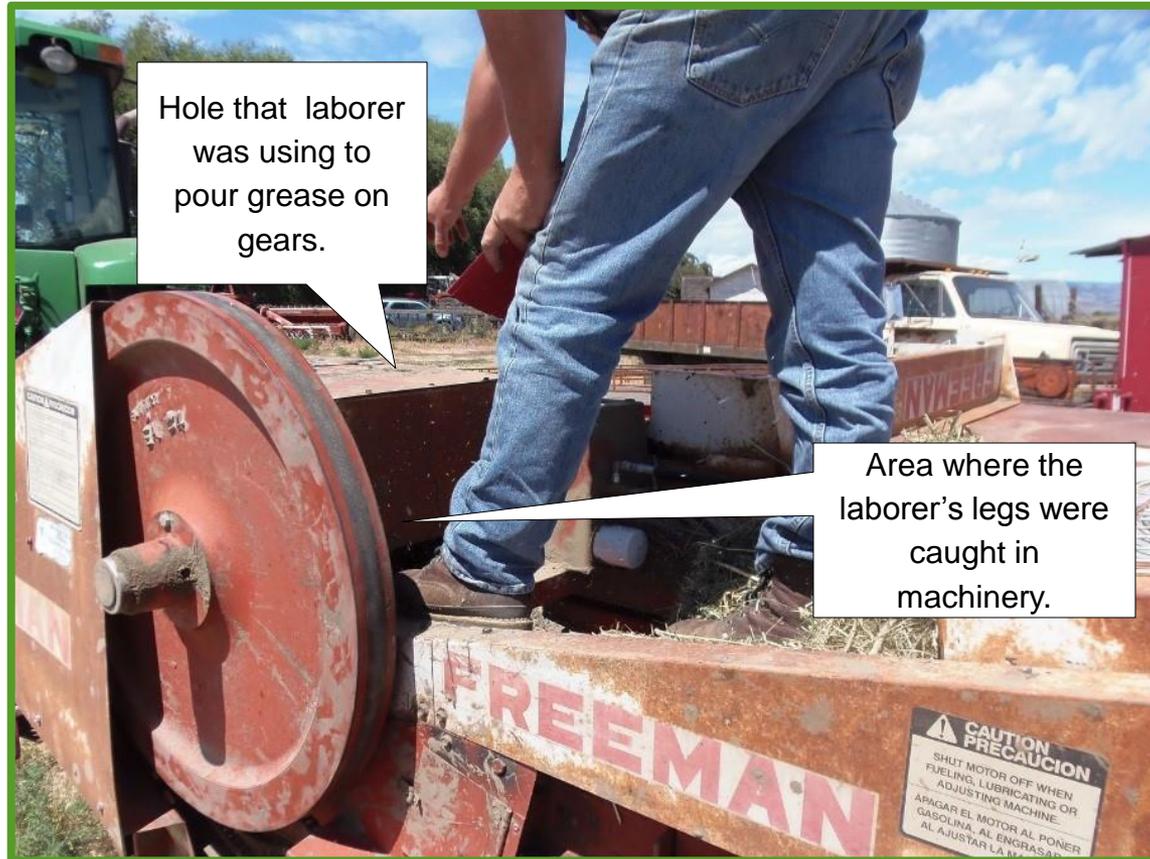
Reenactment of incident scene on top of the baler showing where the laborer was standing when the PTO was activated by another laborer.

Both the manufacturer's operating manual and safety stickers on the baler stated that the tractor motor should be shut off when fueling, lubricating, or adjusting the machine. As the laborer was standing on top of the baler pouring grease through one of these holes, another worker thought he was signaling to turn on the PTO and did so. The laborer was standing on the plunger in a 4½-inch gap between a baler brace and the plunger when it started to move up and down. Both his legs were caught in the machinery. The operator realized what had happened and turned off the PTO.

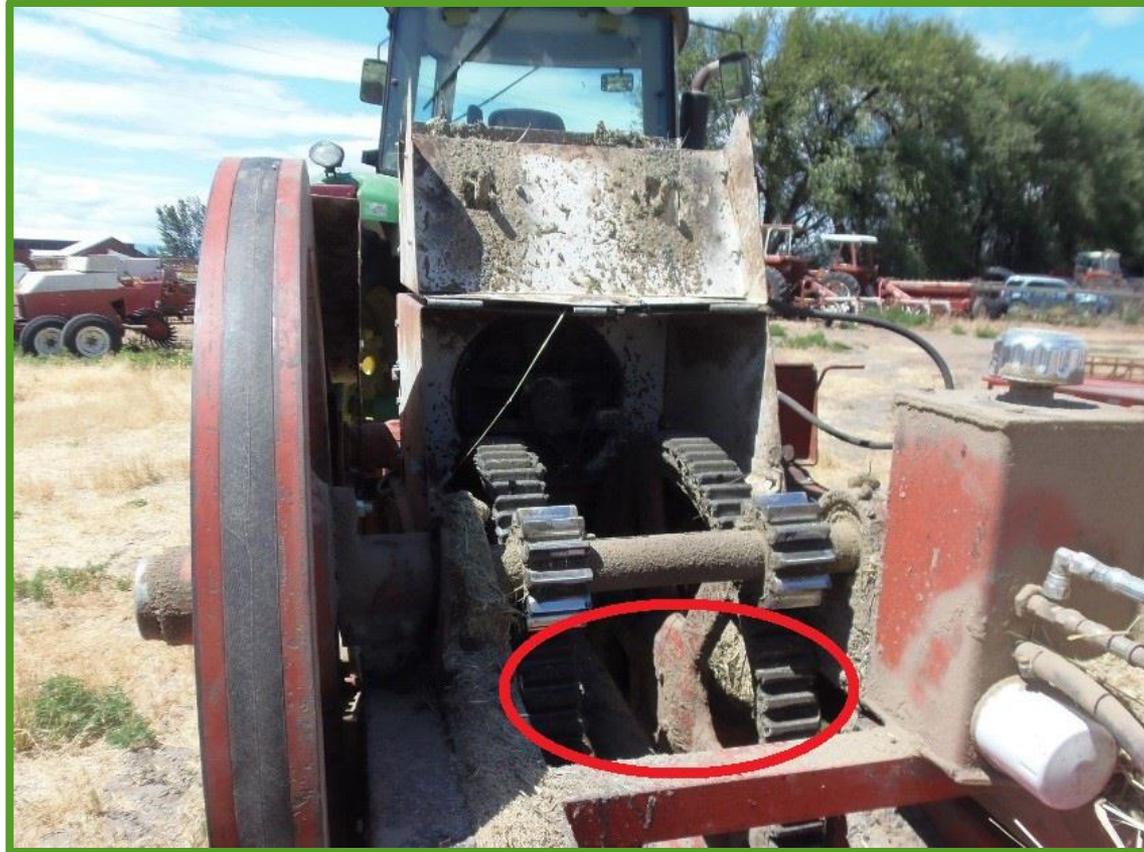
The laborer's legs were caught in the baler's machinery when the PTO was turned on while he was lubricating the gears. The bull gear/plunger shield is shown in its raised position. It was lowered during the incident.

- Ensure that safe work practices are followed, including disengaging the PTO and shutting off the tractor engine prior to working on PTO powered equipment.
- Maintain and operate machinery according to the manufacturer's specifications.

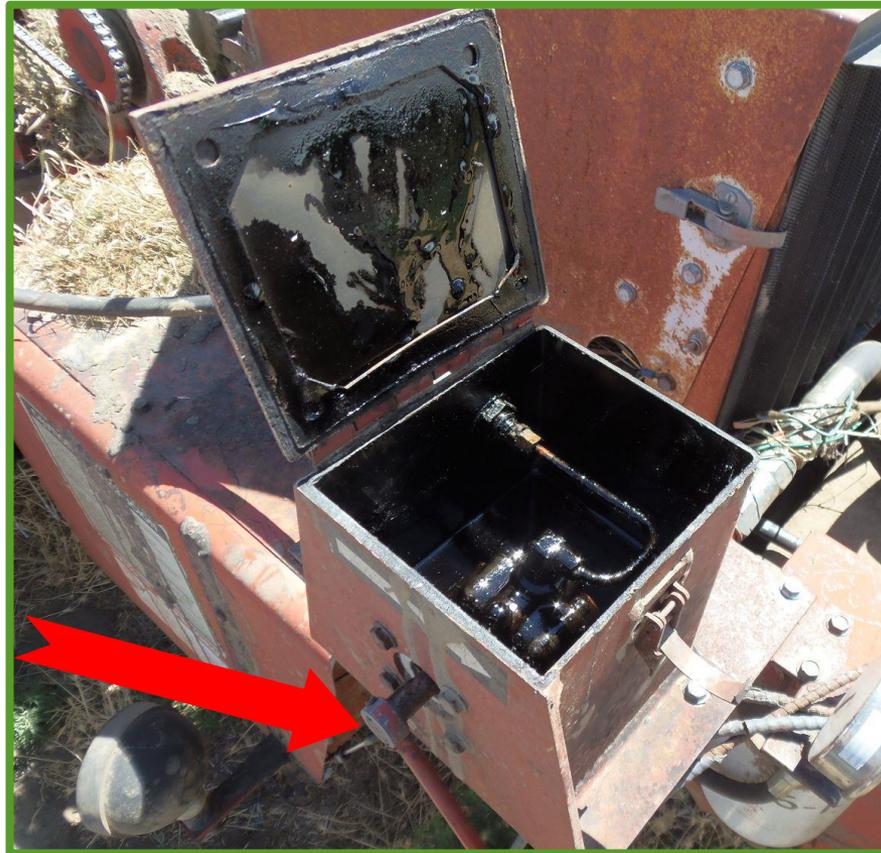
The bull gear luber which is the manufacturer's specified method of lubricating the baler's bull gears. The hand crank (arrow) would not turn, so the laborer did not use this method.

The laborer could not get the hand crank on the bull gear luber to turn. His employer told him that if the crank would not turn to get up on the baler and grease the gears directly. The employer had made two holes on top of the shield surrounding the bull gear and plunger so that grease could be poured directly onto the gears. The employer's practice was then to turn on the power through the PTO to the baler to activate the gears and distribute the grease.

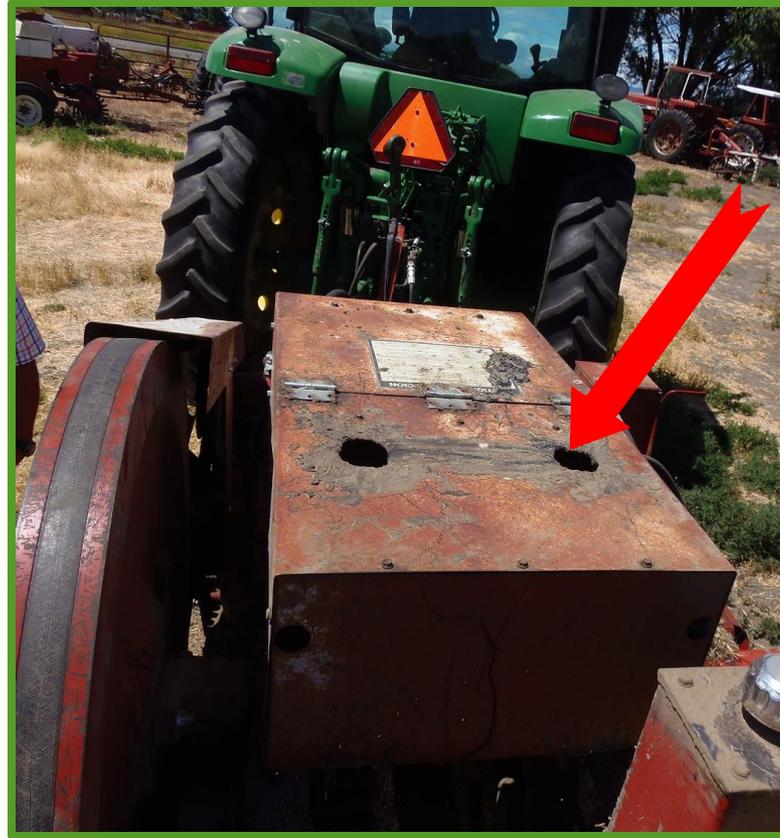
Holes that employer made in bull gear shield to pour grease on the gears.

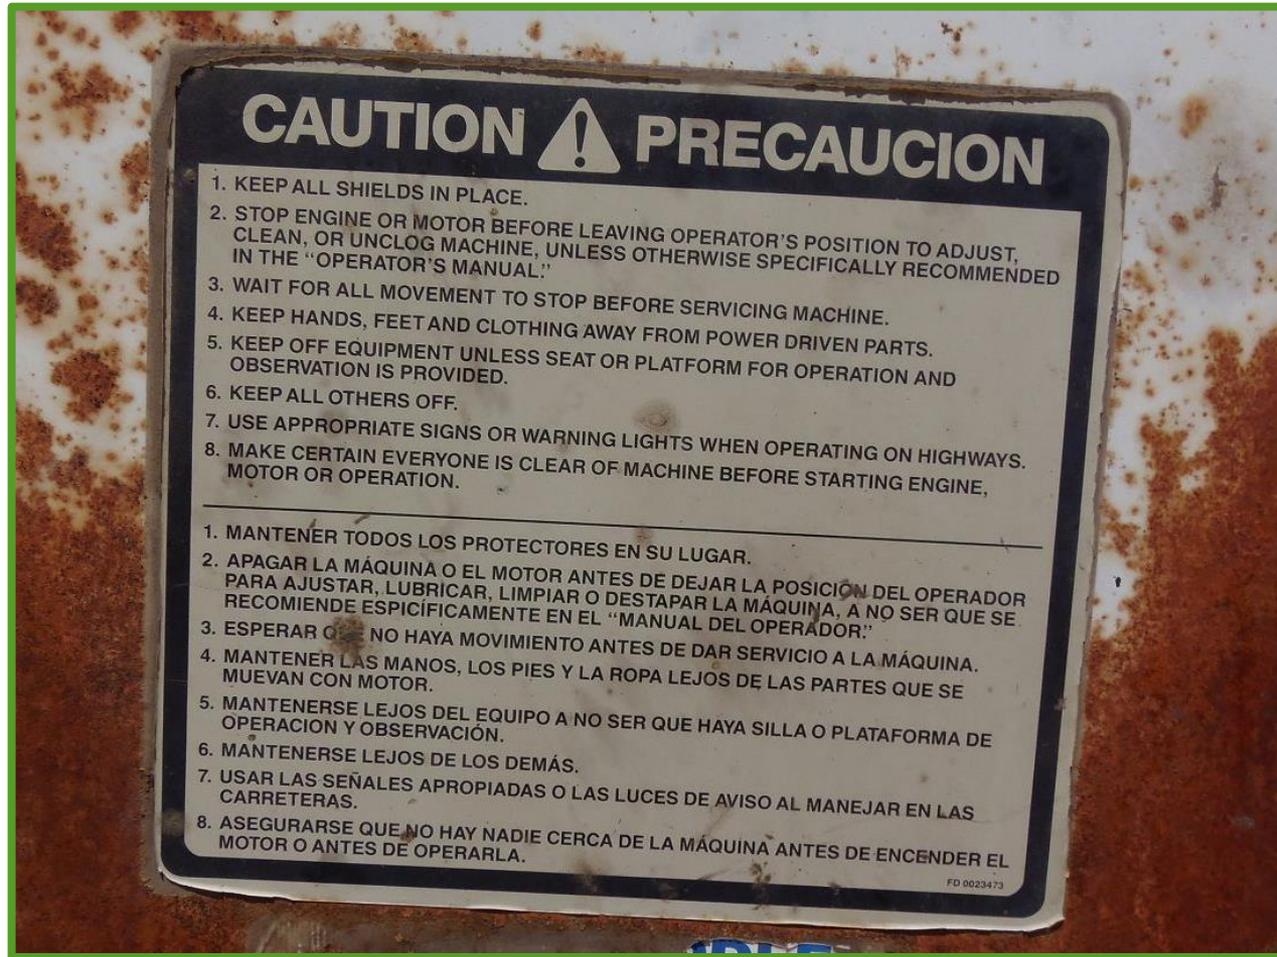
Sticker on baler with instructions for safe operation of baler.

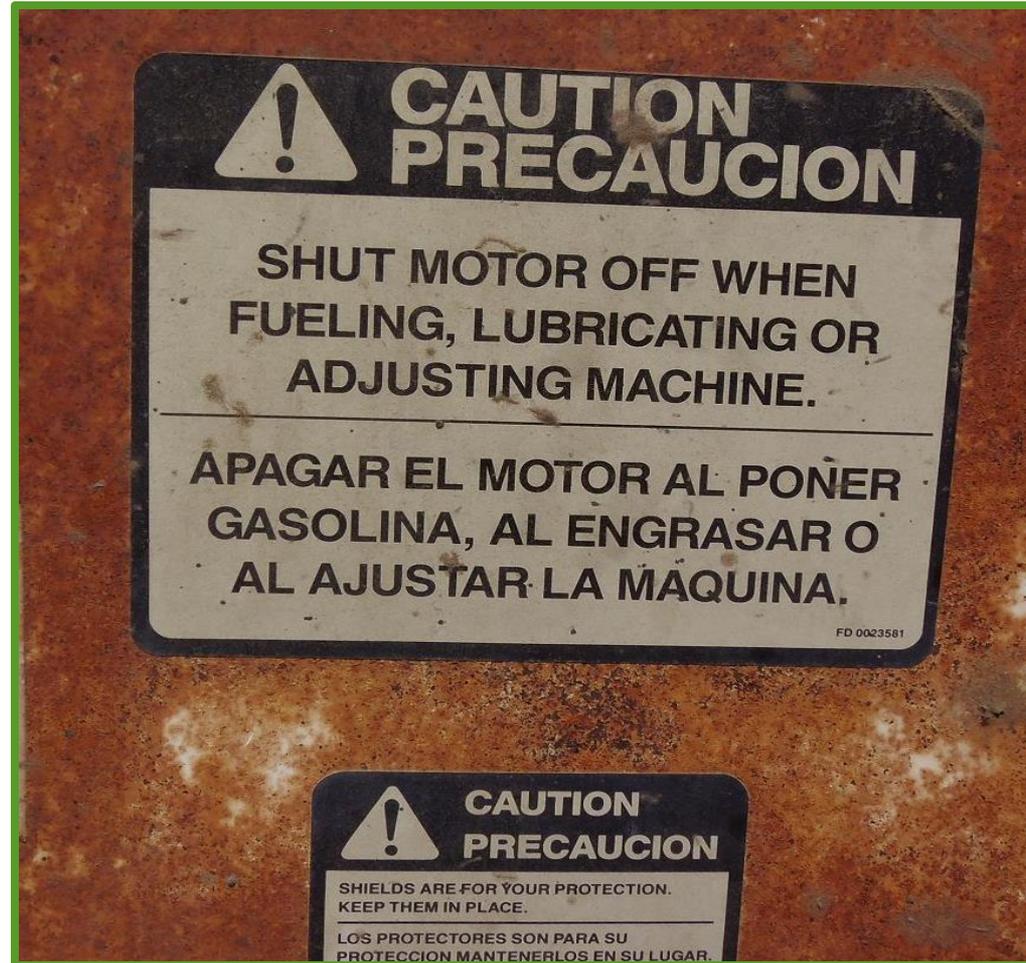
Sticker on baler with instructions for safe operation of baler.
