Worker's Foot Amputated, Lung Collapsed by 3.5 Ton Steel Container

Industry: Steel Manufacturing
Task: Grinding

Release Date: August 18, 2011
Occupation: Welder

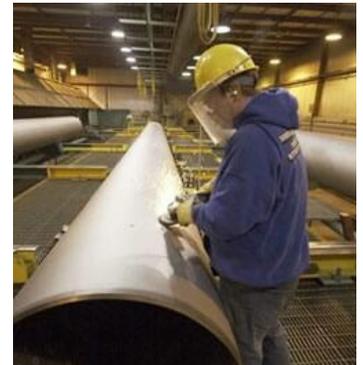
A 22-year-old welder's foot was severed and a lung collapsed when a 7,000 lb steel container he was grinding tipped over onto him. After his injury, it was learned that the power rollers used to rotate the container were not aligned and needed replacement. New rollers were available but had not been installed. Additionally, the stop button for the power rollers was not working. Since the incident the welder has had multiple surgeries and has suffered from depression. After 26 months, he has yet to return to work.

- Verify that controls are within reach of the operator and that they can stop the machine. See [WAC 296-806-20008](#).
- Ensure emergency stop controls are kept in good working condition. See [WAC 296-806-20012](#).
- Protect employees from machine hazards created by falling objects by using one or more safeguarding methods. See [WAC 296-806-20038](#)

- All workers should be trained on how to recognize and minimize work hazards.
- Inspect working areas to ensure that they are free from hazards and set up properly.
- Report unsafe work stations and do not allow or do work in those areas until hazards have been corrected.
