Fifteen-Year-Old Worker Falls from Roof of Building in Washington State

FATALITY INVESTIGATION REPORT

Investigation: # 98WA11301
SHARP Report: # 52-7-2002

Release Date: February 25, 2002

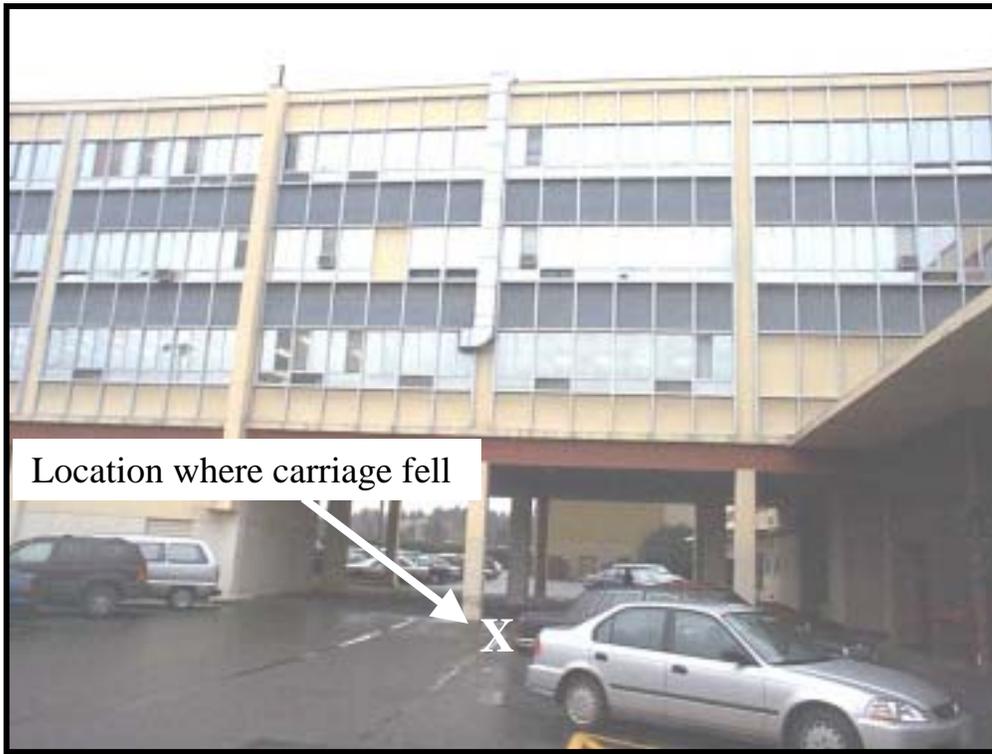
Figure 1. The building from where the victim fell.

On August 17th, 1998, a Monday morning, two crews of two workers went to work cleaning windows at a mall and nearby medical office building (Figure 1). One crew was to clean the skylights of the large mall and the other, the 4-story medical office building's windows. Work started between 9 and 10:30 a.m. The crew working on the mall building in the morning consisted of an experienced window washer and a helper who was 15 years old. The crew working on the medical office building also consisted of a more experienced window washer and a second 15 year-old helper.

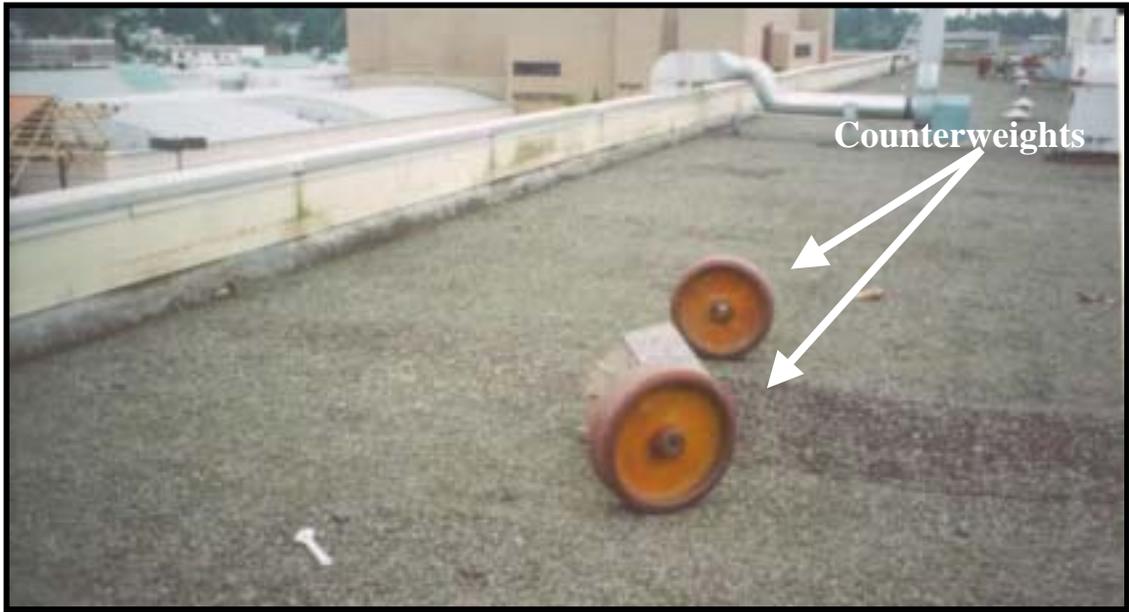
Figure 3. Roof top from where victim fell and counterweights.

The FACE investigation review of this incident revealed that the carriage was not properly counterweighted and was not tied into an independent anchor point. Shortly after the incident occurred, during WISHA's investigation, the counterweights were found on the roof at what appeared to be the previous set-up location where the window washer’s carriage had been. There was no evidence that tie-backs had been used to secure the carriage in either location.

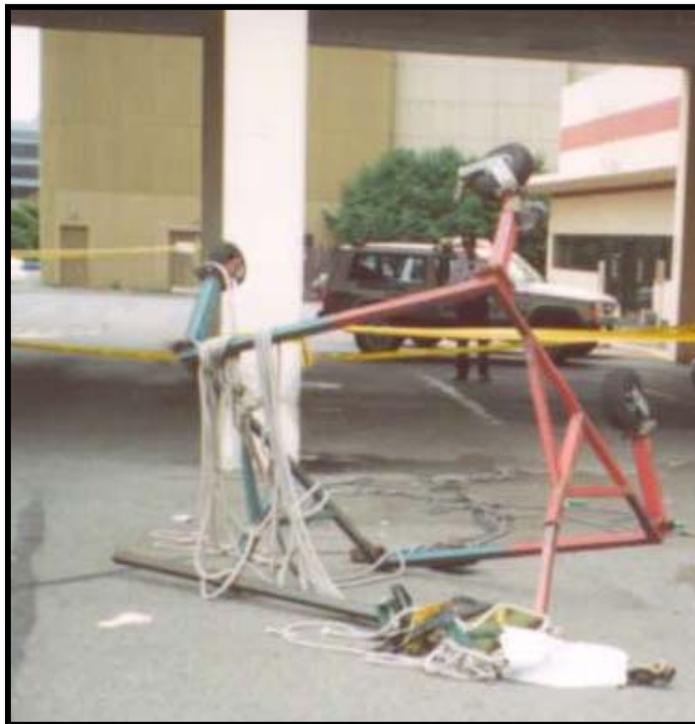
When the window washer and his helper (the victim) got back on the roof, they put on their fall protection/fall arrest gear and anchored themselves to the carriage. The window washer then positioned himself in the boatswain's chair over the side of the parapet. To test the set-up, the window washer bounced in the chair. Because the carriage did not have counterbalance weights attached and was not anchored to an appropriate anchorage point, his bouncing action caused the carriage to be pulled up to the top of the 30-inch parapet. For a short time, one of the carriage's wheels caught on the edge, but was then pulled completely over the edge of the building (Figure 4).

Figure 4. The carriage after falling.

The two window washing employees were using the roof-top portable carriage as their fall protection anchorage. In this incident, the roof-top portable carriage failed due to not being properly set up and secured. The weight of the window washer pulled the carriage off of the roof.

Recommendation #2: The window washer’s “portable support device” (carriage), should be set up with appropriate counterweights and tie-backs. The tie-backs need to be attached to approved, specifically engineered anchorage points.
