Lineman Killed After Being Struck by a Car in Washington State

FATALITY INVESTIGATION REPORT

Investigation: # 00WA040
SHARP Report: # 52-10-2003

Release Date: December 30, 2003

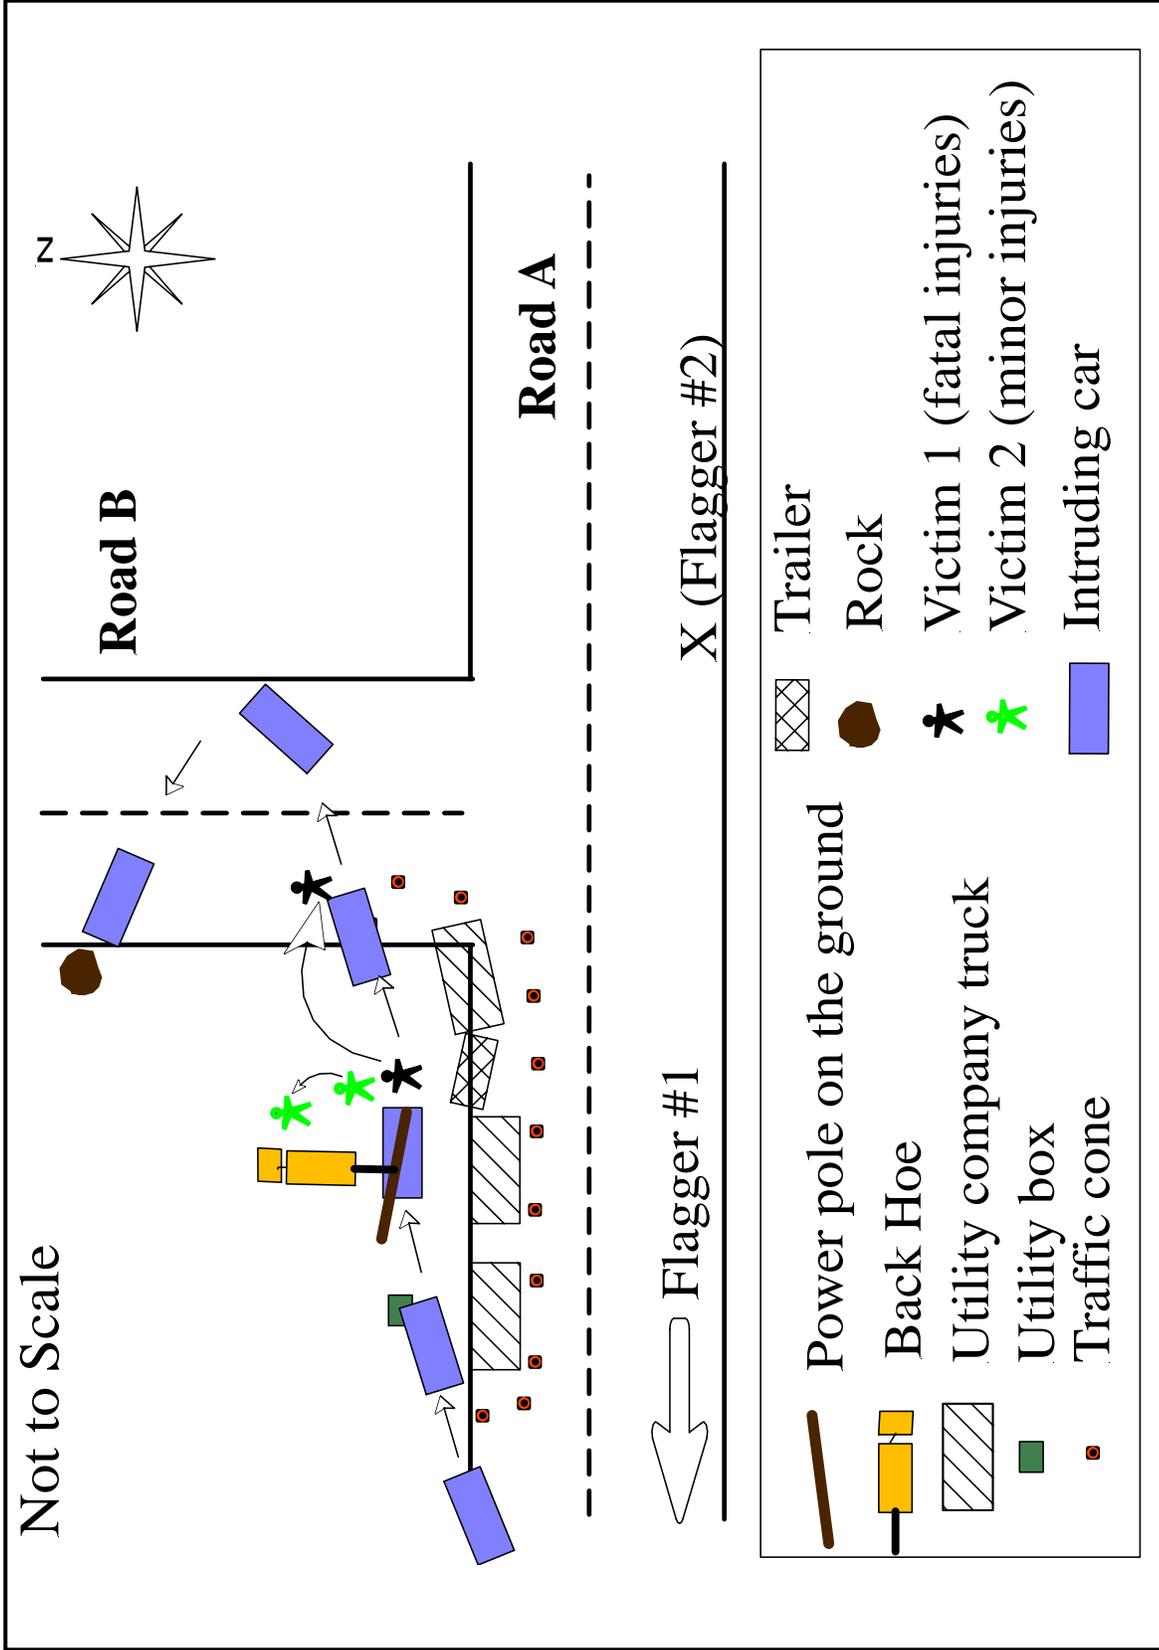
The incident site was located at the “T” intersection of two rural county roads (Figure 1 roads A and B). Both roads were two-lane asphalt-surfaced arterials with moderate traffic flow. Figure 1 shows the road layout with respect to the work zone, the incident site, and the travel path of the intruding vehicle. Flaggers were located west (flagger #1) and east (flagger #2) of the work site along road A. Flagger #2 was positioned along road A and would help direct traffic that would be traveling north and south on road B. Both flaggers were certified, as required by the state. All the utility vehicles had their flashing warning beacons on. A backhoe was also being used in the work area to help in the installation, set up, and positioning of the power pole.

Figure 1 Layout of the incident.

At the incident site, it was identified by WISHA and the Sheriff's Department that construction work signs and other traffic control devices had been set up to meet Manual on Uniform Traffic Control Devices (MUTCD)¹ guidelines as well as the Washington State Department of Transportation guidelines². The site layout is shown in Figures 1 and 2.

The driver still did not stop or slow down. After passing the flagger's station, the driver swerved his vehicle into the opposing lane, left the roadway just in front of a utility truck, crossed a 2 ft deep drainage ditch and entered the work area off of the roadway (Photographs 2 and 3). He then struck and crushed a telephone box and part of the new telephone pole that was being prepared for installation. The pole was suspended from one end by a backhoe and was in the process of having its frame attached by the victims. The vehicle struck the pole at a slight angle, drove under the elevated section of the pole, struck a portion of the frame that was being installed and continued

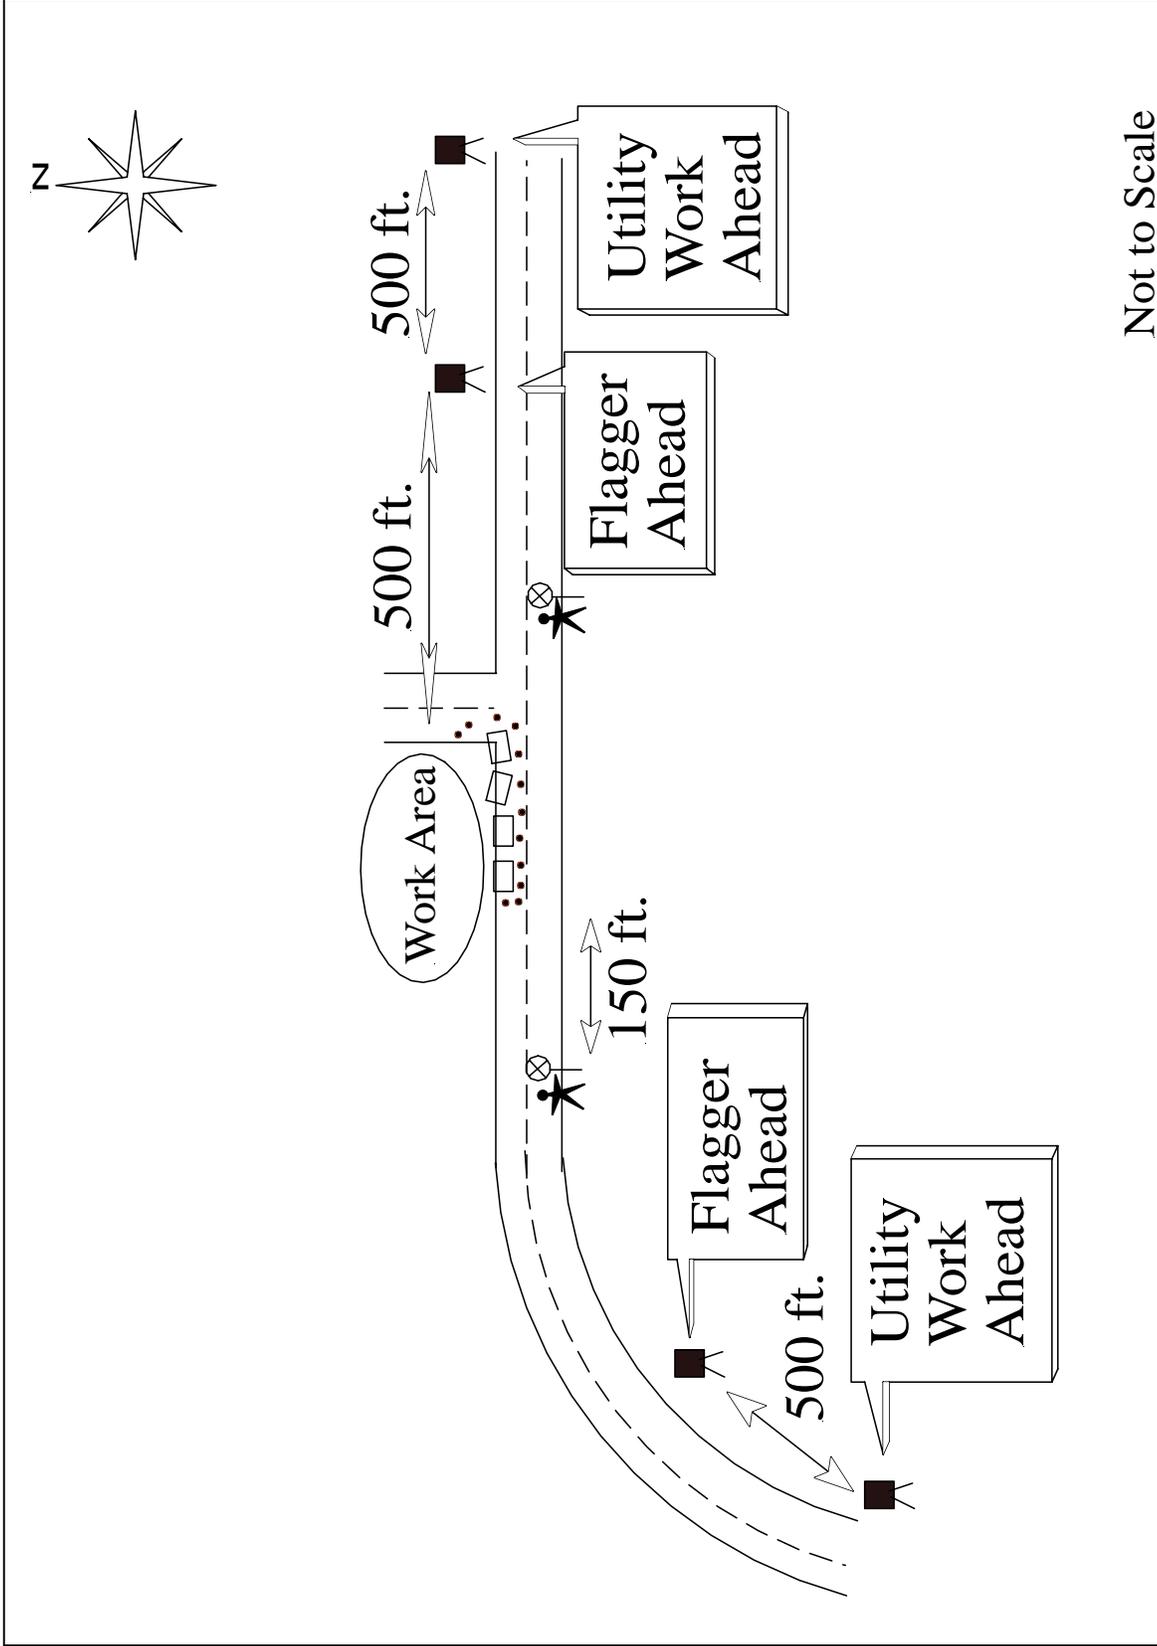
Figure 2 Layout of the work zone.

At the time of the incident, a new WISHA rule required the work zone to have at least 3 signs prior to the physical location of the flagger. The former requirement was for 2 warning signs (see Figure 2), as used in this work zone. In Washington State, if the Washington Administrative Codes (WAC) have more stringent rules for work zones than the MUTCD, then the WAC requirements take precedence over MUTCD guidelines.

The signage for the work zone could have been improved by having the following four signs:

- Utility work ahead,
- One lane ahead,
- Flagger ahead, and
- Prepare to stop.

Also more traffic cones or barrels in the down stream and shifting taper could have been used. This would have made the work zone more visible to eastbound traffic. The employer could also have set up “lane separating” channeling devices around the work zone to give the work zone more definition and make it more visible to drivers along the restricted area of the roadway.

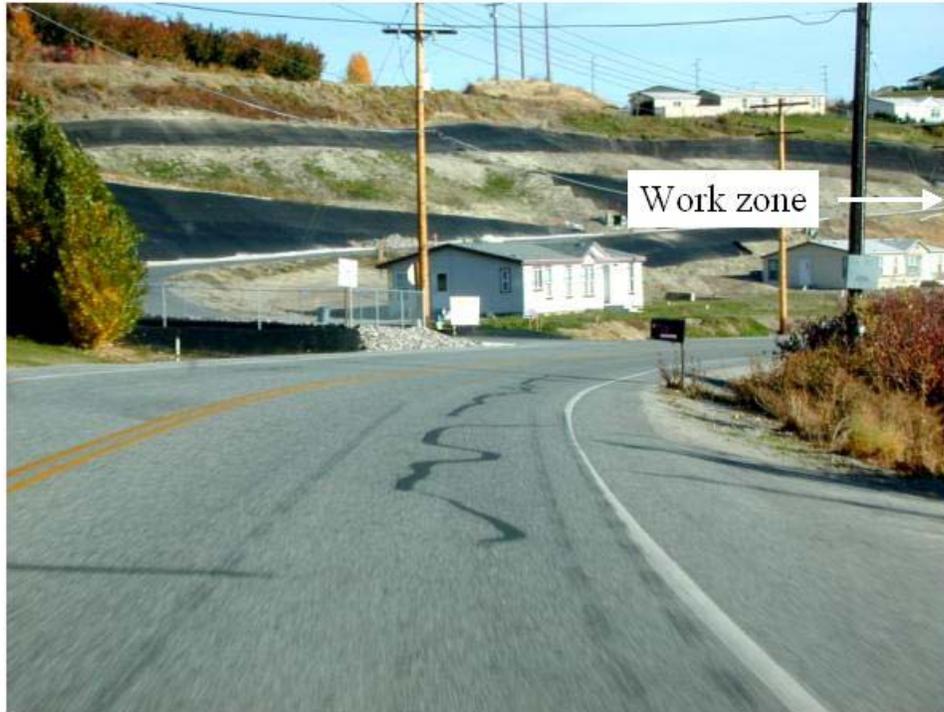
Photograph 1. View approaching the work zone from the south (direction from which the intruding vehicle approached).

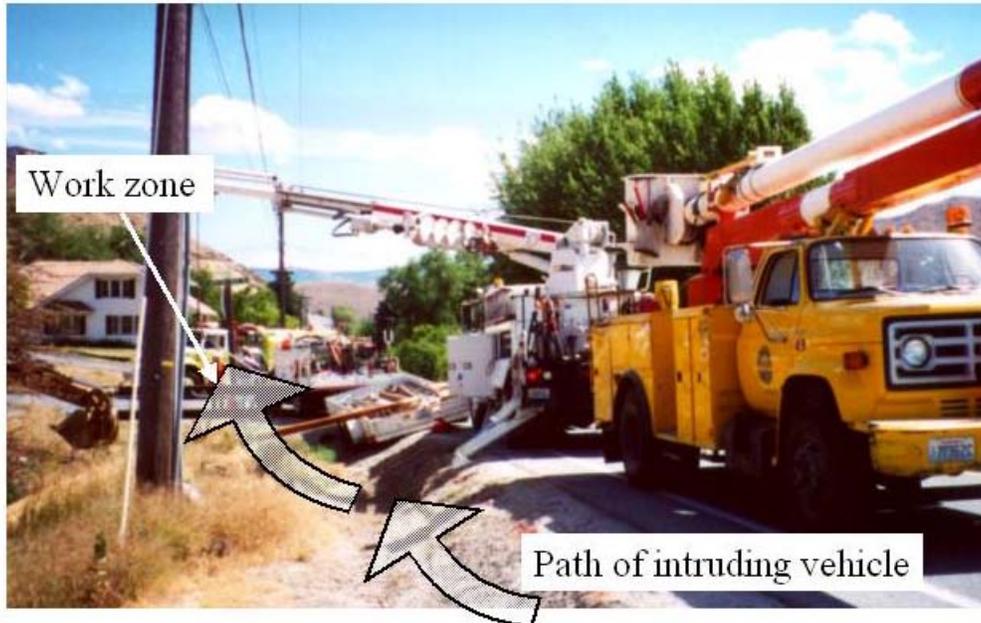
Photograph 2. The work zone.

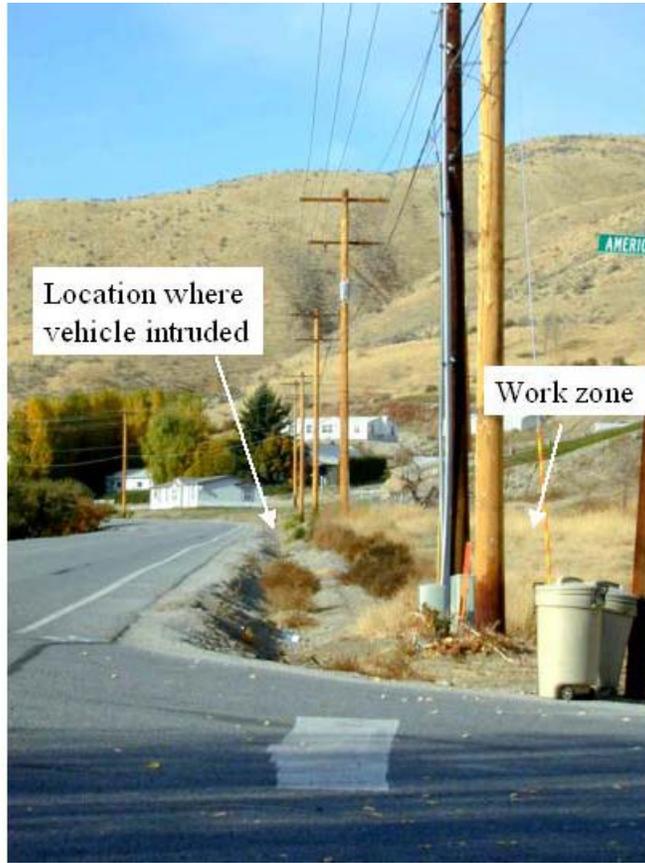
Photograph 3. The location of the work zone, after the incident.
