# Crane Operator Dies after Falling From Crane Turntable Deck in Washington State

Investigation: # 10WA046  
Release Date: October 11, 2011  
SHARP Report: # 52-22-2011

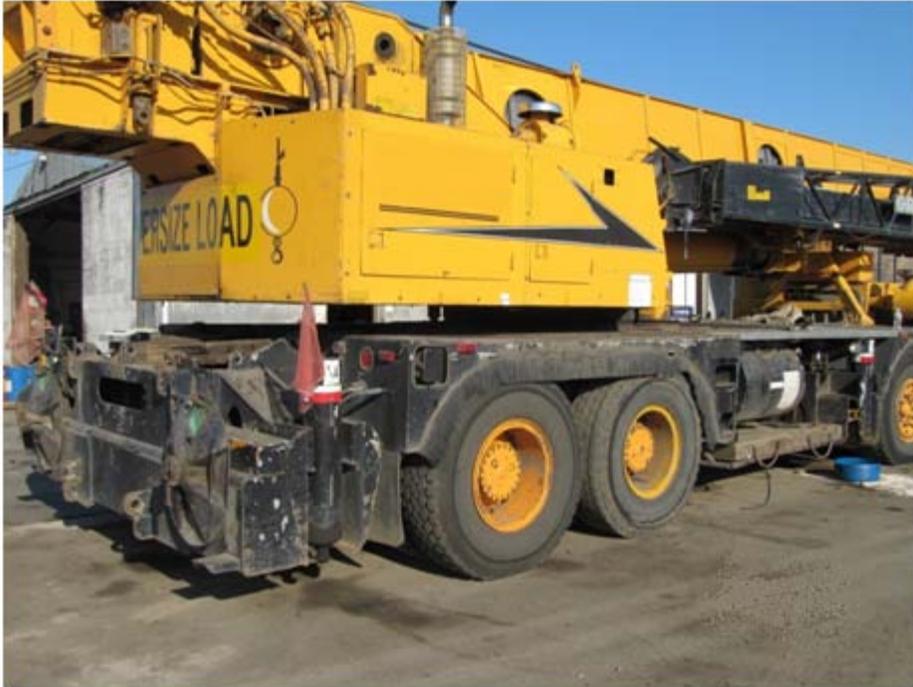
Photo 1. Incident crane viewed from the right rear. At the time of the incident the cab was rotated approximately 30 degrees right.

The crane involved in this incident was a 120-ton truck- or carrier- mounted hydraulic mobile crane with a telescoping boom (see photo 1). The crane's wheel-mounted truck carrier, designed for transporting the crane's superstructure which is mounted on it, is 40 feet 9 inches long by 10 feet 11 ½ inches wide. The top of the crane's turntable deck is 5 feet 1 ¼ inches high off the ground. The crane is designed to travel to and about a job site under its own power. It was manufactured in 1991 and was purchased used the employer. In addition to the original manufacturer's placement of ladders, steps, handrails, and handholds used to access parts of the crane and as aids to mounting and dismounting, the previous owner had added extra handholds and steps at various locations (see photos 3-5, 8, 9). The crane's walking surfaces were coated with an anti-slip coating. No modifications to the crane were made by the current owner. In Washington State all cranes used in construction must be certified that they meet certain requirements for safe operation, as specified by state law. The crane was a certified crane, as specified by state requirements. Comprehensive crane safety inspections are done yearly. Pre-job walk around safety inspections are performed by the crane operator before the crane leaves the company yard.

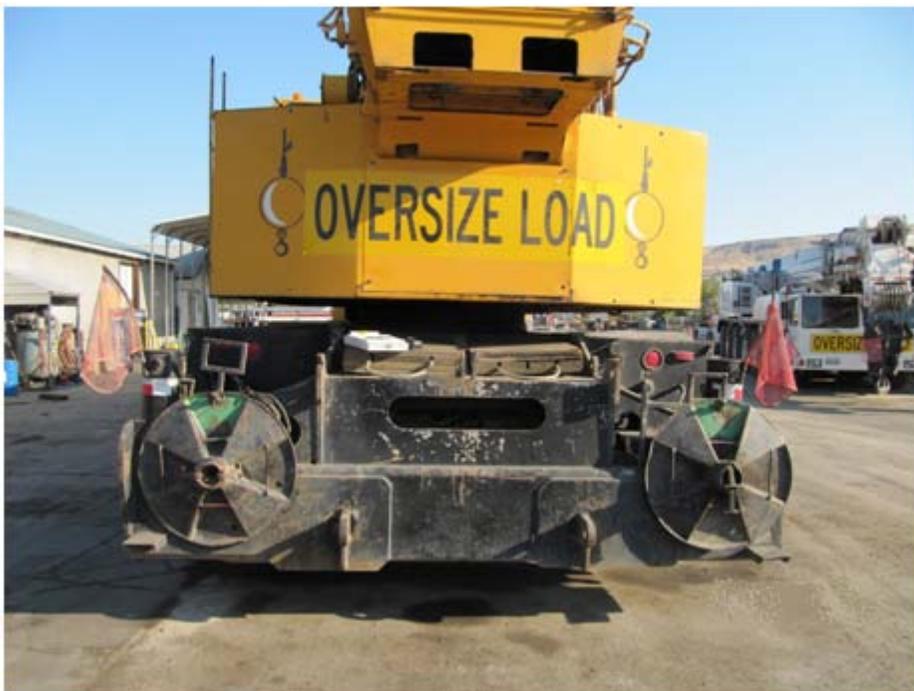
Photo 2. Incident crane rear view. Victim fell from the right rear crane turntable deck.

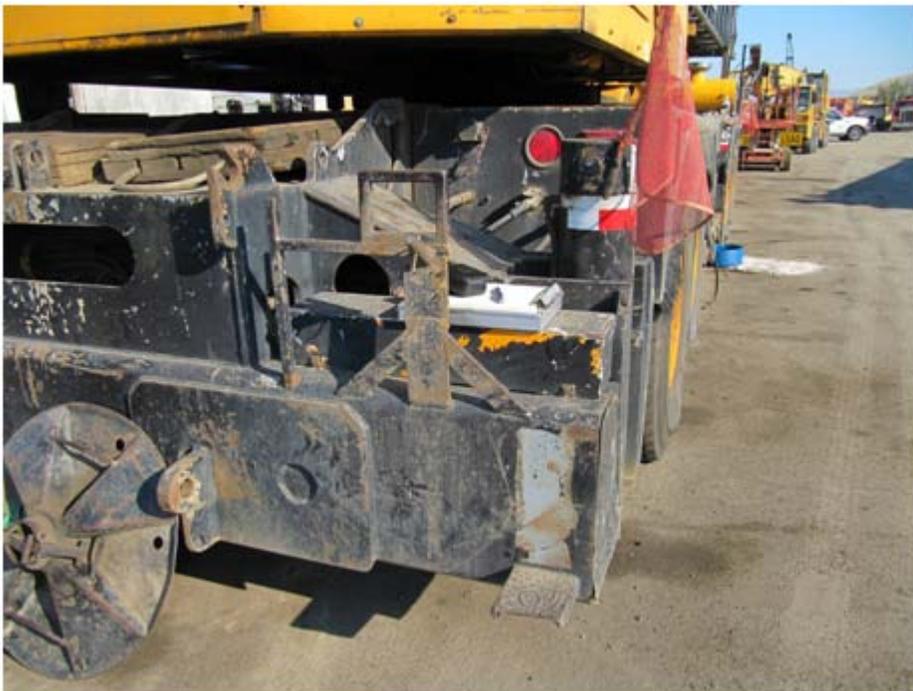
Photo 8. Incident crane rear access system where victim fell.

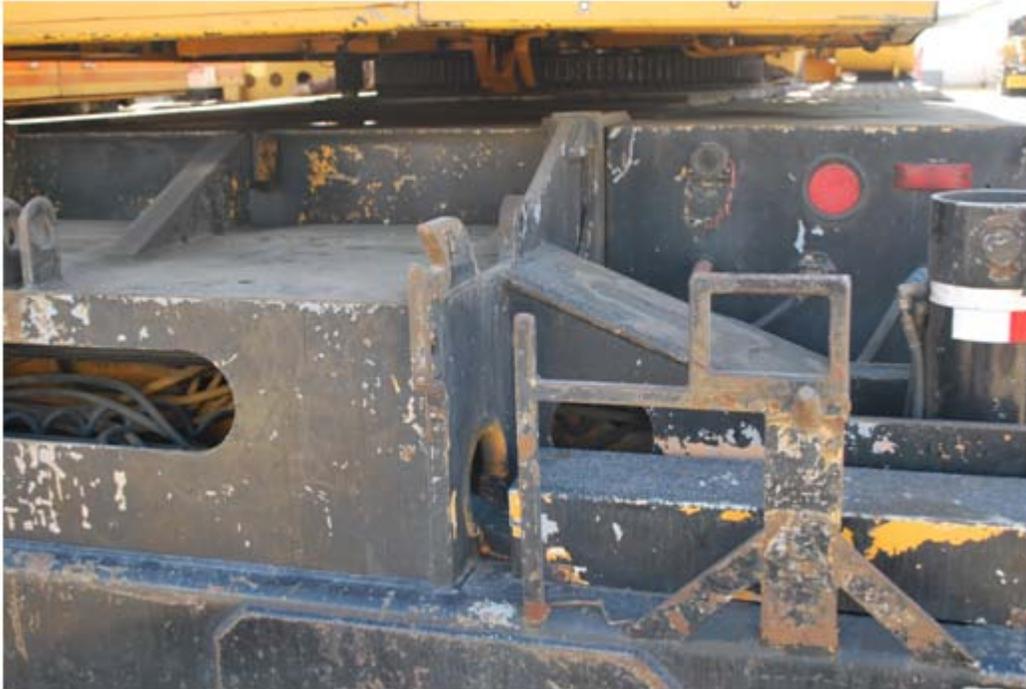
Photo 9. Incident crane close-up of features of rear access system.

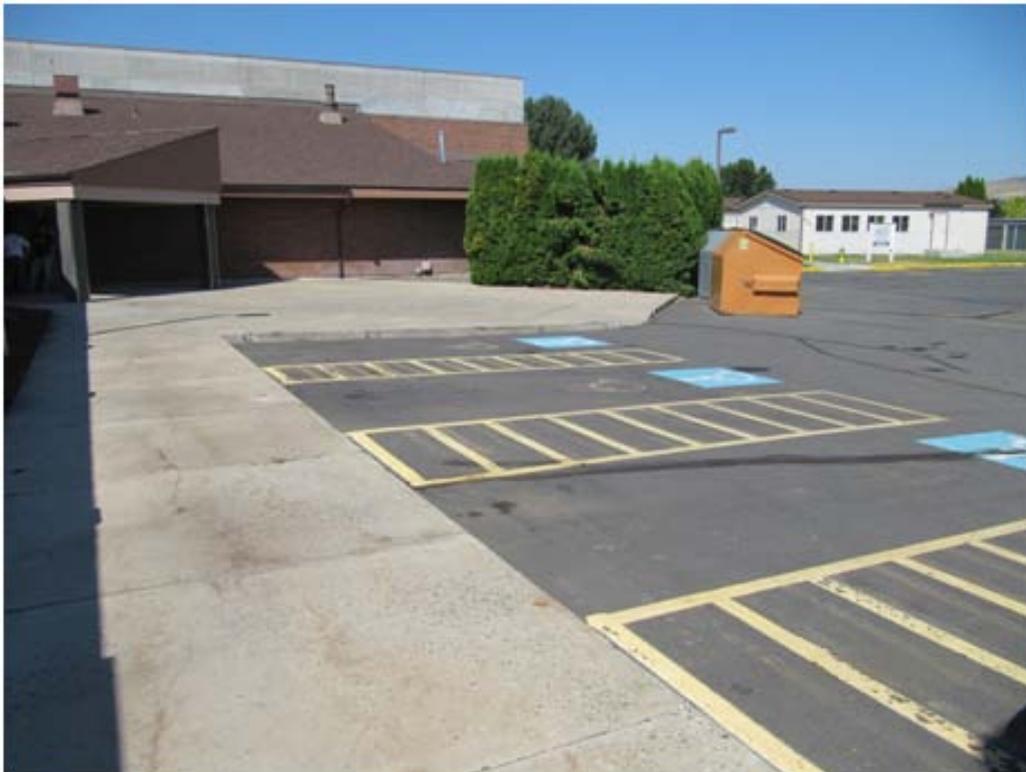
Photo 10. Incident location in parking lot of elementary school. Crane was backed into the parking stall in the upper middle of the photo.

The victim and oiler discussed what they needed to do and where to best perform the pick of the HVAC unit. The victim was responsible for making decisions about the lift at this job site; this was the normal company procedure. If the operator determined that there were any problems he would contact his company office and, if necessary, talk with representatives of their general contractor on the job site. They determined where they wanted to make the lift and in preparation for the lift they backed the crane into the school parking lot (see photo 10). Following standard operating procedures they put down cribbing, leveled the crane, and put down its outriggers for stability. The ground beneath and around the crane was a flat and level parking lot. The back of the crane was next to the curb of a concrete sidewalk.
