# Machinist Dies After Being Struck by Rotating Steel Bar Stock in Lathe in Washington State

Investigation: # 10WA01001  
Release Date: July 15, 2012  
SHARP Report: # 52-25-2012

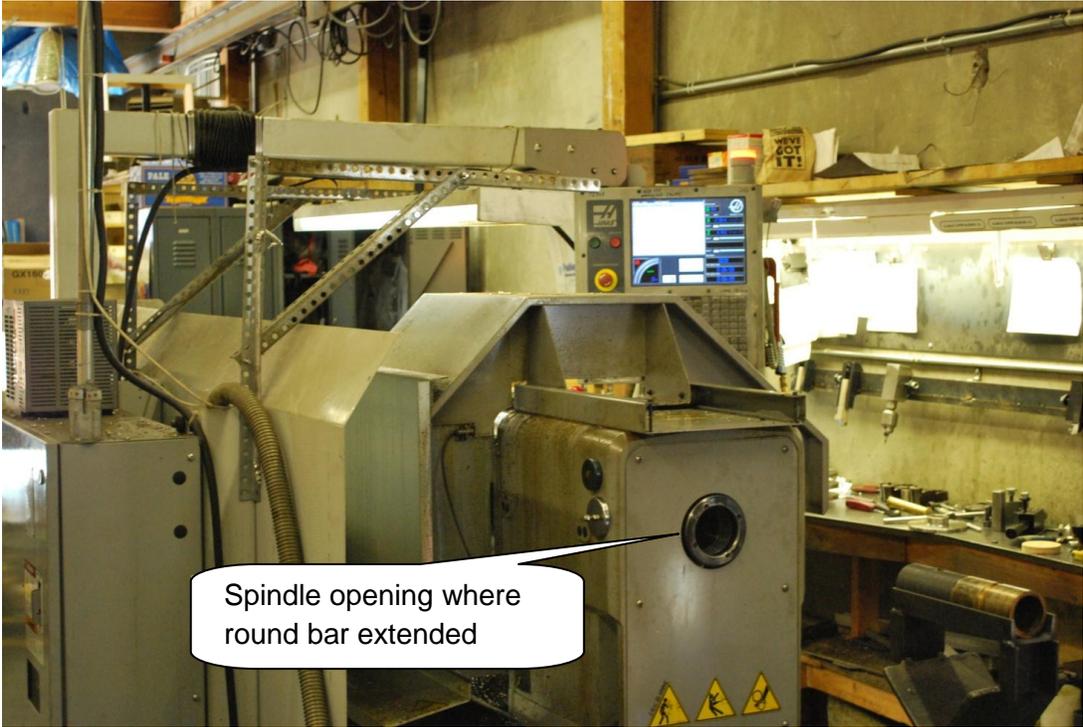
**Photo 1. HAAS Model TL-3 lathe viewed from rear showing spindle opening**

The lathe involved in this incident is a HAAS model TL-3W Computer Numerical Control (CNC) lathe (photos 1 & 2). It was purchased new by the employer and installed by a representative for HAAS. A lathe uses either automatic or manual controls to produce a machined product by rotating the workpiece against a stationary tool.<sup>[1, 2]</sup> This type of CNC lathe is controlled electronically via a computer-aided design (CAD) or a computer-aided manufacturing (CAM) program.

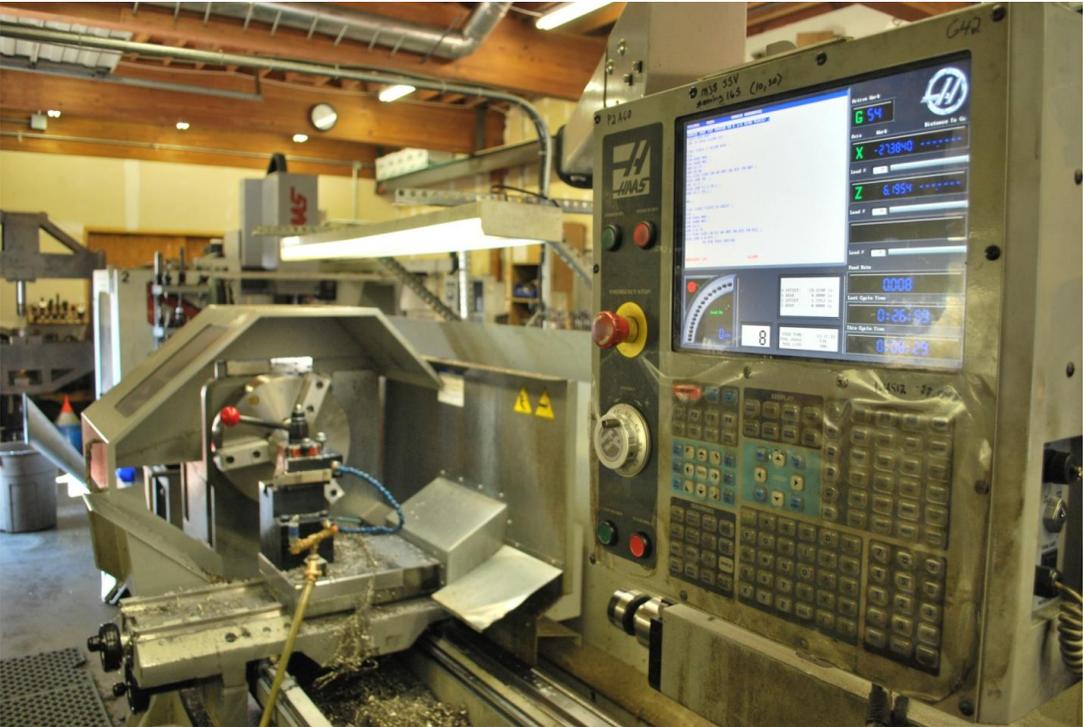
**Photo 2. HAAS TL-3W lathe bed, control panel, cutting head, and chuck**

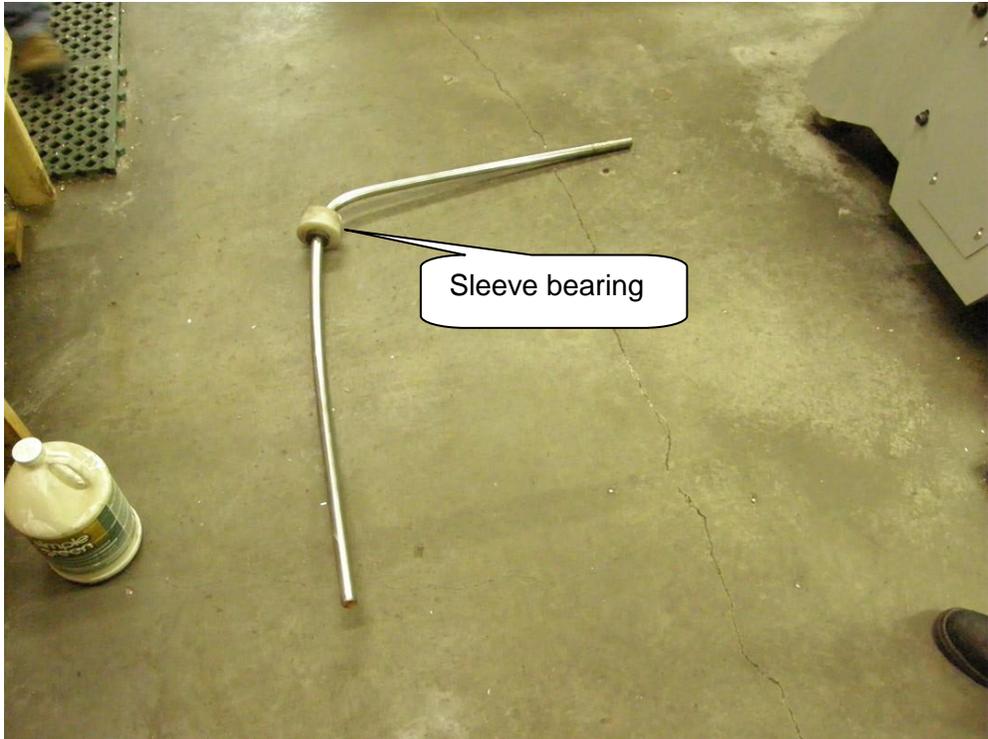
The maximum rotational speed of the lathe is 1,800 revolutions per minute (RPM).<sup>[3]</sup> However, the employer limited the speed to 1,000 RPM. The employer manufactured a sleeve bearing system to help support materials that extended into or through the spindle (photo 3). According to a HAAS representative, sleeve bearings like this are commonly used and recommended by the manufacturer to support material in the spindle but should not be used as the only support system for material extending past the spindle.

Soon after the victim started the lathe, the bar stock extending out the spindle bent to about an 80 degree angle (photo 3). The location of the bend in the stock was close to the center of the bar and adjacent to the sleeve bearing used to stabilize the spinning piece of stock. The bend caused approximately 3 feet of the bar stock to rotate outward

Photo 3. Bent bar stock with shop-designed plastic sleeve bearing

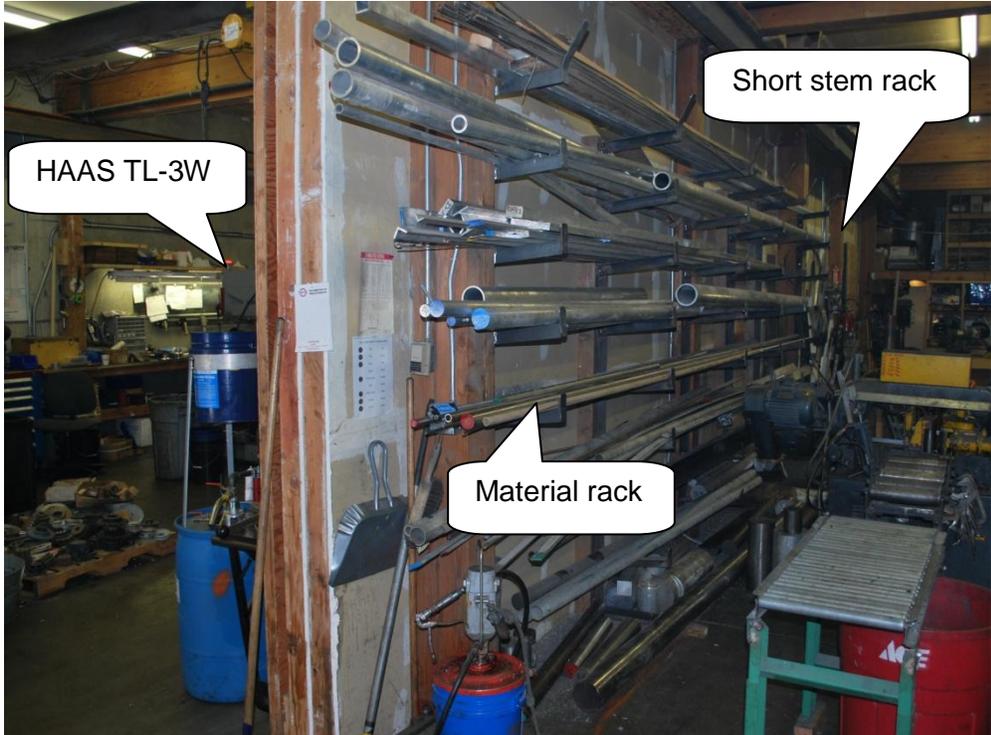
The material stock room and the shop's workroom where the HAAS TL-3W lathe was located were separated by a wall and a sliding door. Through the sliding door were material racks that held the longer and shorter pieces of stock. The short stock rack was approximately 15-20 feet away from the door (photo 4). The material stock room also

Photo 4. Shop layout showing material stock room relative to lathe

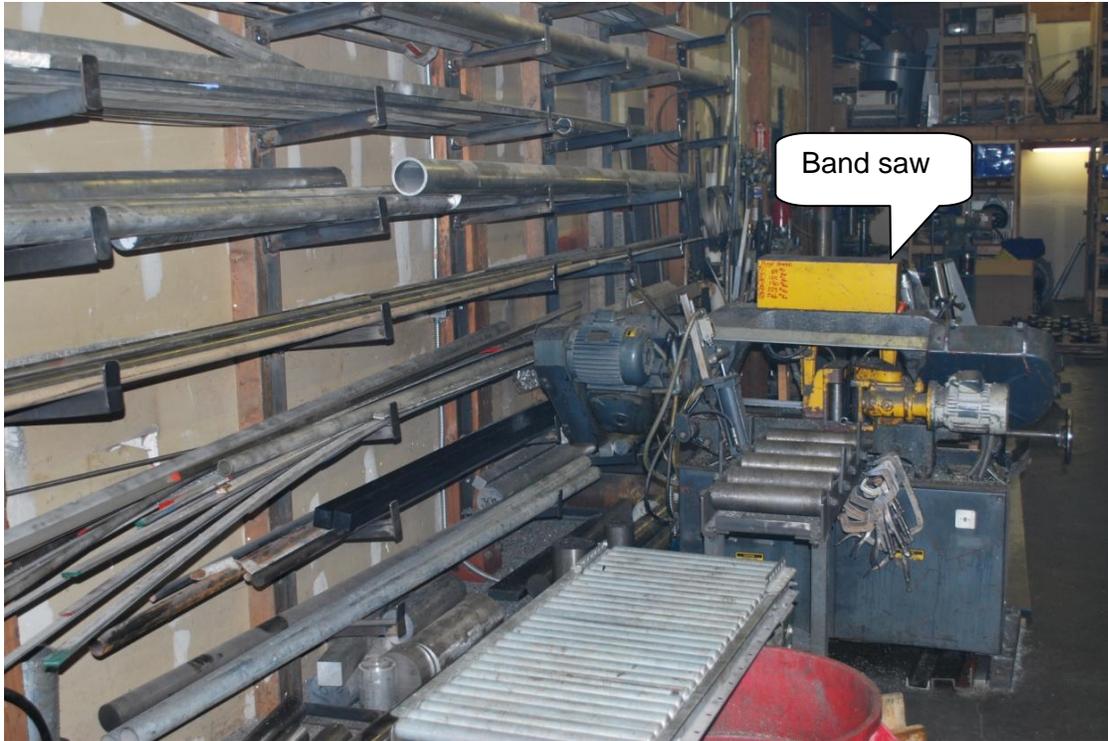
had a band saw that could have been used to cut longer pieces of stock into shorter lengths (photo 5).

Photo 5. Material stock room and band saw for cutting stock

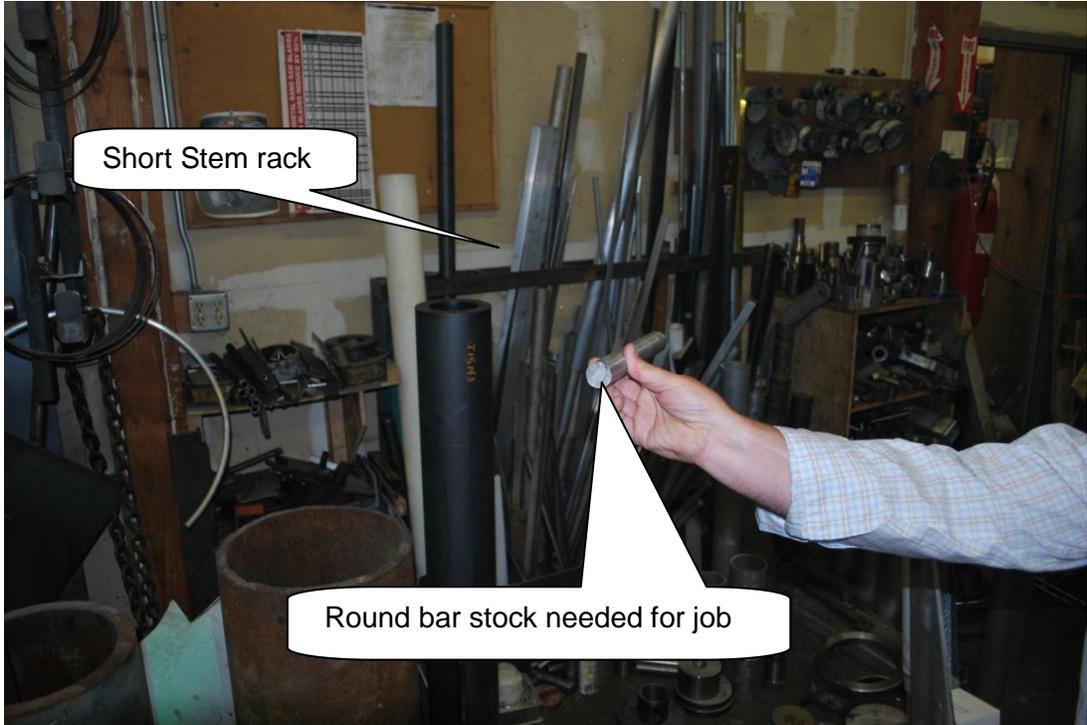
The round bar stock was a 1 inch diameter 303 stainless steel rod measuring approximately 6 feet in length. The 303 stainless steel, also referred to as chromium-nickel alloy steel, round bar stock is commonly used in free machining. The victim was attempting to cut approximately 1.7 inches of the stainless steel round bar stock to make the washers (Photo 7).

Photo 6. Short stem rack and length of 303 round bar stock needed for job

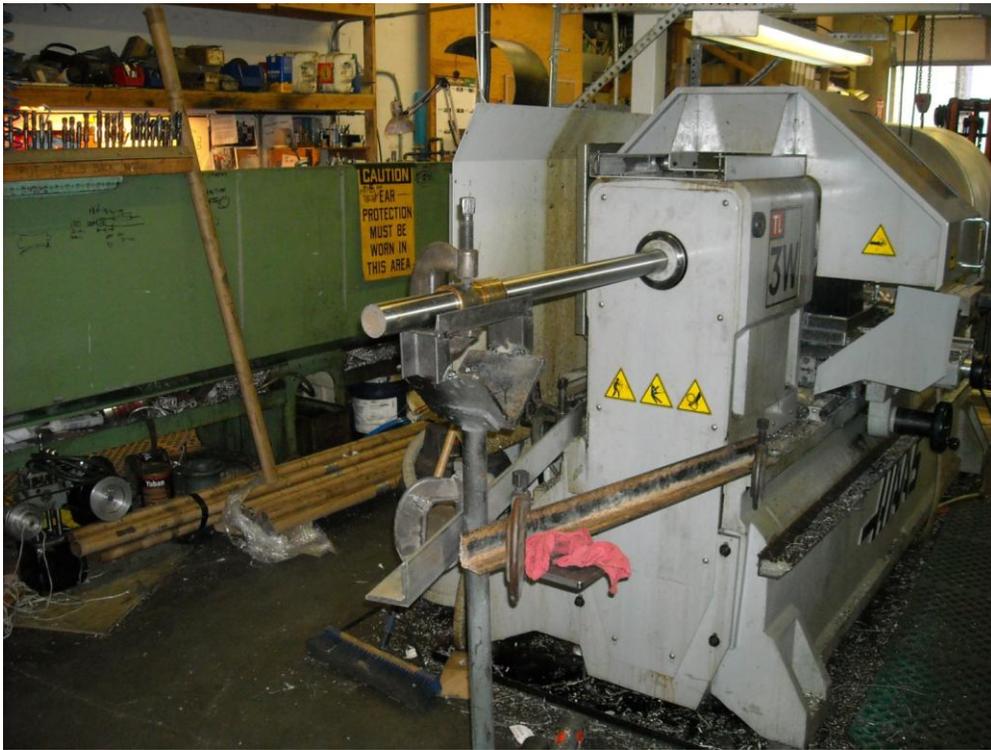
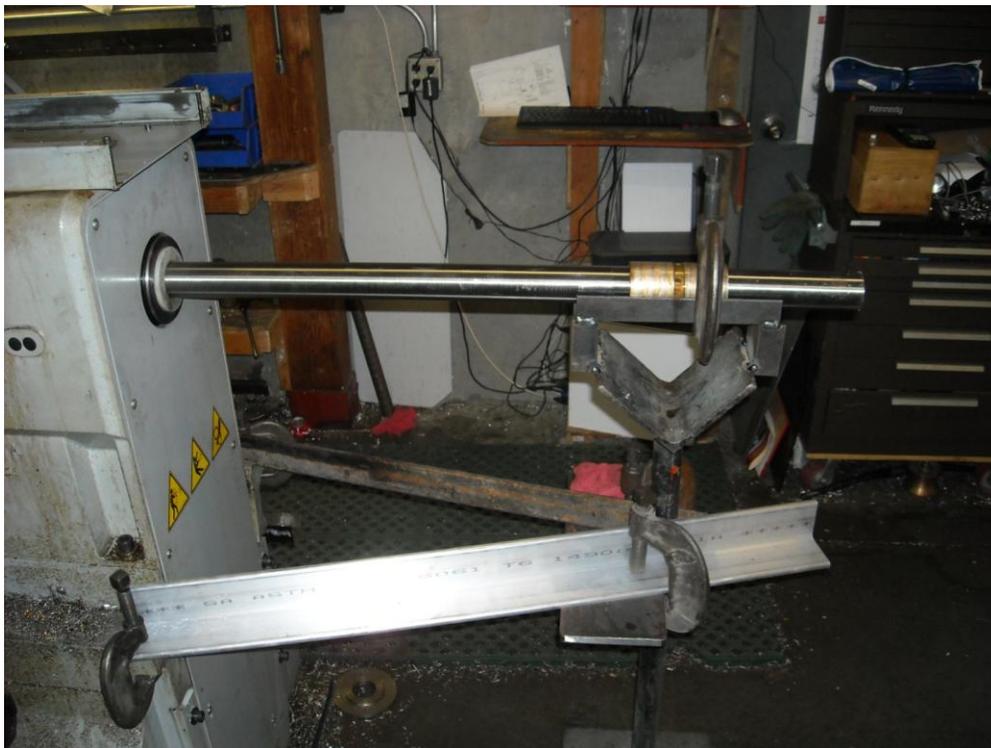
**Photo 7. Shop-built support system for supporting extended bar stock**

**Photo 8. Shop-built support system for supporting extended bar stock**

Following the incident, the employer fabricated a system to support bar stock extending from the spindle while it is machined (photos 7 & 8). The system can be anchored to the lathe to enhance stability to help prevent similar future incidents. The employer also developed a written accident prevention program (APP) and now holds monthly safety meetings with employees. The general manager has been designated as the shop safety coordinator.

Following the incident, the employer manufactured a system that supports bar stock that extends past the spindle. If this support system had been in place, the incident may have been prevented. Employers who manufacture their own support system should work with engineers or companies who specialize in creating these support systems to ensure that the system is feasible and safe. Other methods to help abate this hazard include:

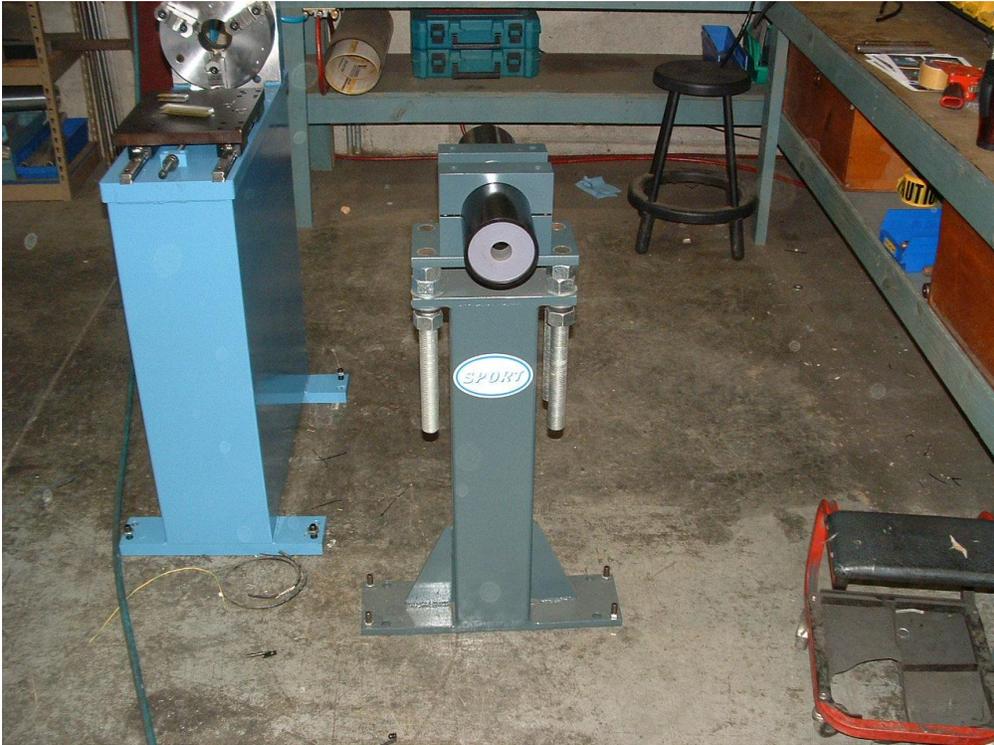
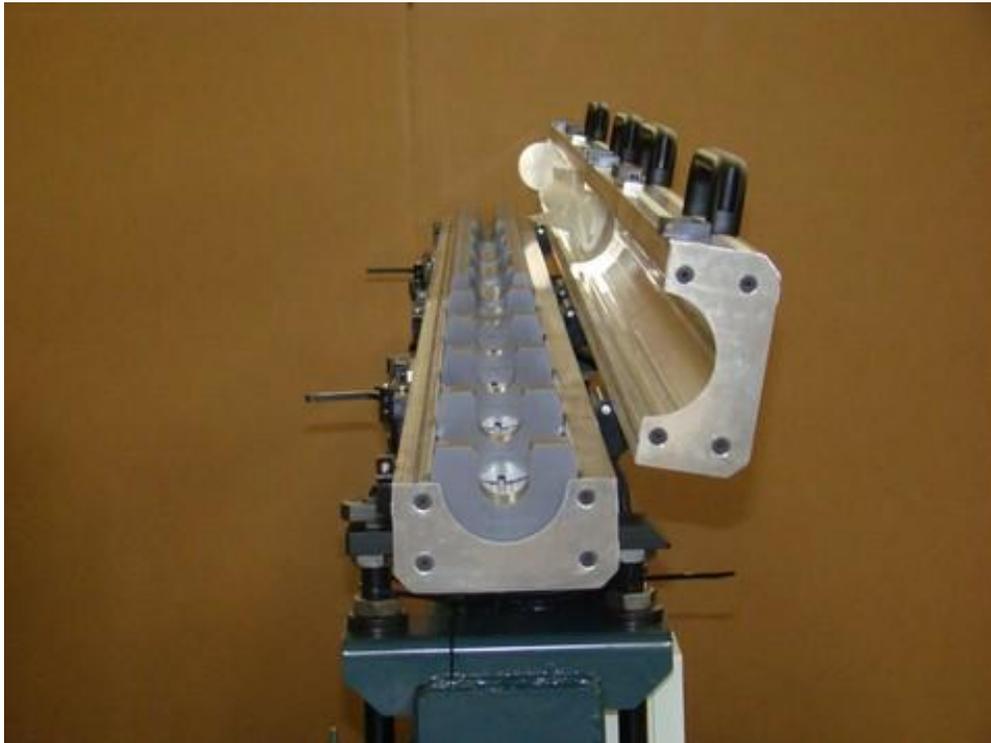
**Photo 9. Sleeve bearing-style support system for extended bar stock engineered by J.F. Berns**

**Photo 10. Cradle-style support system for extended bar stock engineered by J.F. Berns**

Manufactured support systems for extended bar stock (photos 9 & 10) are available from companies such as J.F. Berns ([jfberns.supports.com](http://jfberns.supports.com)). These support systems can be manufactured with variable options and prices. Available options include top loading, retractability, and the ability to hold larger diameter bar stock.

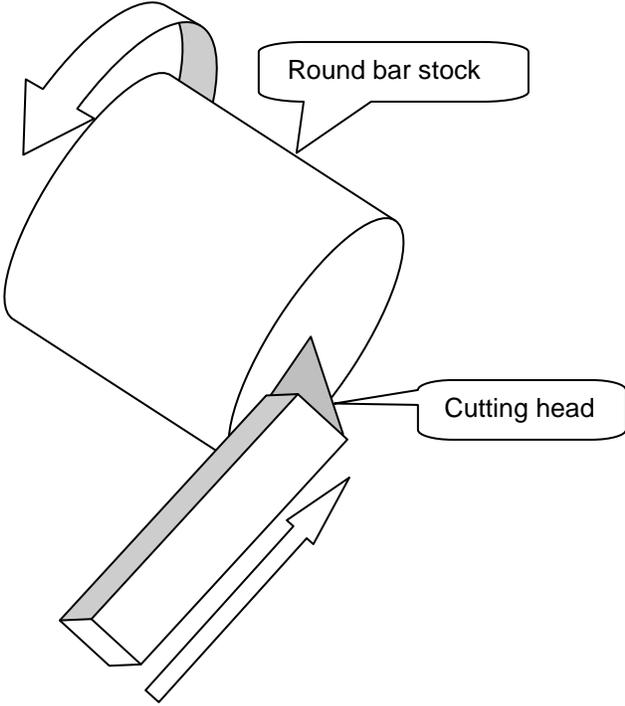
The victim was using a G96 code CNC Cutting Program to make the stainless steel washers. This program maintained a constant surface speed while the cutting tip made a right angle cut to the axis of the rotating work piece, called facing (figure 2).<sup>[5]</sup> A constant surface speed program increases the round bar stock rotating speed as the cutting tool approaches the center of the workpiece. This means that the round bar stock was constantly accelerating as it was being cut.

Figure 2. Diagram of facing process of round bar stock in lathe
