Fertilizer Company Worker Crushed to Death by Falling Concrete Ecology Block

Investigation: #12WA00701

SHARP Report: 52-36-2016

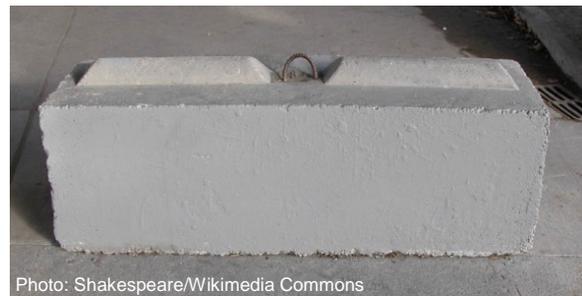
Photo 1: Concrete ecology block

Ecology blocks are stackable concrete blocks designed with an interlocking tongue and groove system on the top and bottom, and sometimes sides, for stability (photo 1). Other names include Eco-blocks, bin blocks, and bunker blocks. They are manufactured from unused concrete left over from other construction processes. Common ecology block dimensions are 2' x 2' x 3', 2' x 2' x 4', and 2' x 2' x 6'. They typically weigh between 2000 and 4000 pounds. They are usually equipped with a rebar loop, or picking eye, on the top of the block for loading, unloading, and placement. Ecology blocks are marketed for use in retaining walls, storage of bulk materials, and other applications. Their modular nature makes them convenient to use when permanent structures would not meet the needs of the user.

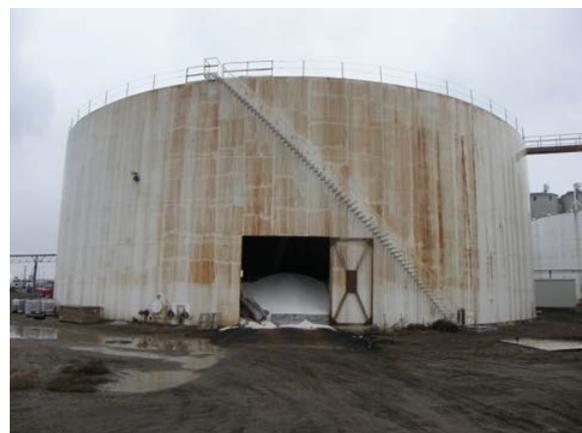
Photo 2: Steel tank used for bulk fertilizer storage

The incident took place in a large tank used for storing dry bulk fertilizer material (photo 2). The six-million-gallon steel tank had originally been used to store sugar beet

syrup, but had been converted for dry fertilizer material storage. The tank's original steel floor remained. The interior of the tank was partitioned into containment bays using stacked, concrete ecology blocks to create retaining walls approximately six to eight feet high. The ecology blocks used interlocked on the top, bottom, and sides. Two large doors had been cut on either end of the tank to create a corridor to allow semi-trucks and equipment to move in and out. At the time of the incident, extra space had been needed in the storage tank and one of the doors had been blocked off with a retaining wall to create another area for material storage. Most of the ecology block walls within the storage tank had been constructed by stacking the blocks in an offset manner: however, the rear wall of the section where the incident occurred was stacked without offsetting the blocks, with higher blocks directly on top of the lower blocks (figure 1).

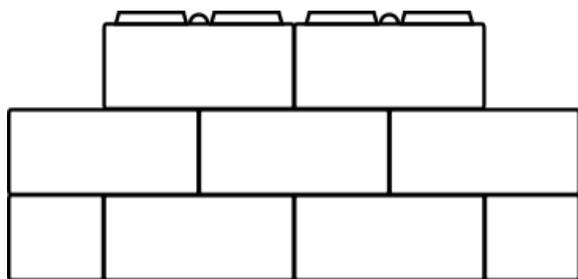
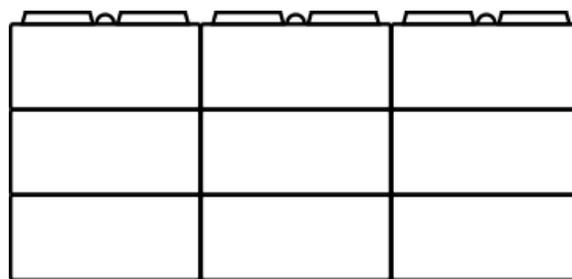
Figure 1: Offset vs. vertical wall assembly

Offset

Vertical

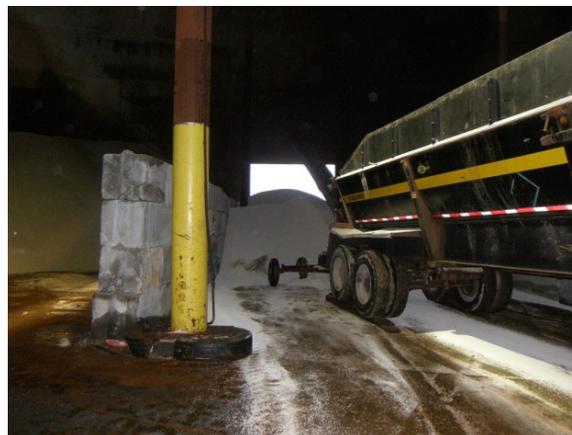
At approximately 5:00 p.m. on the day of the incident, the victim and another worker were in a large steel storage tank unloading a semi-truck trailer of granular bulk fertilizer into a containment bay partitioned by retaining walls assembled using concrete ecology blocks stacked four high. Each trailer contained approximately 25 tons of fertilizer. It was the last truck of the day; two trailers had already been unloaded into the containment area. The trailer had been backed into the containment area (photo 3) and connected to a mobile conveyer belt, or piler, operated by the victim's coworker. Fertilizer was offloaded from the trailer onto the piler, which would drop the fertilizer into the containment bay. The victim was operating a front end loader. As the fertilizer dropped from the conveyer into a pile, the victim would periodically use the front end loader to push the material further into the

Photo 3: Semi-trailer and "piler" positioned to unload product in the storage tank containment bay

bay, against the rear retaining wall. According to the employer and other workers, it was common for the bucket of the front end loader to run into the block walls during this process. The storage tank wall served as the back wall in most other containment bays, and other walls in the center of the storage tank had material on either side. The bay they were working in had previously been part of a corridor that consisted of two large open doorways on either side of the storage tank. When more area for material storage had been needed approximately two years prior, the bay had been created by blocking the large opening with an ecology block retaining wall. No inspection of the block wall had occurred before workers began unloading fertilizer on the day of the incident.

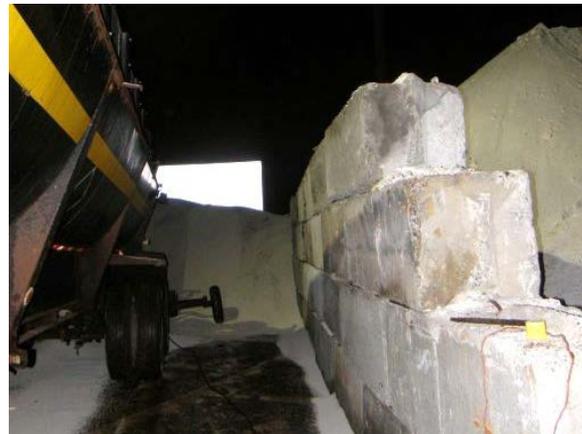
When the trailer had been approximately one-third of the way unloaded, the victim stopped the front end loader and left the machine. He climbed onto one of the sidewalls (photo 4) and walked on top of it toward the rear of the bay, presumably to check to see if material was leaking through the back wall. Shortly after, the victim's coworker heard several loud noises and yelled for the victim, but there was no answer. He ran to the top of the fertilizer pile and saw that blocks had fallen from the back wall. He ran to the outside of the tank. After pulling some of the fertilizer out of the way, he saw the victim pinned to the side of the storage tank wall by a fallen ecology block (photo 5). Another worker immediately called 911 and emergency responders arrived within five minutes. The victim was declared dead at the scene.

Photo 4: Ecology block wall that victim walked on top of to get to the rear of the containment bay

- Never attempt to brace or stabilize a leaning ecology block wall on your own.
 - Avoid walking on top of ecology block walls.
 - Avoid contacting ecology block walls with heavy or other equipment.

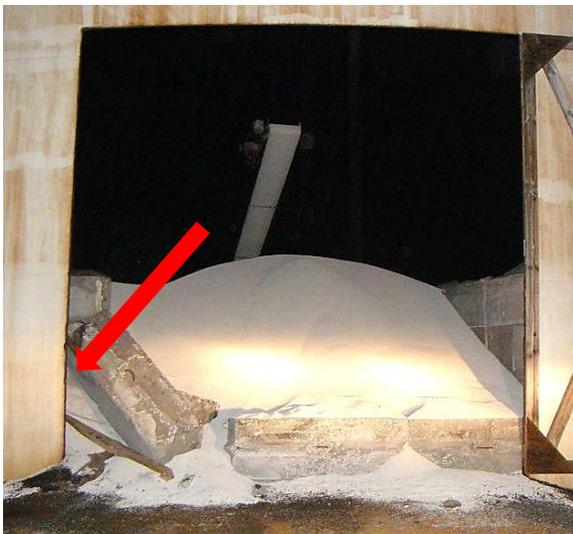
Photo 5: Arrow points to area where victim was pinned to tank wall by falling ecology block

Investigators and the employers believe that the victim saw that material was, in fact, leaking through the retaining wall and climbed down a ladder on the back wall of the storage tank to take a closer look. It appeared that he had been attempting to brace the wall with some long 2" x 6" pieces of lumber when it collapsed.

- Lack of proper design, construction, and maintenance of material storage areas
- Lack of training regarding the dangers of working around bulk material and ecology blocks
- Possible destabilization of block wall due to granular material leaking between the blocks
- Possible destabilization of block wall through contact with the front end loader bucket

Recommendation 1: Plan bulk material storage facilities for safety and stability by choosing structures designed specifically for bulk material containment, whether they are permanent or modular.

Recommendation 2: Consult a registered professional engineer prior to constructing bulk material containment walls or other structures using ecology blocks.

Recommendation 3: Provide employees with training on the hazards of working around ecology block walls, and safe practices, including to:

Recommendation 4: Regularly assess and audit the structural stability of ecology block walls. If integrity appears compromised, work around the wall must cease and the wall must be repaired or rebuilt.
