Fertilizer Company Worker Crushed to Death by Falling Concrete Ecology Block

SHARP Publication # 52-36-2016_summary

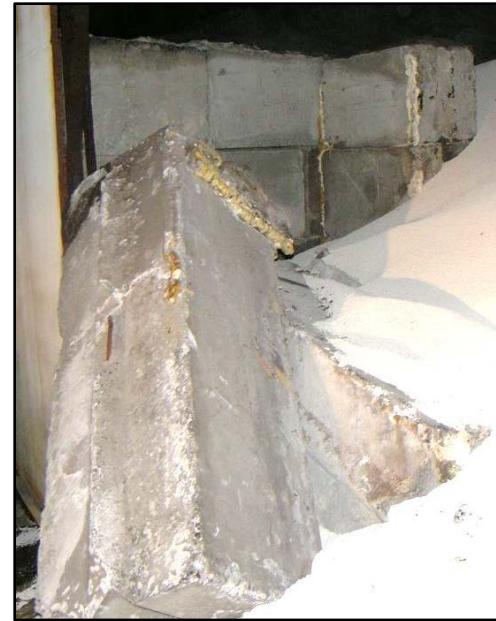
Investigators suspect that the victim saw that material was leaking between the blocks of the wall and climbed down a ladder on the back of the tank to take a closer look. The victim was apparently trying to brace the unstable block wall with some long pieces of lumber when it collapsed. The top block of the wall fell directly onto the victim's head and neck, crushing him against the wall of the storage tank. First responders arrived within five minutes, but the victim was declared dead at the scene.

Photo of fallen ecology block against tank wall

- **Plan bulk material storage facilities for safety and stability by choosing structures designed specifically for bulk material containment, whether they are permanent or modular.**

- **Consult a registered professional engineer prior to constructing bulk material containment walls or other structures using ecology blocks.**
- **Provide employees with training on the hazards of working around ecology block walls, and safe practices, including:**

- Inspect ecology block wall storage areas before and after loading in material
 - Immediately stop work around ecology block walls showing signs of material leakage, leaning, moving, or other damage

- Never attempt to brace or stabilize a leaning ecology block wall on your own
 - Avoid walking on top of ecology block walls
 - Avoid contacting ecology block walls with heavy or other equipment

- Notify the proper person if structural integrity issues in an ecology block wall are found
- **Regularly assess and audit the structural stability of ecology block walls. If integrity appears compromised, work around the wall must cease and the wall must be repaired or rebuilt.**
