Forest Crew Worker Electrocuted While Trying to Cut Tree Fallen on High-Voltage Power Line

Investigation: # 12WA04501

Release Date: November 14, 2016

SHARP Report: 52-38-2016

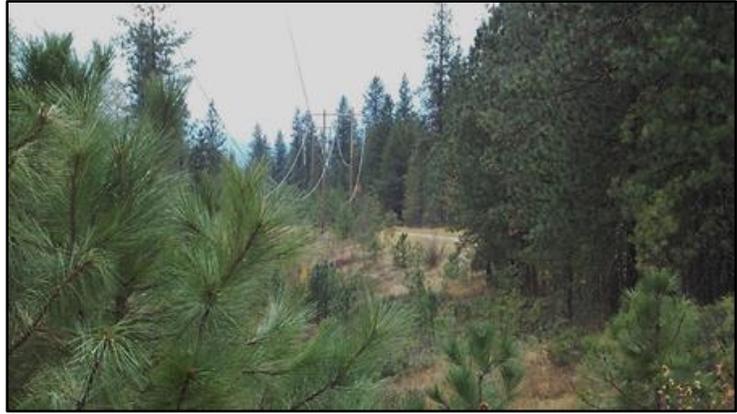
The incident occurred on state-owned forest land between a rural road and a 60-foot power transmission right-of-way. The site was part of a unit where the crew had been performing pre-commercial tree thinning operations, and consisted mostly of Western Larch, Douglas Fir and Ponderosa Pine species. Part of the timber stand was at the top of a slope bordering the road (photo 1). The three 115,000-volt transmission lines ran along the base of the slope. It was approximately 45 feet from the tree line to the nearest power line (figure 1).

Photo 1: North to South view of stand of trees where victim was working and proximity to power lines.

In this incident, the tree line of the stand of trees in which the victim was working was approximately 45 feet from the nearest of the three power lines. The tree that the victim fell on the line was approximately 58 feet in length; much taller than would allow at least 15 feet of clearance between the line and the tree as it fell. Investigators also found that the face cut made in the tree aimed the direction of fall at the power lines. Had he received thorough safety training regarding falling trees near power lines, it is possible that the victim would have recognized and avoided the hazard.

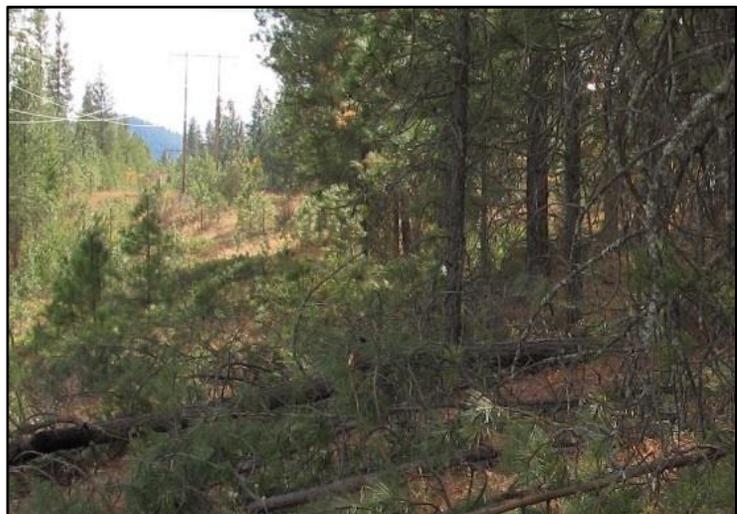
The victim was working falling trees within the stand adjacent to the road at the top of the slope (photo 2). His partner was working with his back to the victim, bucking the trees felled by the victim into smaller pieces. After finishing cutting one tree into sections, the victim's partner turned and noticed the top of a

Photo 2: Tree felled by victim, showing stand of trees and power lines.

Discussion: Investigators determined that the victim had not been using safe cutting practices to control the direction of tree fall away from the hazard of the power lines. The undercut that the victim made in the tree involved in the incident was facing downhill toward the power lines, causing the tree to fall in that direction.

Also, in several instances, the victim and at least one other worker had not left enough hinge wood (also called holding wood) when a tree was cut. Leaving sufficient hinge wood between the undercut and the backcut is necessary to maintain directional control of a tree being felled. It holds the tree to the stump and guides the tree in the intended direction as it falls. If not enough hinge wood is left, a tree could break or twist off the stump and fall in the wrong direction.

The incident tree felled by the victim was found to have insufficient hinge wood, was cut outside of the work boundary, and was larger than prescribed to be cut. Supervisors

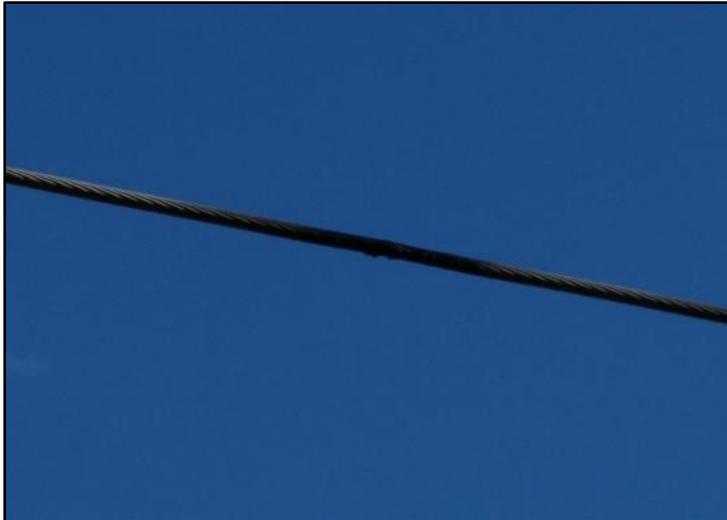
Photo 3: Burn damage on power line where tree fell onto it

Around this time, the supervisor had been notified by other workers that a tree had fallen on the line. He looked and saw a tree caught on the power line and what appeared to be a worker shaking the tree. He heard a loud “pop” and saw an electrical arc from the power line to the tree. Flames travelled down the tree and the ground at the base of the tree caught fire. The tree fell from the power line. He yelled for workers to get away from the tree and to return to the work truck to get their fire suppression supplies. The supervisor tried to make an emergency call on his hand-held radio, but reception was not clear. He then drove the work truck back up to the county road and made the call on the truck radio.

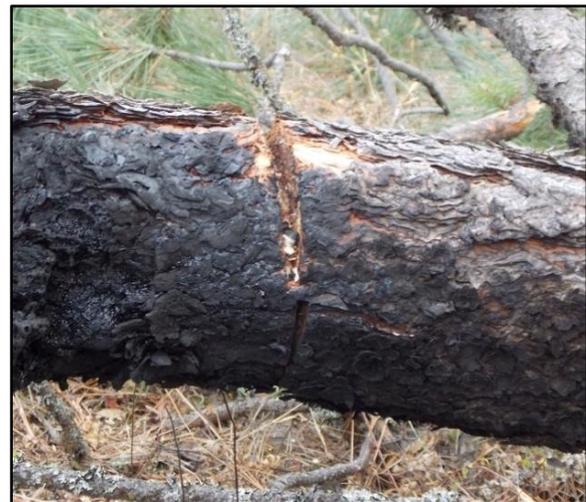
Investigators later found that the victim had made one cut without incident through the tree approximately 11 feet from the base of the tree in his attempt to remove the tree from the power line. When the tree remained hung-up after this cut, he moved 9 feet further up the trunk and made cuts to the top and bottom of the tree (photo 4). It was as he was making one of these cuts that the tree became energized and created a path to ground through the victim.

Photo 4: Top and bottom cuts on tree at location where electrocution occurred

When the tree he was falling became hung-up on the power line, the victim attempted to remove it by cutting it using his chainsaw. Without specific training, workers may not come to a job with knowledge of how electricity is conducted through power lines, what

types of materials readily conduct electricity, and how electric shocks can occur. Safety training for workers who may be exposed to high voltage hazards should include such important basic background information about electricity, in addition to how to avoid exposure. In this incident, the victim's attempt to cut a fallen tree off of a live power distribution line made clear that he was unaware of the danger of electrocution in that situation. Other members of the work crew also told investigators that they were not aware that trees could conduct electricity. If information about high voltage hazards had been effectively communicated to the crew, the victim may not have attempted to remove the tree from the line himself.
