Bark Company Owner Dies After Being Crushed By Ecology Block Wall

SUMMARY

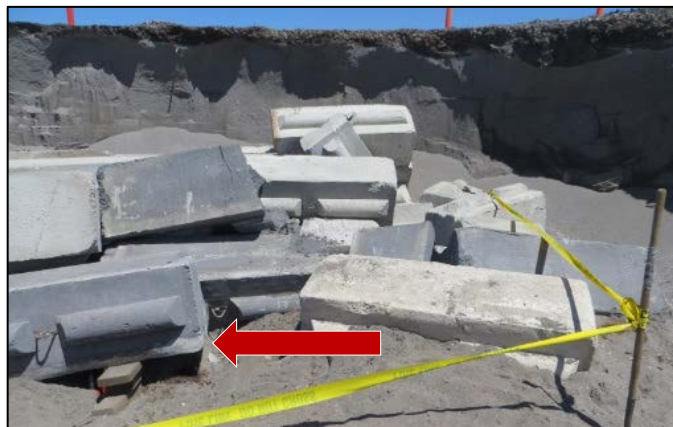
The first section of the bunker had been completed the previous day. It consisted of two adjacent walls, each approximately 21 feet long and 10 feet (5 blocks) high. When completed, employees reported that the walls appeared to be sitting level on the sand. The second section of the bunker was to consist of an 18-foot wall, perpendicular to the first wall, with rows of 6-foot-long ecology blocks horizontally stacked 5 blocks high.

On the morning of the incident, as the excavator operator was lowering the first block of the second bunker section into place, the victim stood near and used a shovel to guide the block’s alignment. The two other employees were working near the victim. As the block was set onto the sand against the base of the inside wall of the first bunker section, both original walls began to destabilize and collapse. The victim and the two employees ran to avoid the falling blocks. At some point, the victim hesitated and turned back to look at the wall and was struck by a falling block, crushing his right leg and pinning him to the ground.

Collapsed ecology block wall. Arrow indicates block that struck victim

- **Plan and design bulk material storage areas for safety and stability. Make sure all walls, whether temporary or permanent, are built on a stable foundation able to support the weight of the structure.**
- **Develop, implement, and enforce a comprehensive written safety program that is tailored to ecology block wall construction. Create Standard Operating Procedures that address hazards in both construction of and working near ecology block walls. Ensure that all employees are trained in and follow the procedures.**
- **Conduct a thorough job hazard analysis (JHA) before construction begins on any project involving stacked ecology blocks.**
- **Encourage employees to recognize and report safety concerns, and train workers on the protocol for reporting hazards. Ensure that all safety concerns are effectively addressed before employees are further exposed to the hazard.**
