FATALITY INVESTIGATION REPORT

REPORT #: 52-44-2018

A Boat Maintenance Crew Supervisor Dies of Carbon Monoxide Poisoning While Using a Gasoline-Powered Pressure Washer

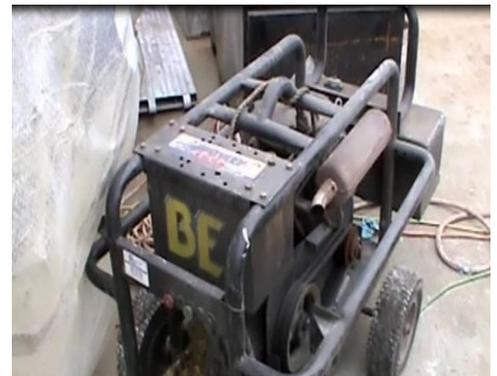
The piece of equipment was a 24 HP, 5,000 PSI maximum pressure gasoline-powered pressure washer. The engine was mounted on a roll cage frame with tires. Its engine was an air-cooled, 4-stroke overhead valve, 2 cylinder, V-Twin. The manufacturer states that this small engine has common applications in powering pressure washers, commercial lawn and garden equipment, tillers, generators, small vehicles, water pumps, and forestry, construction, industrial and agricultural equipment.⁸

Photo 1: Incident gasoline-powered pressure washer.

Discussion: Incident scene photos of the pressure washer do not show any safety labels affixed to the machine warning of CO exposure. It is unknown whether the pressure washer previously had these labels, and if so whether they were worn off or obscured by grime and dust. The manufacturer of the incident pressure washer's engine provides a safety warning label that reads, in part, "engine emits toxic carbon monoxide – do not run in enclosed area."

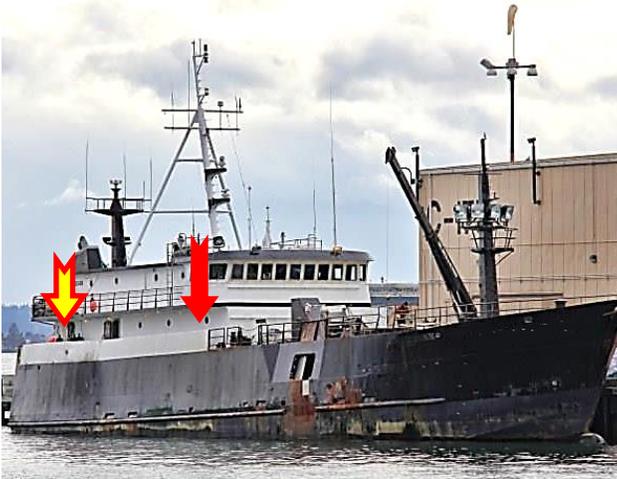
Photo 2: The yellow arrow indicates where the victim had been pressure washing the exterior of the wheelhouse. The red arrow indicates where the victim was found unconscious on top of the pressure washer. Plastic sheeting covered the entire area. [Photo not at incident scene.]

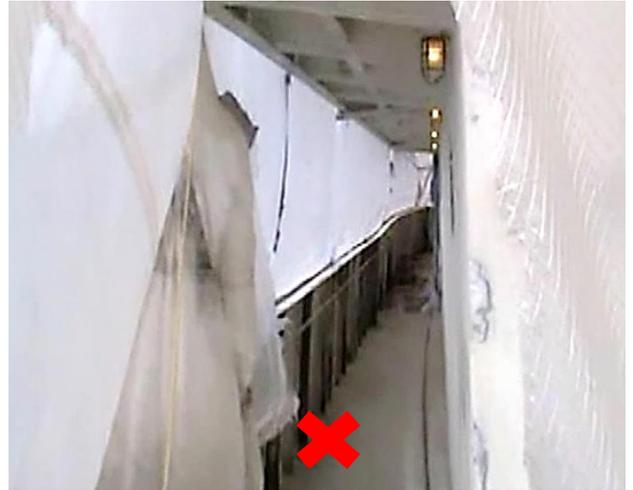
Photo 4: The boat's wheelhouse companion way where the victim was found slumped on top of the pressure washer (red "X"). Temporary plastic sheeting enclosed the area (it was cut open by EMS responders). The hose on the deck leads to the stern where the victim had been pressure washing.

Recommendation 1: Employers should ensure that gasoline-powered pressure washers or other fuel-powered equipment and tools are not used in enclosed or partially enclosed areas where CO can build up.

If the pressure washer had remained on the dock, this fatality would not have occurred. It is essential that coordination of work activities at job sites be planned and communicated to all affected contractors and their employees to ensure work is conducted in a safe manner.

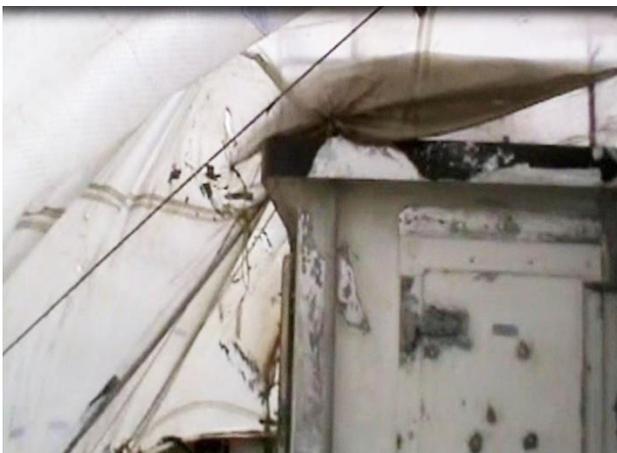
Photo 3: Exterior of the boat covered with a plastic tarp located near the stern where the victim was pressure washing.

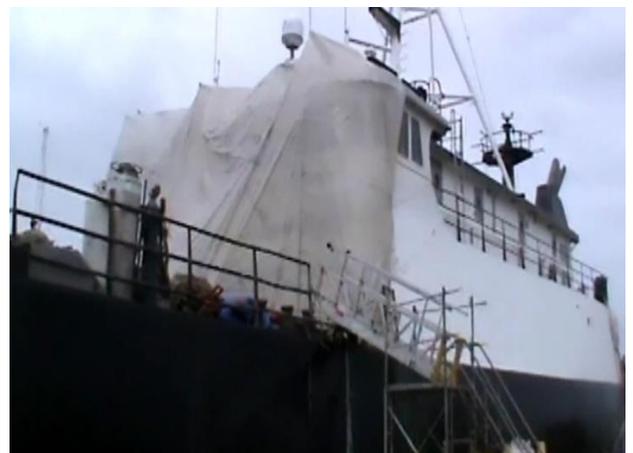
In order to prevent paint chips and dust created by grinding and pressure washing from entering the lake water, the workers had put up plastic tarping covering the front and right side of the boat's wheelhouse.

Photo 5: Exterior of fishing boat showing plastic sheeting covering the front of the boat's wheelhouse.
