INCIDENT FACTS

71-189-2019

Operator Crushed by Irrigation System Wheel

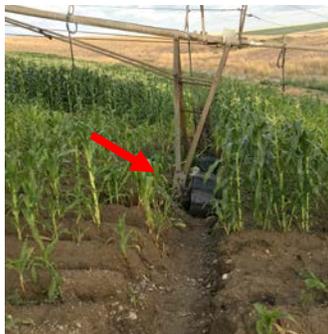
Wheel that ran over operator.

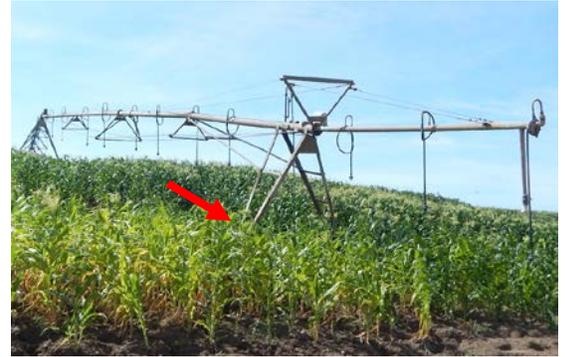
On the day of the incident, workers at the farm's maintenance shop last saw the operator near the end of his shift at about 6 p.m. when he left to work in the fields. At 6:30 p.m., he called his wife to say that he would be home soon. At 10 p.m., when he had not returned home, his wife contacted the county sheriff's office and filed a missing person's report. His brother went looking for him and found him early the next morning. He was deceased with his body pinned and crushed under the outer wheel of the center pivot's tower. Investigators concluded that the operator was most likely trying to jump across the two-and-a-half-foot deep rut made by the center pivot's wheels when he slipped and fell into the rut where one of the wheels ran over him, crushing his legs.

A wheel at the base of the irrigation system's tower ran over and crushed the operator.

- Employers should have a lone worker safety plan that requires that:
 - Lone workers inform their supervisor of where they will be working on a daily basis, and to check in with their supervisor periodically or if their work locations change.
 - Supervisors check in with workers working alone in remote locations through both periodic visits and phone or radio.
 - The supervisor or another employee verifies that lone workers have returned to an agreed upon place or home after completing their task.
- Conduct risk assessments to determine if work may be done safely by lone workers.
- Train workers not to walk in front of moving equipment.
