Operator Crushed By Irrigation System Wheel

INCIDENT FACTS

REPORT #: 71-189-2019s

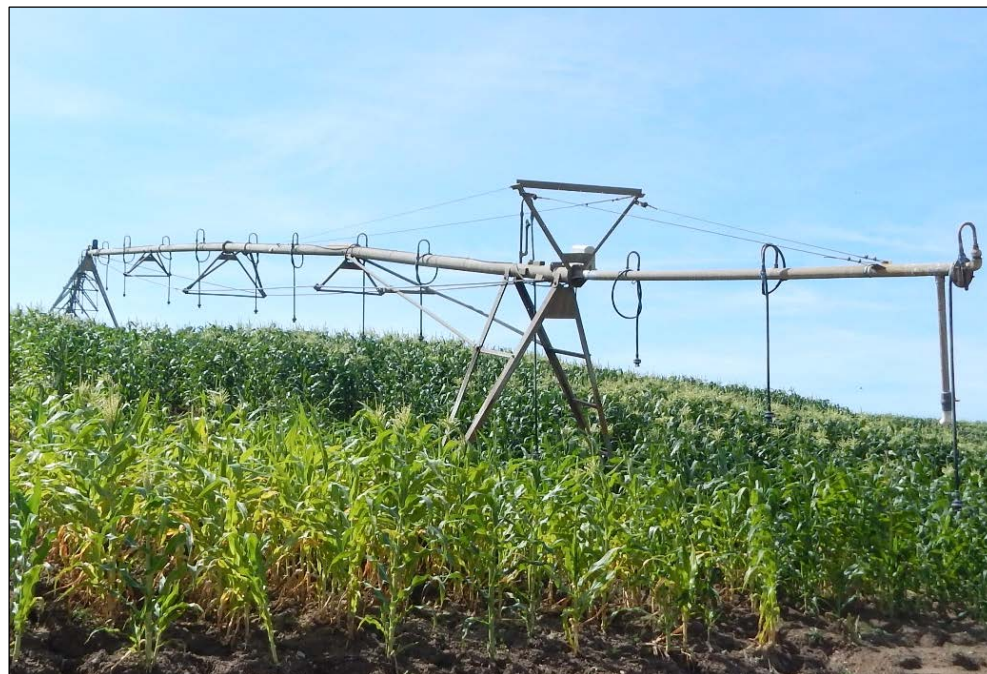
A 30-year-old operator died when he was crushed under a wheel of a self-propelled irrigation system.

These irrigation systems are self-propelled by a motor around a center pivot point. They have drop sprinklers installed along horizontal pipes supported by steel towers that have wheels.

His brother went looking for him and found him early the next morning. He was deceased with his body pinned and crushed under the outer wheel of the center pivot's tower.

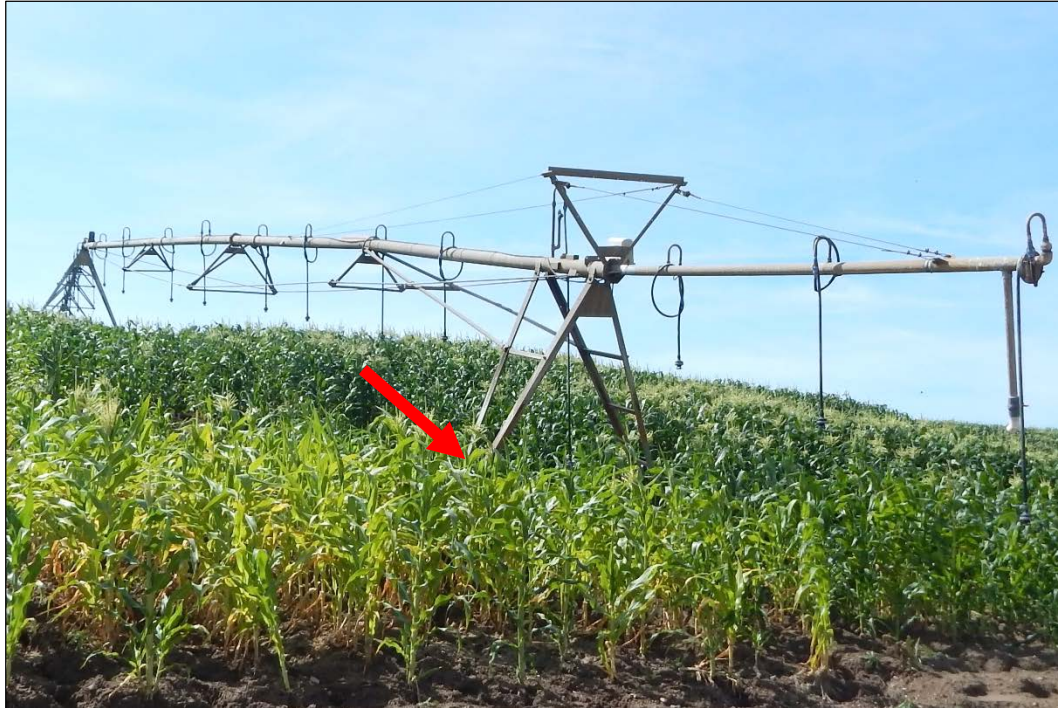
Investigators concluded that the operator was most likely trying to jump across the two-and-a-half-foot deep rut made by the center pivot's wheels when he slipped and fell into the rut where one of the wheels ran over him, crushing his legs.

Photo 1. Incident scene with self-propelled center pivot irrigation system. A wheel (indicated by the arrow) at the base of the system's tower ran over and crushed the operator.

- Conduct risk assessments to determine if work may be done safely by lone workers.
- Train workers not to walk in front of moving equipment.

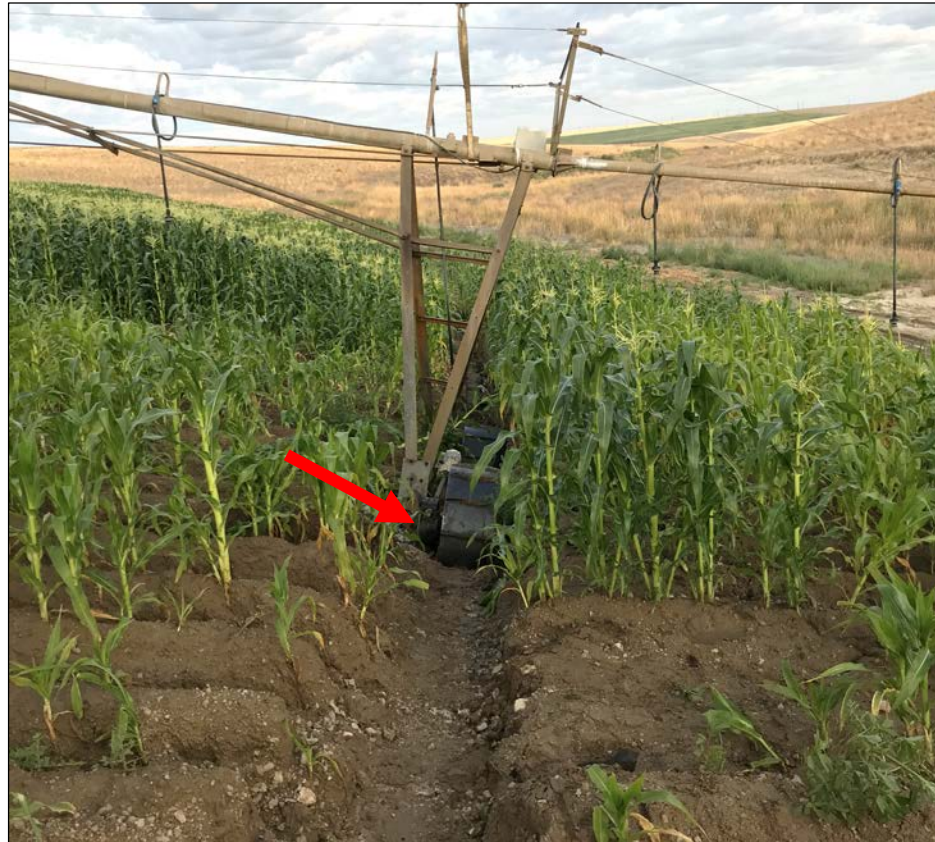
Photo 2. Wheel that ran over and crushed the operator.

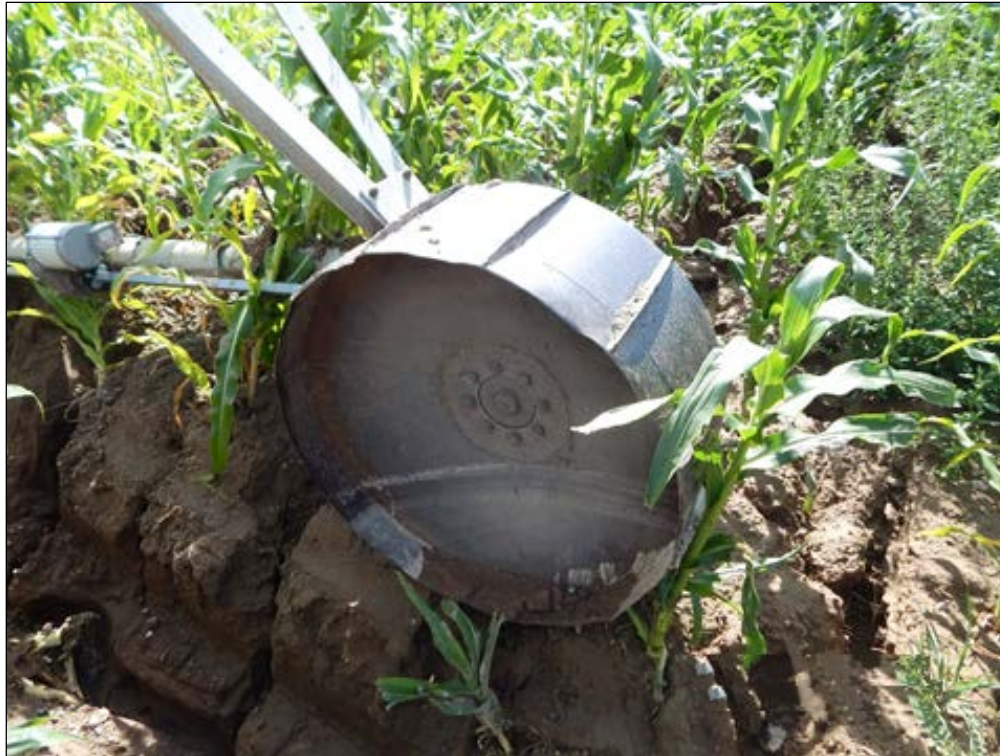
Photo 3. The 38-inch diameter steel wheel at the base irrigation system's tower that ran over and crushed the operator.

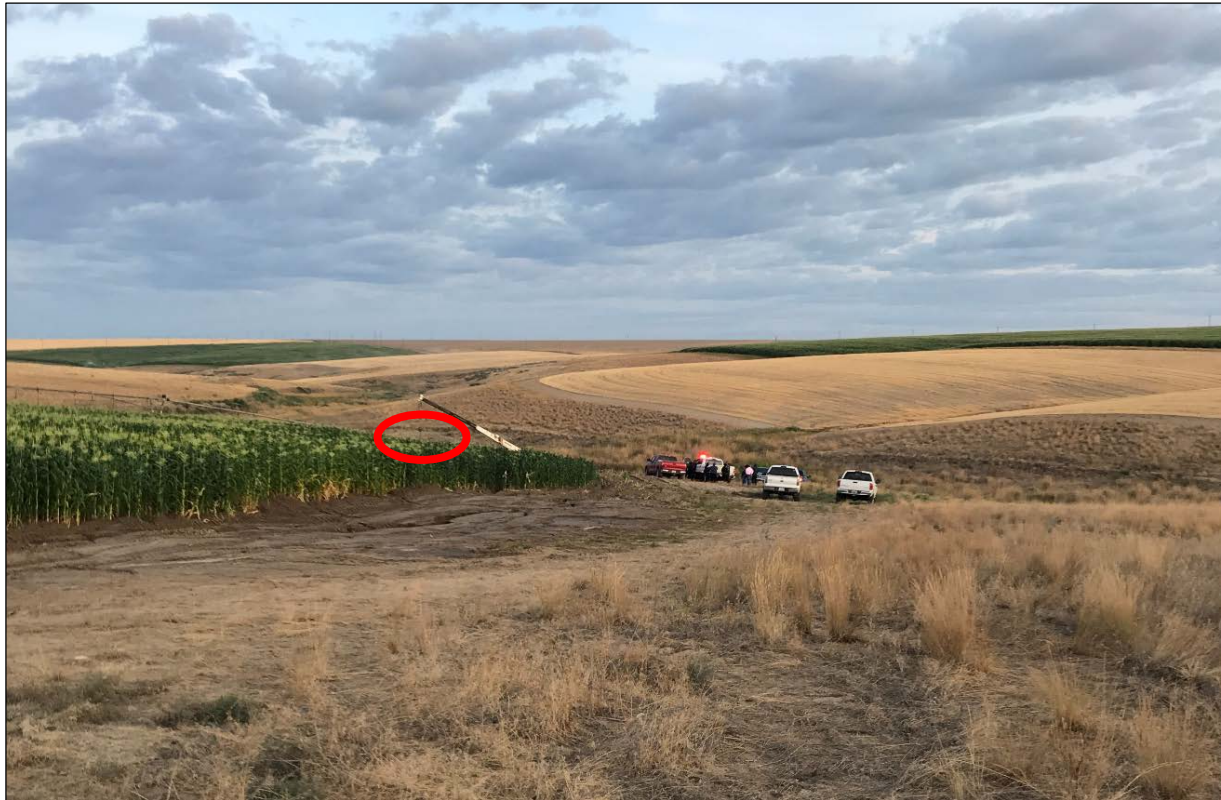
Working alone for 12 to 13 hours per day, the operator drove to field locations to check on these systems. The fields were in isolated locations, often far from other employees.

Photo 4. The incident scene showing the remote location of the corn field. The circle indicates the location where the operator was found.

Employers should have a lone worker safety plan that requires that:

- Lone workers inform their supervisor of where they will be working on a daily basis, and to check in with their supervisor periodically or if their work locations change.
- Supervisors check in with workers working alone in remote locations through both periodic visits and phone or radio.
- The supervisor or another employee verifies that lone workers have returned to an agreed upon place or home after completing their task.
