**INCIDENT FACTS**

71-187-2019

## Vineyard Laborer Falls from Grape Harvester

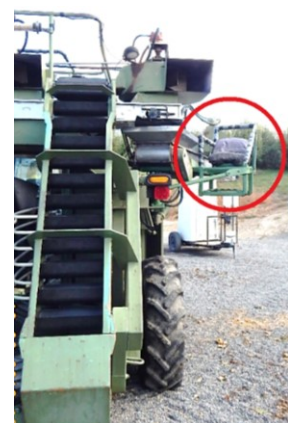
Chair (indicated by circle) from which the laborer fell.

The employer modified this harvester by attaching a chair to the harvester's conveyor. The laborer had sat in this chair for five seasons to pick out and discard material other than grapes (known as MOG), such as vines and leaves as the harvester moved through the vineyard rows.

- Employers should not modify, install, or retrofit components of equipment without consulting the manufacturer.

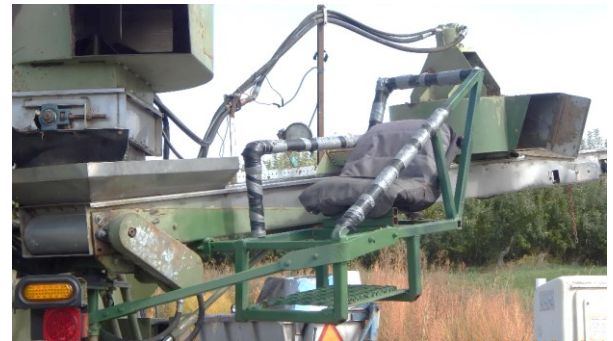
The manufacturer did not approve this modification. The harvester operator's manual cautions that no one should ride on the harvester while it is moving, as this may result in serious injury or death.

Chair installed by employer from which the laborer fell.
