71-193-2020

School gymnasium new construction

Laborer Falls 24 Feet from Roof Deck

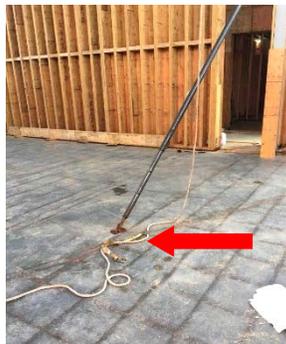
Rope grab showing slack in lifeline.

Investigators found that the laborer had not adjusted his rope grab short enough on the lifeline to arrest his fall. After the incident, the rope grab resting on the floor had two feet of slack between it and the vertical section of lifeline.

- Employers should train workers to inspect and use fall protection properly to ensure safety.
- In order to stay safe, workers using rope grabs need to continually take the slack out of their lifelines as they work.

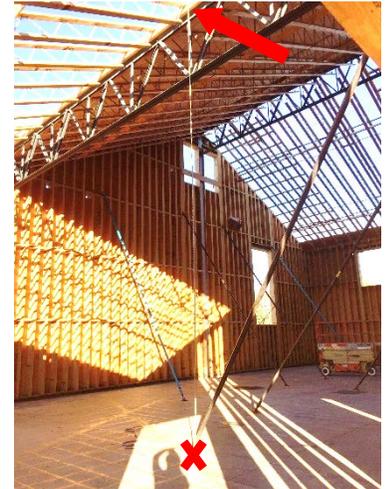
As he did this, he slipped on frost and slid about 20 feet down the roof. He attempted to arrest his fall by grabbing a roof truss but was unable to. Believing the rope grab on his lifeline would arrest his fall, he did not attempt to hold on to the rope. He slid over the roof's leading edge and fell 24 feet, landing on a concrete floor. He suffered fractures to his thigh, heel, and wrists.

Location where the laborer fell from the roof deck (arrow), and where he landed on the floor ("X").
