Laborer Falls 24 Feet from Roof Deck

REPORT #: 71-193-2020s

SCENE: School gymnasium new construction

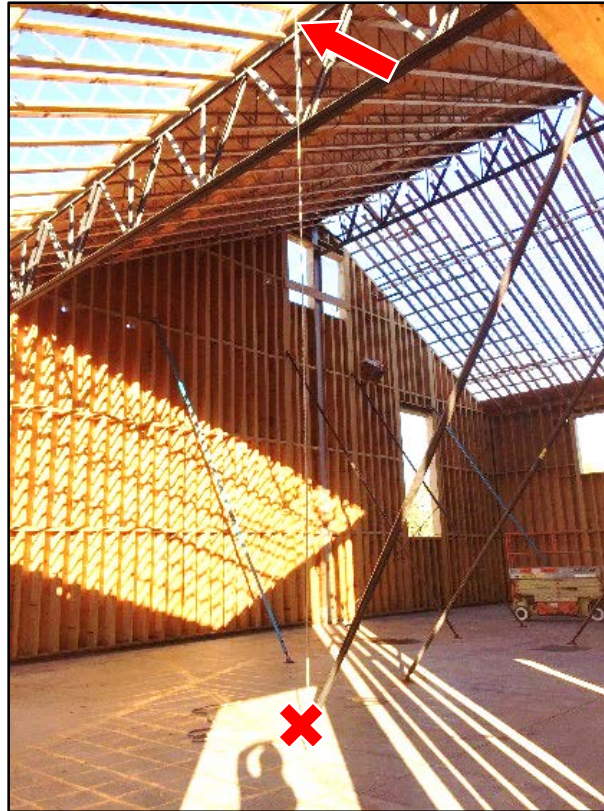
Using the torch, he worked his way up the roof. As he did this, he slipped on frost and slid about 20 feet down the roof.

He slid over the roof's leading edge and fell 24 feet, landing on a concrete floor. He suffered fractures to his thigh, heel, and wrists.

Photo 1. Location where the carpenter fell from the 8/12 pitch roof deck (arrow). The “X” indicates where he landed on the floor.

Regardless of work activity, employers must ensure that employees exposed to fall hazards of 4 feet or more while working on a roof with a pitch greater than 4/12 use one of the following systems: fall restraint, fall arrest, or positioning device.

- Employers should train workers to inspect and use fall protection properly to ensure safety.
- In order to stay safe, workers using rope grabs need to continually take the slack out of their lifelines as they work.

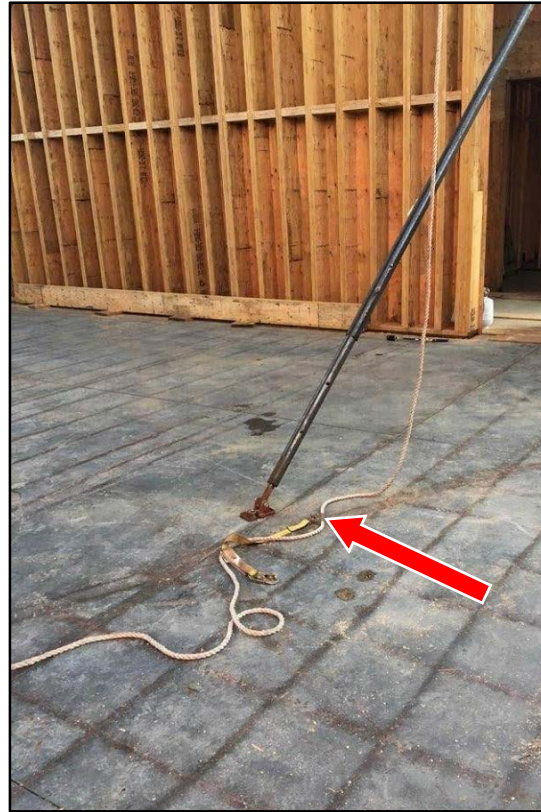
Investigators found that the laborer had not adjusted his rope grab short enough on the lifeline to arrest his fall.

After the incident, the rope grab resting on the floor had two feet of slack between it and the vertical section of lifeline.

Photo 2. Incident location with the rope grab (arrow) showing slack in the lifeline.

When stopping a fall, personal fall arrest system must be rigged to allow a maximum free fall distance of 6 feet so an employee will not contact any lower level.
