## Framer Struck by Falling Wall Section

**REPORT #:** 71-195-2020s

**INDUSTRY:** New Single-Single Family Housing  
Construction

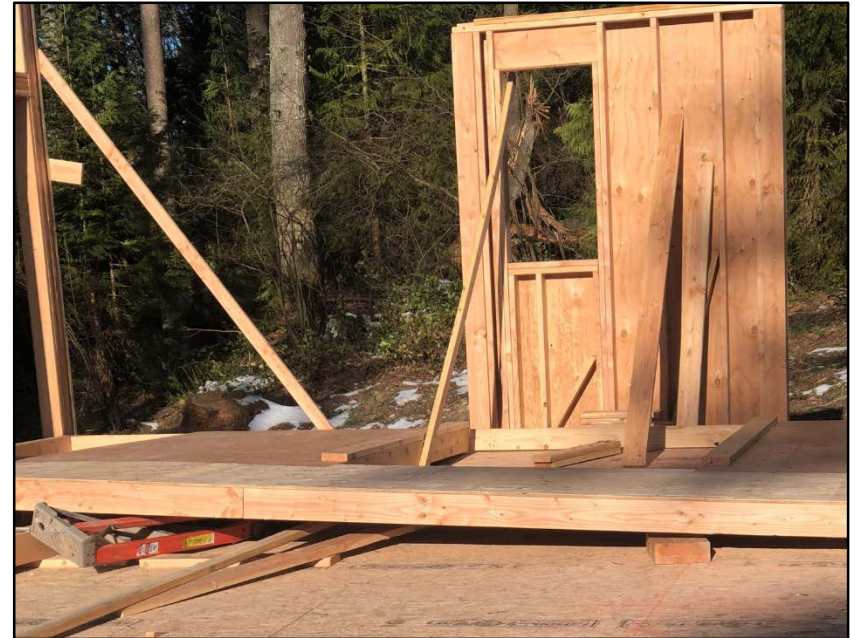
As the framer was securing a brace pole under the wall, the pole broke. The wall then fell in sections, with one section striking and crushing him underneath.

**Photo 1.** Section of the fallen wall where the framer was crushed. The arrow indicates the broken 2x4 brace pole with wall jack.

- Inspect all wall jack equipment, including the wall jack pole, before and after each use to be sure there is no damage or deformation to any of the equipment.
- If it is safe to lift the wall manually and that is the method chosen, ensure that a sufficient number of workers are continually assisting while the wall is being raised to prevent the wall from falling back onto them.

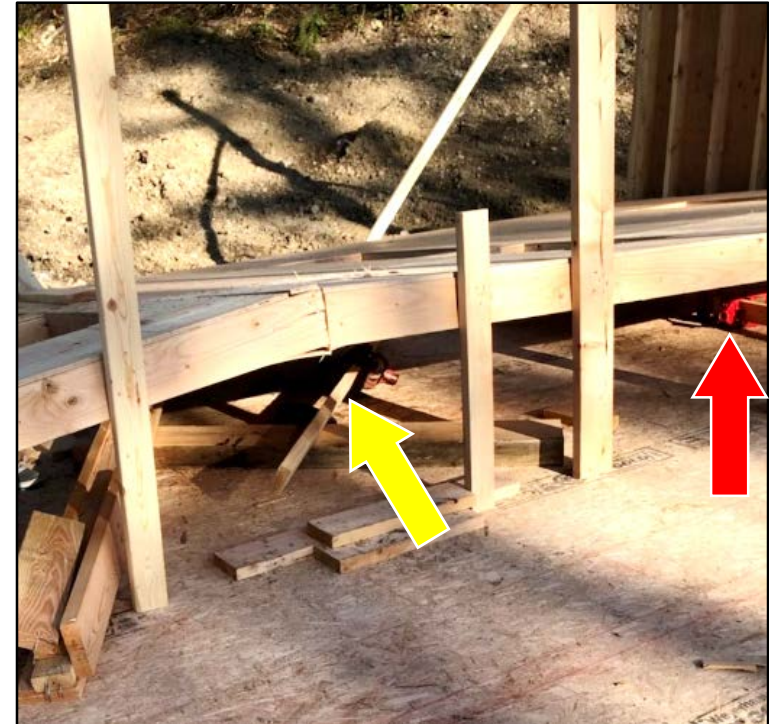
**Photo 2.** Another view of the section of the fallen wall. The red arrow indicates the broken 2x4 brace pole that broke. The yellow indicates another brace pole.

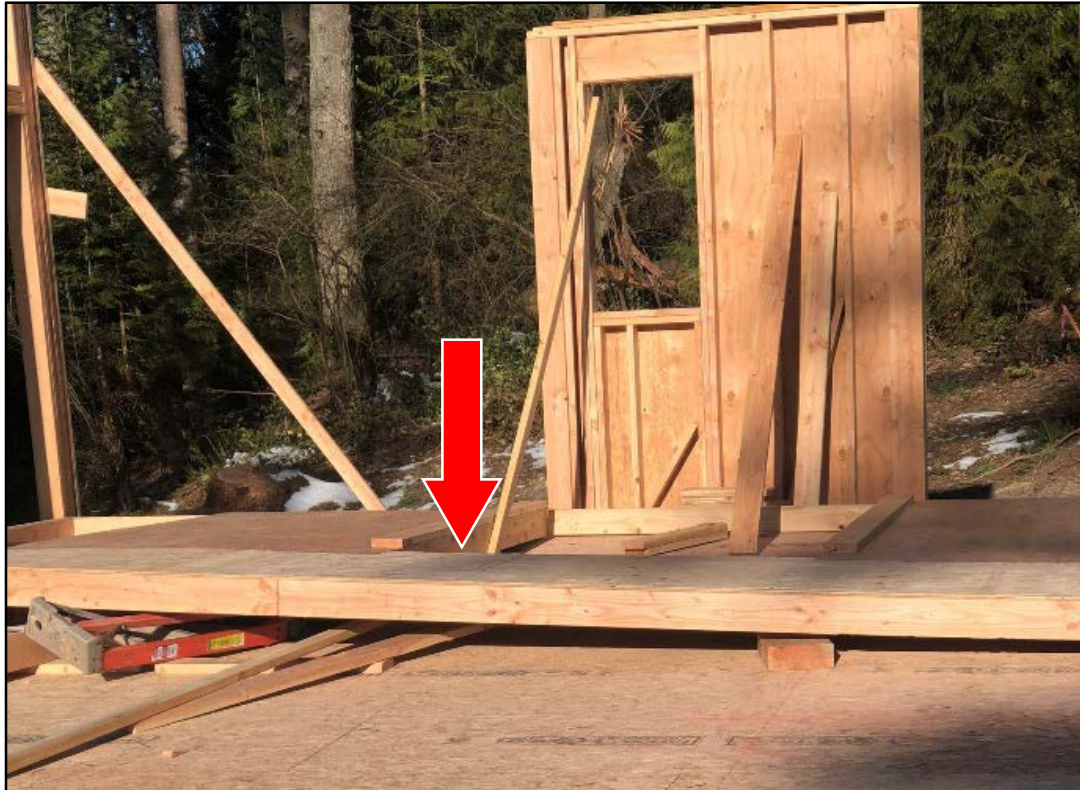
**Photo 3.** Section of fallen sheathed wood frame exterior wall at the two-story house construction site. This was the location where the crew leader was working. He was not injured.

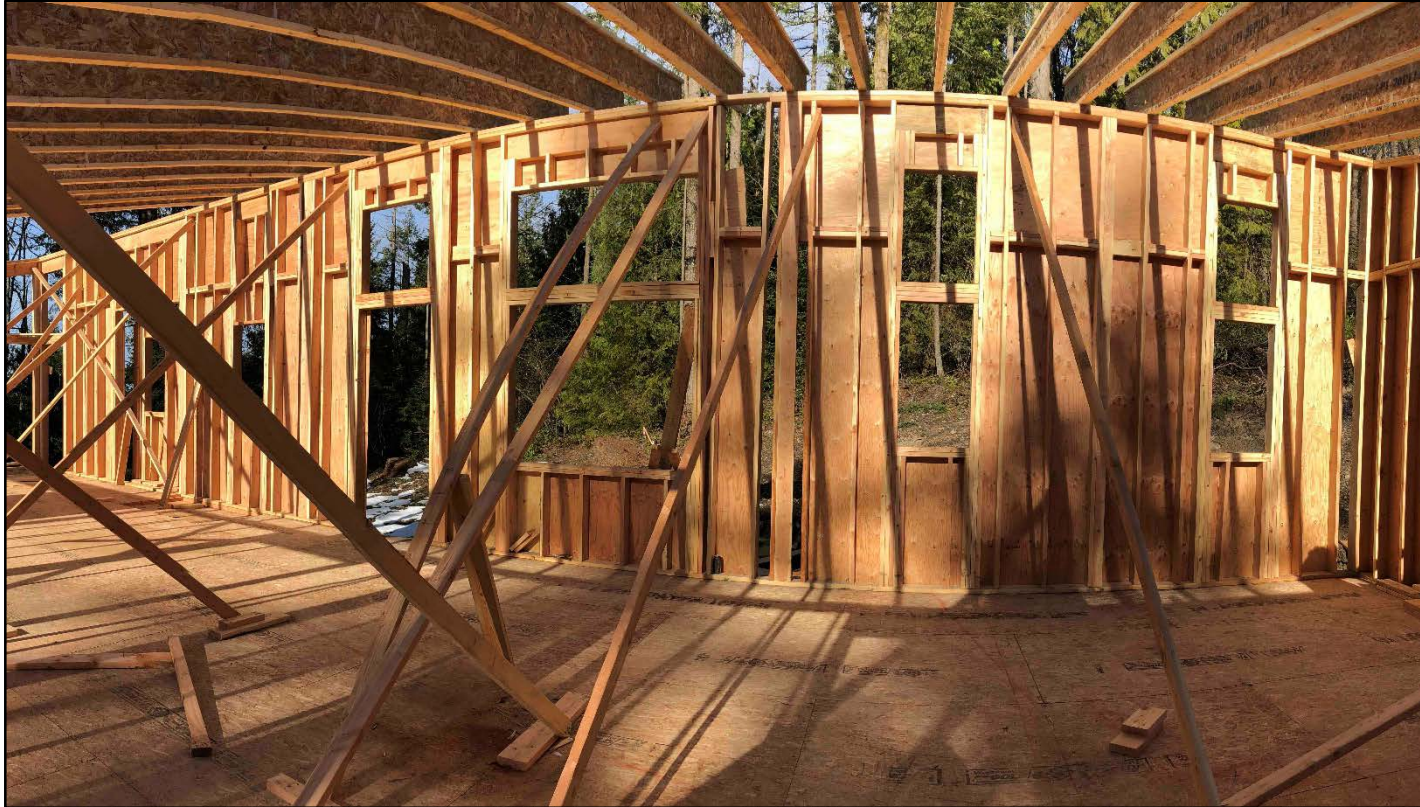
The wall was approximately 43 feet long by 13 feet high. The workers did not determine the weight of the wall prior to raising it, but after the incident the wall was estimated to weigh at least 1,000 lbs.

**Photo 4.** Panoramic view of wall that had fallen. The wall was approximately 43 feet long by 13 feet high.

- Determine the weight of the wall before raising it.
- Conduct a “pre-lift” meeting to determine the safest method for raising a wall.
- When raising a wall, always stand behind the wall jack pole. Never stand under the wall.
- Follow manufacturer’s instructions and guidance on the use and maintenance of wall jacks.
