INCIDENT FACTS

71-196-2020

Laborer Partially Buried when Trench Wall Collapses

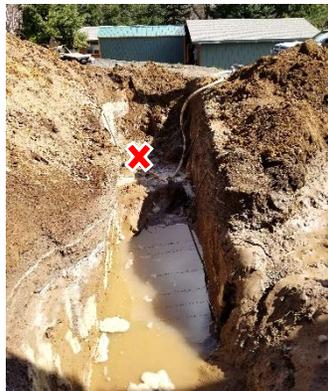
Unprotected trench after its sidewall collapsed, partially burying the laborer. The "x" indicates the laborer's location.

Investigators found: **1)** The trench was not protected from cave-ins by an adequate protective system. **2)** Spoil piles three feet high of type C soil were placed within two feet of the trench edge. **3)** Spoil piles were positioned on the uphill side of the trench creating a surcharge towards the trench opening. **4)** It is possible that the excavators created vibration in the ground and caused the trench side to sluff.

- Never enter an unprotected or uninspected trench, even for a short task.
- Do not assume that there will be a warning sign to alert you before a cave-in, or that you will have time to move out of the way.
- Be aware that heavy equipment operating nearby a trench may cause soil distress.

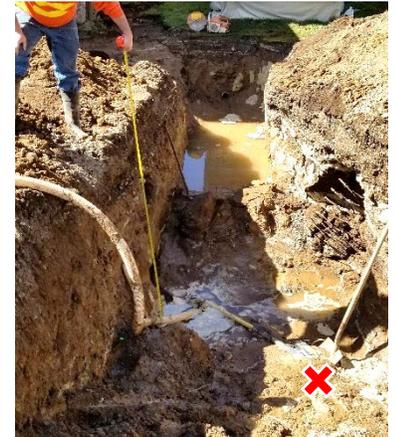
Unprotected trench after its sidewall collapsed. The "x" indicates the laborer's location.
