**INCIDENT FACTS**

71-191-2020

Tractor rollover

**Operator Dies When Orchard Tractor Rolls Down Embankment**

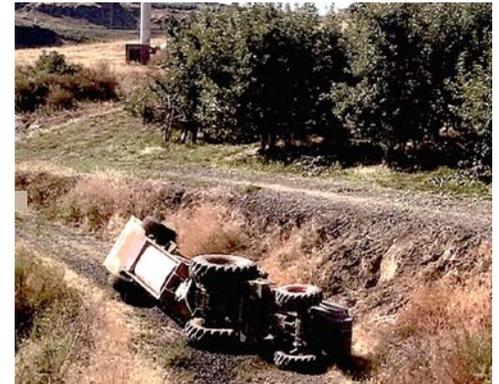
He found the operator's tractor at the bottom of a 6-foot embankment. It had left the service road a few yards from the orchard row and rolled down the embankment. The operator was lying next to the tractor. He died from a skull fracture due to blunt force trauma.

**Overturned tractor at bottom of embankment.**

- Employers should mark edges of hazardous embankments with visual cues, such as elevated reflective stakes, fencing, or permanent barriers to alert equipment operators.
- Workers should be trained to use extreme caution when operating tractors on or near sloped terrain, ditches, or embankments.
