Pipelayer Backed Over by Excavator While Clearing Lot

Grade Checker Severely Injured when Struck by Grader

Grade Checker's Legs Run Over by Grader

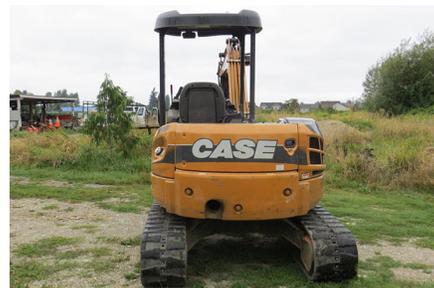
An excavator operator and a pipelayer were clearing logs and debris from a lot. The operator asked the pipelayer to get a chain to use to move a log. The pipelayer grabbed the chain and walked behind the excavator as it was moving forward, about 20 feet in front of him. He was looking down and around as he walked and didn't notice the excavator start to reverse. When he looked back up, the excavator was directly in front of him.

The pipelayer yelled as his left leg was crushed under the excavator's track. He was taken to the hospital by ambulance where he had surgery to repair two broken bones in his leg.

Excavator that struck pipelayer walking behind it.

- Create a policy to **separate workers on foot from operating equipment.**
- **Train workers how to recognize struck-by and crush hazards** posed by the moving equipment they will work around.
- **Inspect equipment before operating:**
 - Check that back-up alarm is audible.
 - Adjust and clean mirrors.
 - Clean windows.
 - Check brakes.
 - Look under equipment and wheel wells for animals or people who may be taking cover.
- **Only operate equipment with all guards** in place.
- Make sure that equipment operators **use safe speeds and look in the direction of travel.**

- Operators must look in the direction of travel, and keep a clear view of the path when operating in reverse. See [WAC 296-155-615\(1\)\(h\)](#)
- You must make sure that earthmoving or compacting equipment with an obstructed view to the rear in reverse is not operated unless:
 - A reverse signal alarm distinguishable from the surrounding noise level is used; or
 - An observer signals that it is safe to back up.

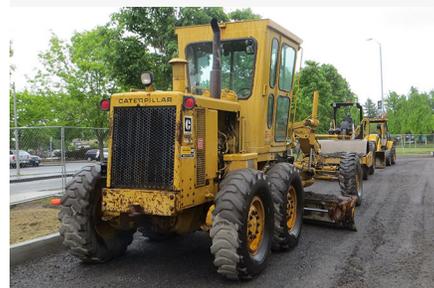
An operator was using a grader to level out a new parking lot. At the same time, a grade checker was cleaning gravel off a curb nearby when he noticed a hub in the grading area with its feathers torn off. He walked over to the hub while the grader was driving forward away from him. As he knelt down to fix the hub, the grader began backing up toward him. He was not looking up and didn't hear the grader's back-up alarm.

The grade checker was struck by the left two rear wheels of the grader and suffered multiple fractures, including his skull, jaw, rib, lower leg, and pelvis. He also sustained face lacerations and a collapsed lung.

Grader that struck grade checker who was kneeling to fix hub feathers.

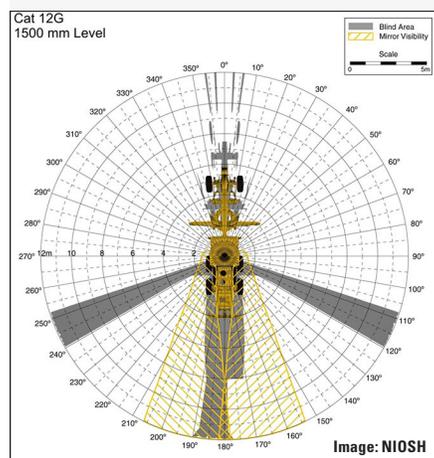
Two grade checkers were checking the grade of a roadway; one setting hub stakes and the other checking the level and acting as a spotter. After the grader passed them moving forward, the hub setter walked to the center of the roadway and knelt to pound a stake while the other worker crossed to the other side. Neither worker noticed the grader reversing near them. When the hub setter looked up and saw the grader backing toward him, he tried to get out of the way but tripped.

The grader backed over his legs and then ran over him again as the operator moved forward to free him. Both of his lower legs were fractured, and he suffered foot and nerve injuries.

Blind Area Diagram representing operator visibility for an object at a height of 1500mm for a Cat 12G grader.

- **Know the blind spots.** Equipment operators and ground workers should be aware of the blind spots for equipment in use.
- **Maximize visibility.** Make sure ground workers properly wear clean high-visibility garments. Wearing dark clothes or a dirty vest blends in with surroundings.
