**INCIDENT FACTS**

71-208-2021

Single family home under construction-framing

**Laborer Falls from Wall while Setting Trusses**

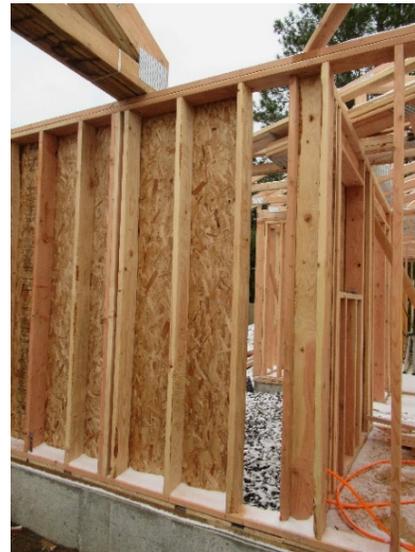
View of the wall from which the laborer fell. A roof truss is marked with a red flag.

Framed wall from which the laborer fell nearly 10 feet.

- Before beginning a job, perform a worksite hazard analysis to identify fall protection needs and ensure systems are in place to protect workers.
- Do not work while standing on top plates. They are not walking/working surfaces. Use mobile elevating work platforms (MEWPs), scaffolds, or platform or step ladders.
- Always use fall protection when exposed to fall hazards and when working in MEWPs, regardless of height. A fall can be fatal from any height.
- Do not tie off directly to wood trusses unless a qualified person has determined that the truss or series of trusses will meet the strength requirements of a fall-arrest anchor.
