Roofer Falls 10 Feet from Fixed Ladder

REPORT #: 71-211-2021s

REPORT DATE: October 29, 2021

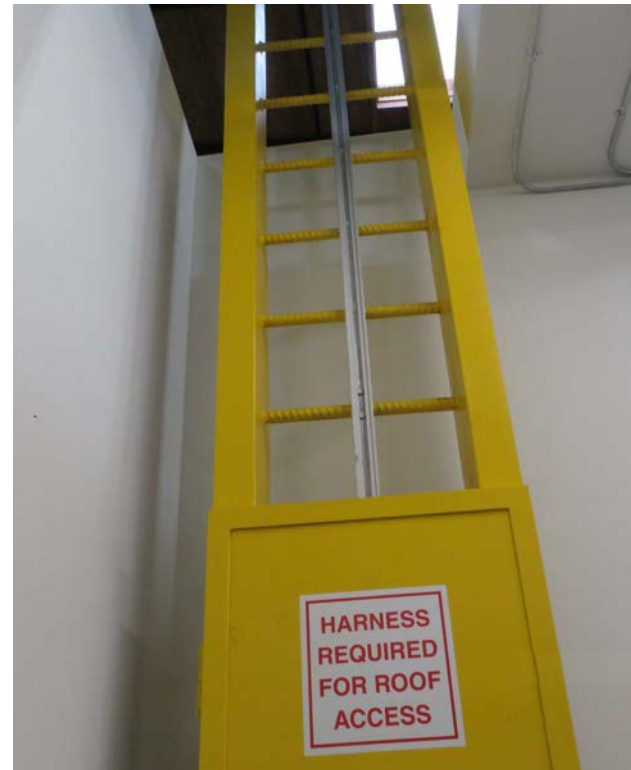
The 38-foot steel vertical fixed ladder had a metal cover at its bottom secured by a padlock, to prevent unauthorized use.

The ladder also had a safety system installed on it consisting of a climbing trolley attached to an aluminum track or carrier located between the ladder's side rails.

The trolley had a locking carabineer to which the climber can directly connect the front waist D-ring of their full body harness. The trolley moves with the climber and if they fall, it immediately arrests the fall.

The superintendent then unlocked the ladder cover. One of the roofers climbed the ladder and went through a hatch onto the roof. Another roofer began climbing the ladder. Rainwater coming through the open roof hatch had made the ladder slippery, which caused him to lose his grip on a ladder rung. He then fell 10 feet to the plywood roof of the electrical room.

- Employers must train employees to recognize ladder hazards and the procedures to minimize these hazards. See [WAC 296-876-15005\(1\)](#).
- Climbing and descending fixed ladders. See [WAC 296-876-80010](#).
- Ladder safety devices. See [WAC 296-876-60080](#).

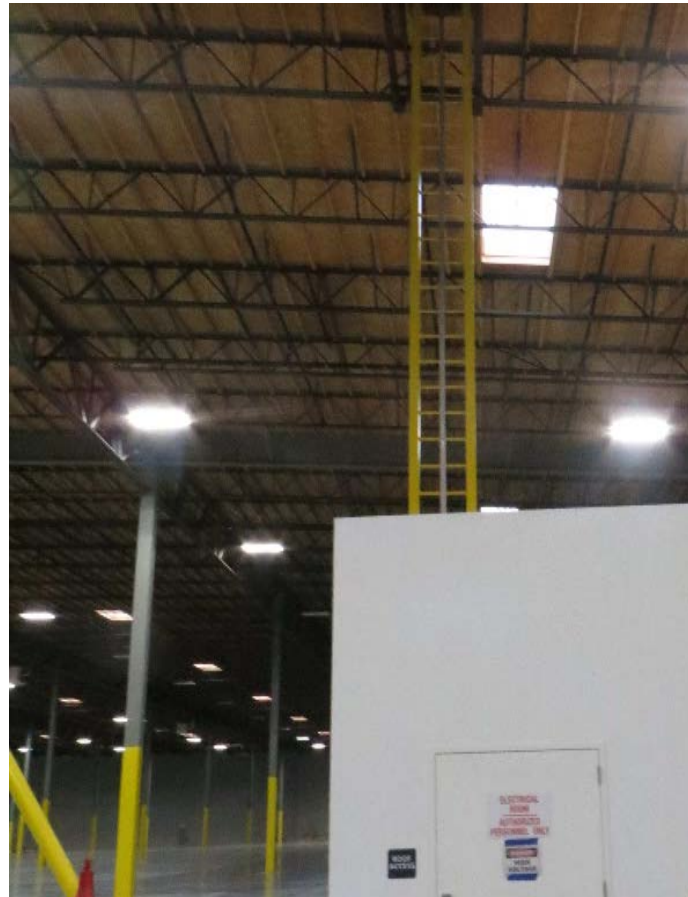
Photo 1. Roof access fixed ladder inside warehouse. Access to the ladder was located inside the electrical room.

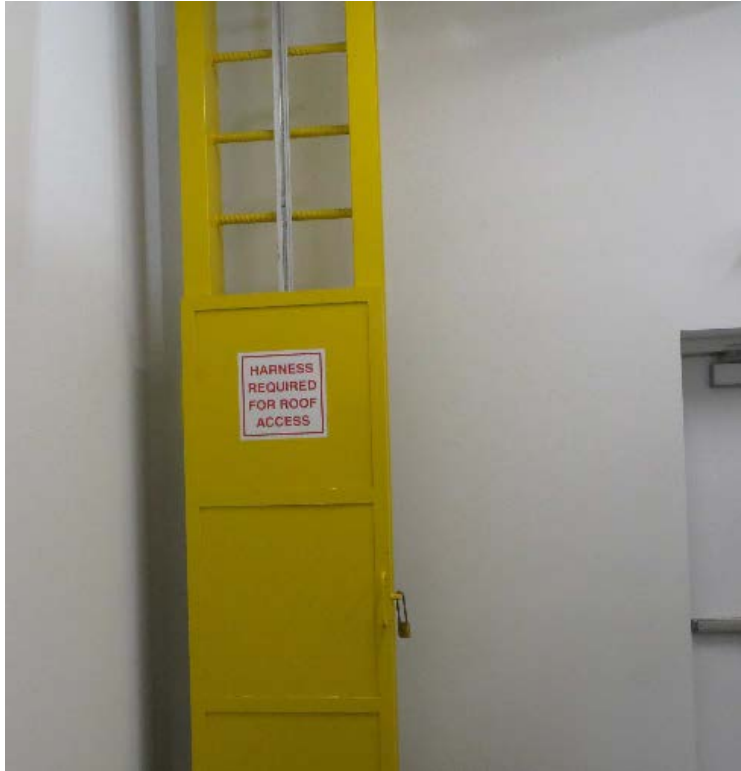
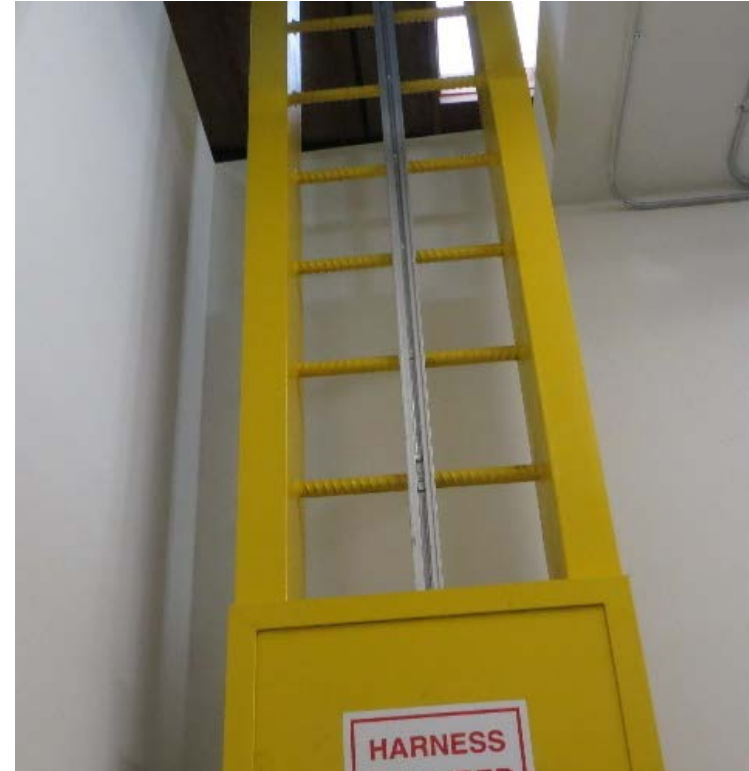
Photos 2 and 3. Two views of the padlocked access point used to gain access to the warehouse roof. **At the time of the incident there was no sign indicating that fall protection was required to access the ladder.**

- Ensure that employees have safety equipment, systems, and devices required for assigned tasks and that they are trained on how to properly use them.
- Follow the manufacturer's instructions when using ladder safety systems.

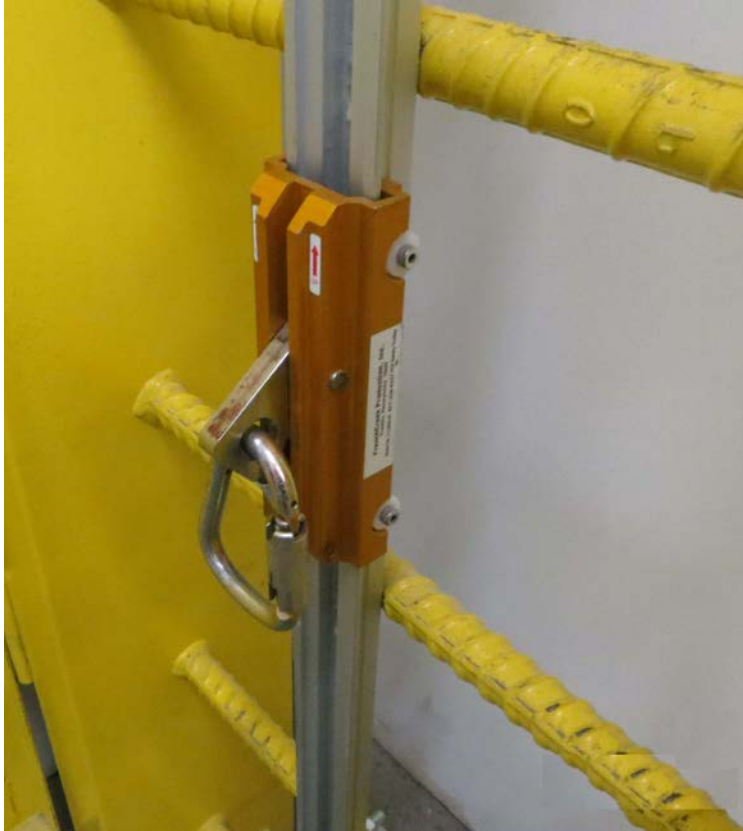
Photo 4. Ladder safety system consisting of a climbing trolley with tie off point attached to a track mounted to the ladder.

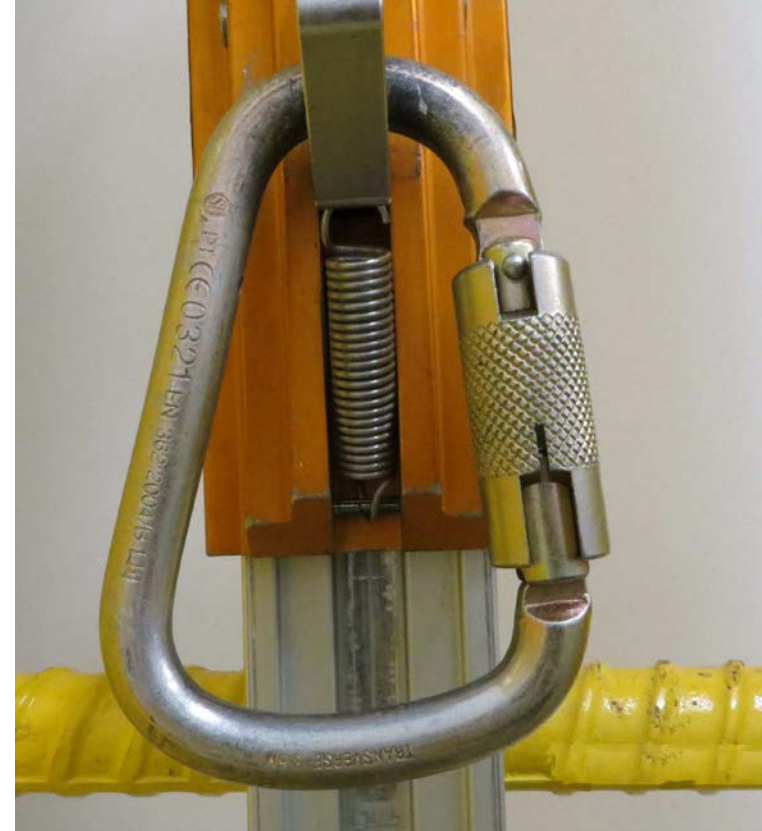
Photo 5. Locking carabiner to which the climber can directly connect the front waist D-ring of their full body harness..
