Apprentice Ironworker Struck by Dropped Steel Wedge

REPORT #: 71-217-2022s

SCENE: New construction of cold storage facility

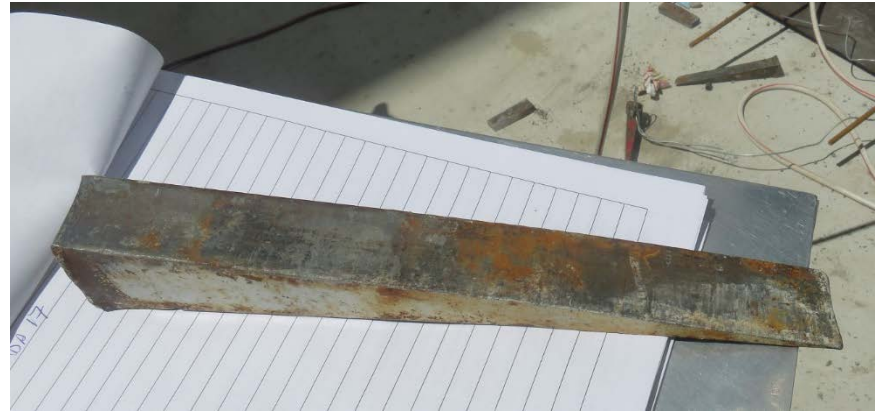
A 25-year-old apprentice ironworker was seriously injured after he was struck by a dropped steel wedge.

The ironworkers were using a steel wedge between the column and beam to help tighten the bolts securing them. One of the ironworkers was removing the wedge, which was under pressure, using a hammer to knock it loose.

As he was doing this, the untethered wedge broke free, but he was unable to hold on to it, and it fell approximately 50 feet.

At this moment, the apprentice was in the area below getting a bottle of water that was being stored there for workers. As he was bending over to pick up the bottle, the wedge struck him in his upper back near his left shoulder.

- Use red caution tape and/or have a spotter on the ground to keep workers from entering areas where objects may be dropped.
- Locate employee water stations away from active work areas.
- Provide safety training to new workers to ensure they understand the hazards associated with the work site.

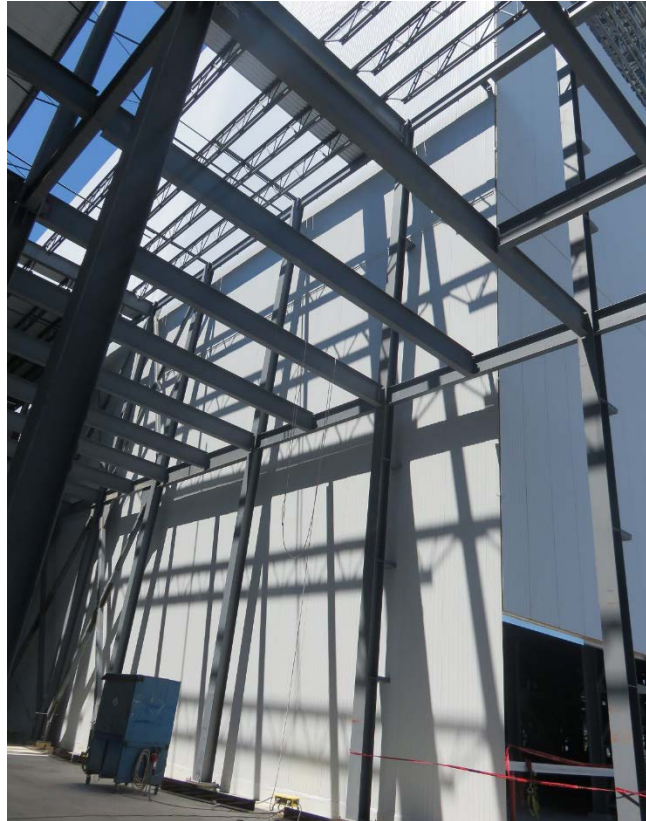
Photo 1. Incident scene at the cold storage facility being constructed. This was the area where an ironworker accidentally dropped a steel wedge that he was attempting to remove from between a beam and column. The wedge fell approximately 50 feet, striking the apprentice on the ground floor below.

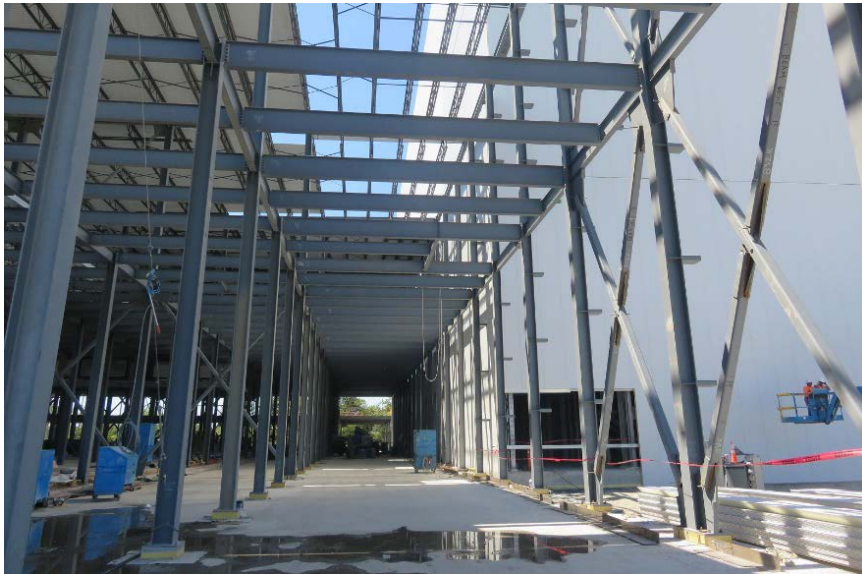
Photo 2. Interior view of incident scene at the cold storage facility under construction.

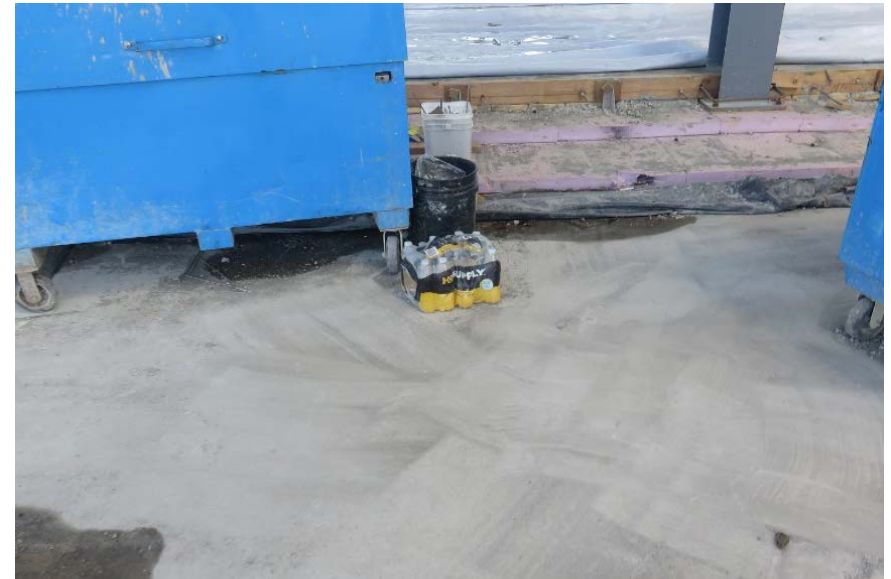
Photo 3. Area where the apprentice ironworker went to retrieve a bottle of water when he was struck by the dropped steel wedge.

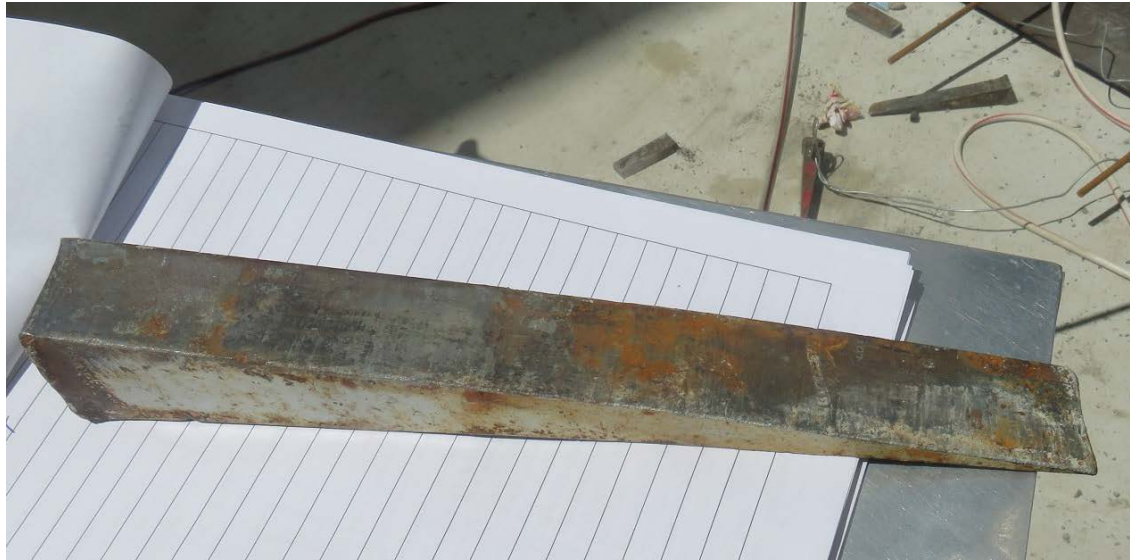
Photo 4. Steel wedge that struck the apprentice ironworker in his upper back near his left shoulder.

- Require that wedges and other tools used by workers at heights have lanyards, tethering devices, holsters, buckets and other devices to secure them.
- Add attachment points to wedges if they do not have them so they can be secured to a tether.
- Ensure that tethering systems are ANSI/ISEA 121-2018 Dropped Object Prevention Solutions compliant.
- Secure wedges and other tools, both when in use and not in use.

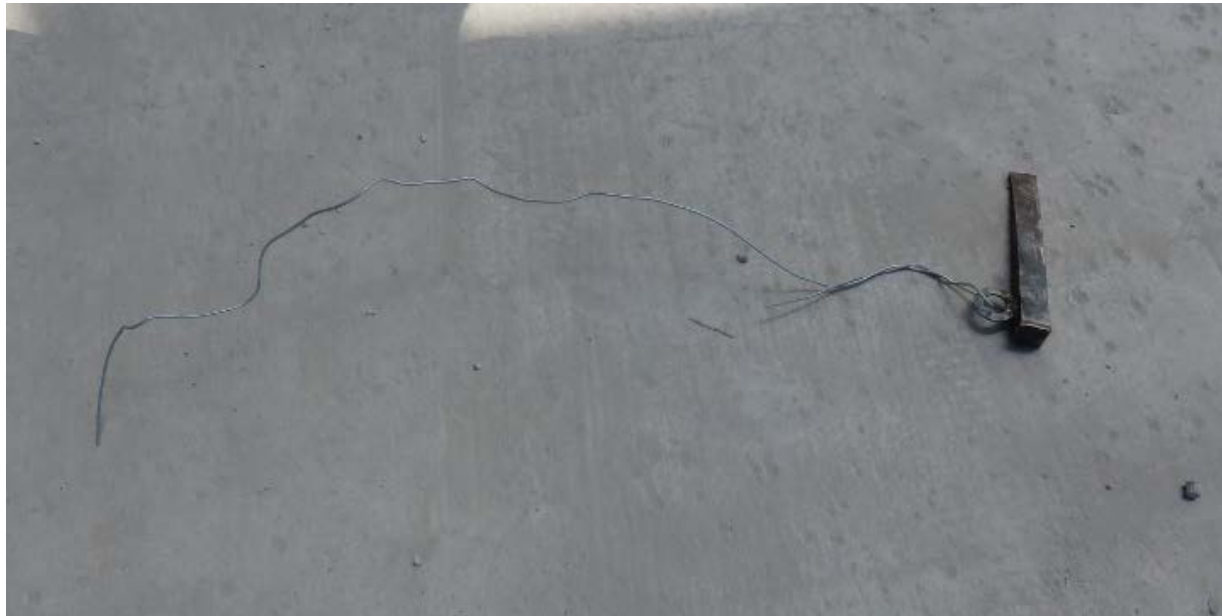
Photo 5. Employer modified steel wedge with a washer welded to the wedge and a wire attached to the washer that is used as a tether. Alternatively, a hole could be drilled into the wedge and a tether attached to it.
