INCIDENT FACTS

REPORT #:
71-219-2022

Truck Driver/Equipment Operator Crushed while Loading Backhoe onto Trailer

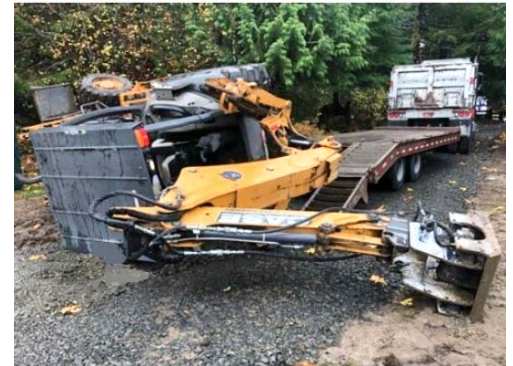
Overturned backhoe and trailer. The driver was not wearing the seatbelt and was crushed under the ROPS.

While the incident was unwitnessed, evidence at the scene suggests that the driver was operating the backhoe in reverse, as the backup warning alarm was sounding when first responders arrived on the scene. It is possible that the driver had started moving the backhoe up the trailer's two metal ramps, and then backed up to better position its wheels. As he was doing this, the wet, muddy tires may have slipped on the ramps resulting in a rear wheel going off the ramp, causing it to rollover on its side.

Either the driver, who was not wearing the backhoe's seatbelt, attempted to jump from the operator's seat or he was thrown from it as the backhoe rolled over. He was crushed under the backhoe's rollover protective structure (ROPS). The backhoe had a seatbelt that was functional. If he had used the seatbelt, it would have kept him in the seat as the backhoe rolled on its side.

Overturned backhoe and the trailer onto which the driver was attempting to load the backhoe when it rolled over, crushing him.

- Train equipment operators and ensure they always use a seatbelt when operating equipment, including when loading and unloading onto or off a transport trailer.
- Use a spotter to provide directions to the equipment operator during loading and unloading to ensure that the operator positions equipment correctly for safe movement on and off the trailer.
- Create a job hazard analysis (JHA) for safely loading and unloading construction equipment on and off trailers.
