# Driver Caught Between Trucks at Warehouse Loading Dock

**REPORT #:** 71-221-2022s

**SCENE:** Warehouse loading dock

**EVENT TYPE:** Struck by – Caught between

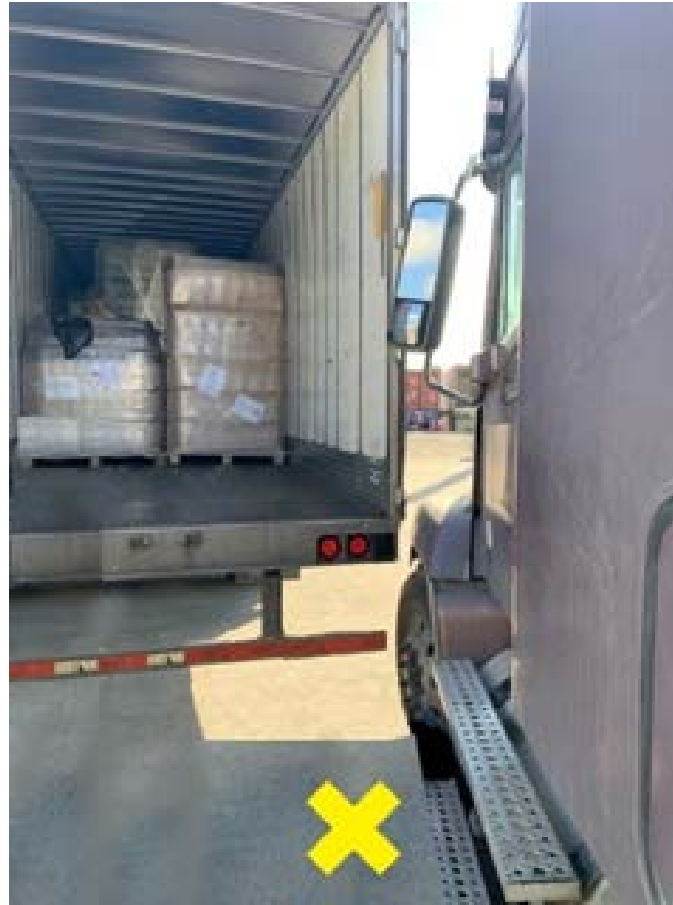
The dry van turned left before it was fully out of the parking slot. The forward position of its trailer's tandem axles caused the last ten feet of the trailer to swing rightward into the space between the trucks where the driver was walking. The swinging trailer struck and pinched the driver against the left side of his truck cab, causing him to go into shock, faint, and fall down. Another driver saw him on the ground and got the dry van driver to stop. First responders transported the injured driver to the hospital. He was released three days later with severe bruises.

**Photo 1.** The driver was caught between the dry van trailer on the left and his truck cab on the right. Yellow X shows where he was found on the ground unconscious.

- Consider equipping trucks with commercially available turn assist systems that alert drivers when pedestrians are detected inside blind spots beside the vehicle.
- Require drivers to slide trailer tandems back before docking to eliminate tail swing when leaving.
- Require drivers to check right side hood tri-pod mirror and pull fully out of the parking slot before turning truck.
- Request customers with loading docks to identify vehicle struck by - caught between hazards and ensure adequate parking and maneuvering space for trucks and safe passage for pedestrians.

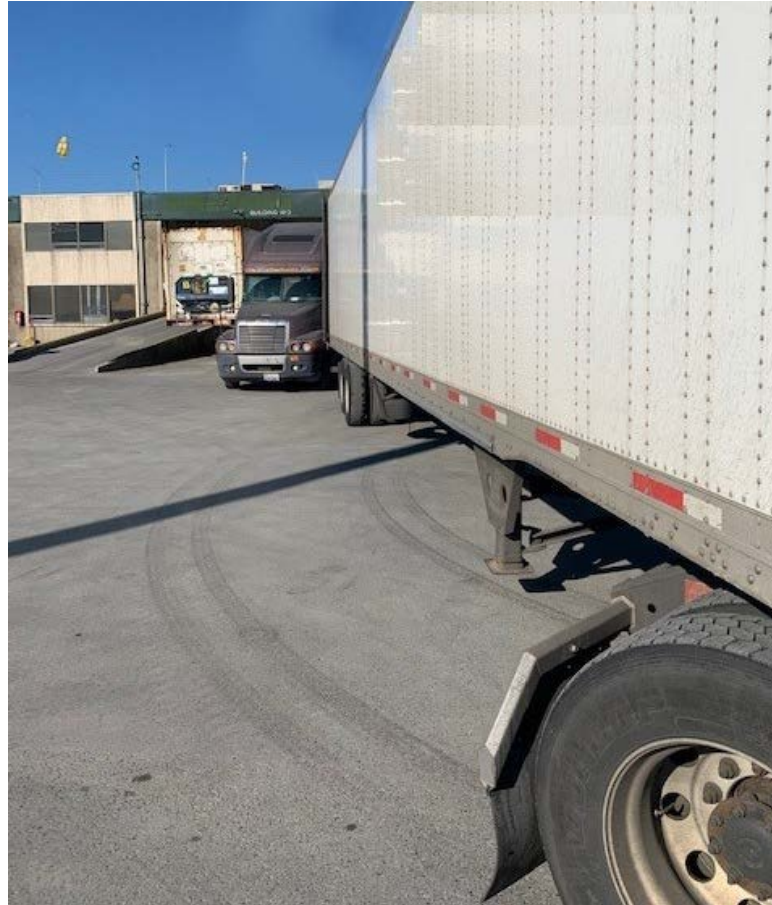
- 1) The incident could have been avoided had the dry van truck pulled fully out of its parking slot before turning.
- 2) Had the trailer's tandem axles been in the rear position, it would not have swung into the space between the trucks where the injured driver was walking.
- 3) The contract between the owner operator and warehouse business placed the responsibility of safe vehicle operation solely on the operator.
- 4) The warehouse did not provide any safety training to truck drivers and only verified that they met federal motor carrier requirements.

**Photo 2.** View looking toward rear of passenger side of dry van trailer and front of driver's truck where incident occurred.

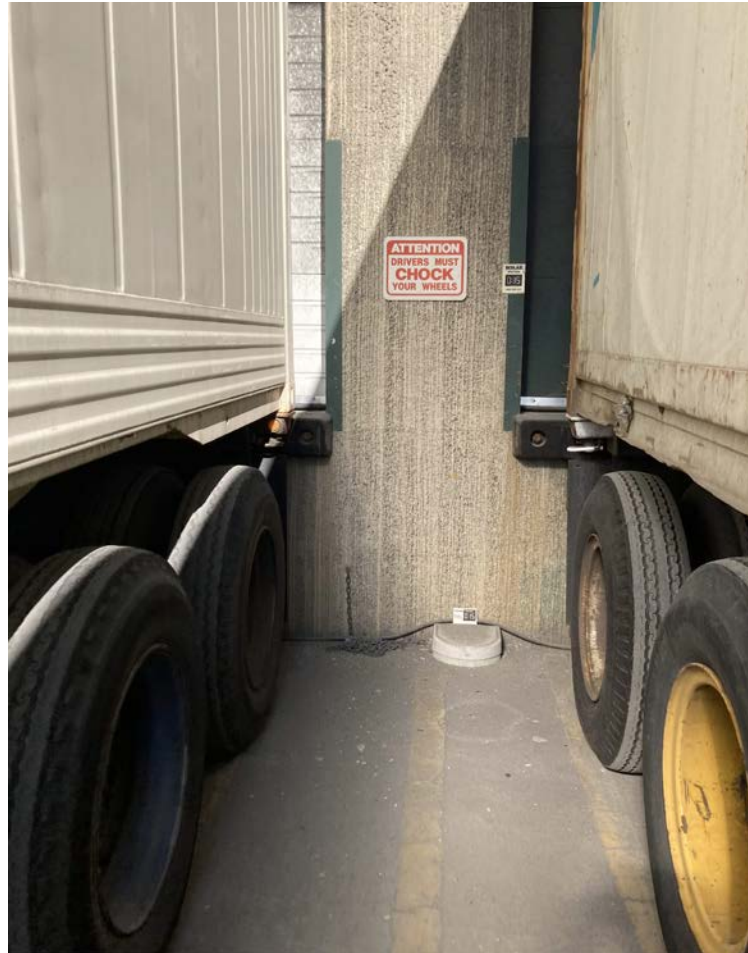
**Photo 3.** Space between trucks similar to where the driver was walking when he was struck by the dry van trailer.
