Farm Worker's Hand Mangled in Hop Harvester

REPORT #: 71-232-2023s

REPORT DATE: January 30, 2023

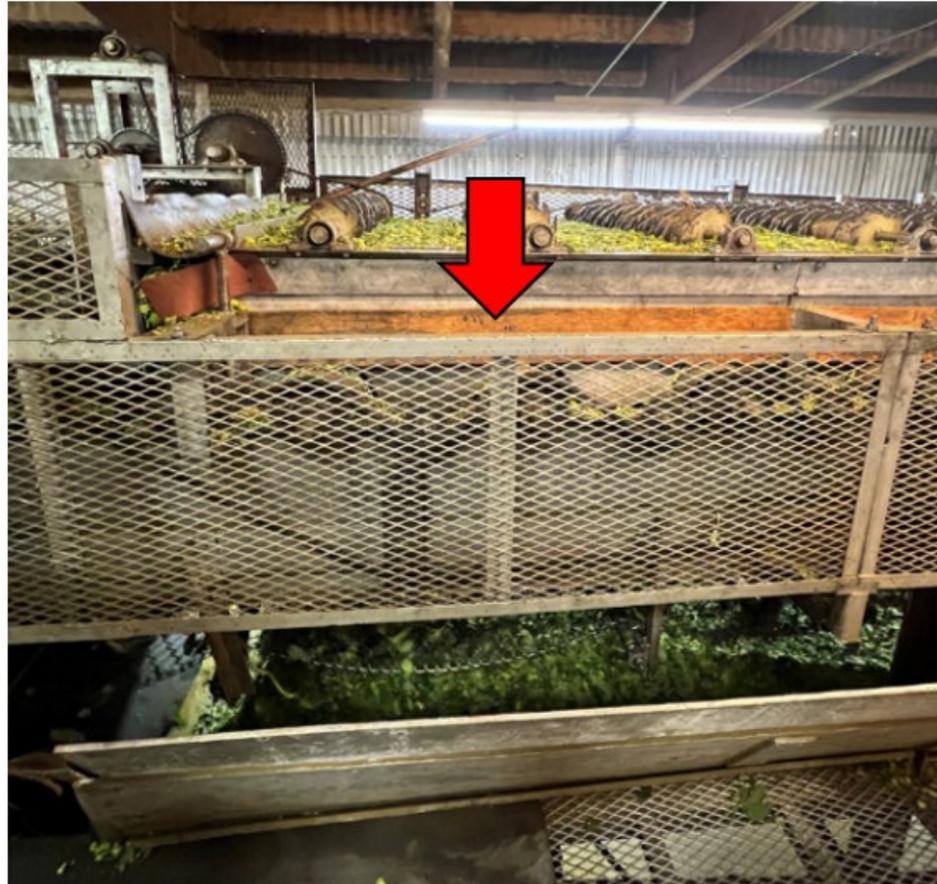
- The hop harvester's arm picker had a horizontal steel guard that was too low to prevent someone from reaching over into an 11-inch unguarded gap above the chain and sprocket drive area.
- The worker did not follow his training from the employer to notify a lead mechanic, who was nearby, to perform lockout/tagout (LOTO) procedure requirements before cleaning out debris.

Photo 1. Hop harvester machine in which worker mangled his hand trying to remove debris. Arrow shows gap above horizontal steel mesh guard and chain and sprocket drive where worker reached in.

- Unless guarded by location, enclose all sprocket wheels and chains. See [WAC 296-307-28030\(3\)](#)

- If a machine cannot be guarded by distance and location, protect workers from hazards created by rotating or revolving parts by using one or more safeguarding methods. Make sure guards are:
 - Made of strong, durable materials, such as angle iron, solid metal, expanded metal, and wire mesh.
 - Securely fastened to the machine or the building structure if they cannot be attached to the machine.
 - Regularly inspected and maintained, or replaced if not in serviceable condition.

- Make sure guards protect workers by preventing hands or other body parts from reaching through, over, under, or around the guard into the hazard area; and preventing objects or debris from falling onto or being thrown towards a worker.
- Install warning signs on and near machines to remind workers of operating hazards and LOTO requirements written in a language all workers can understand.
- Conduct Job Hazard Analysis (JHA) to identify machine operation hazards and solutions before use.

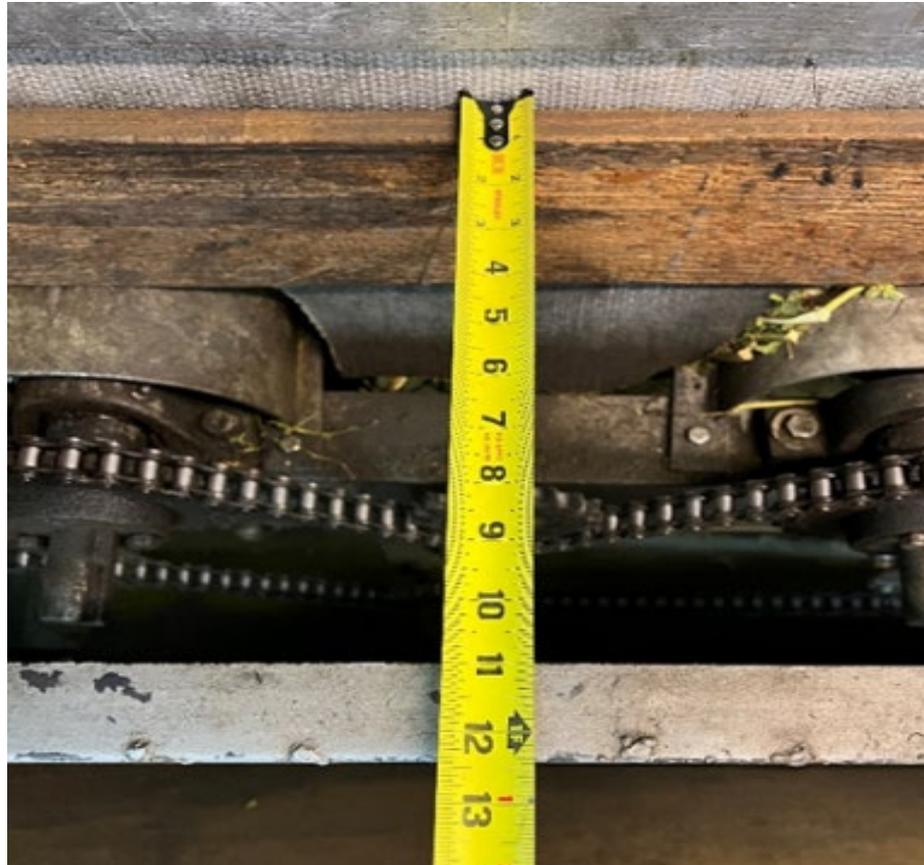
The injury happened around 4 a.m. when the worker's shift was ending. Getting ready to clock out, he saw a long bine sticking out from the hop harvester's arm picker. The picker stripped leaves and stems from hop bines using a chain and sprocket drive that operated between 190 - 210 rpm. When the worker reached over into an open 11-inch gap above the picker to remove the bine, the energized rotating chain pulled his left hand in, shredded his work glove, and badly mangled his fingers and palm.

Photo 2. Close up of 11-inch unguarded gap above chain and sprocket drive where worker reached in and mangled his hand. Torn pieces of the worker's glove were found in the chain after the incident.

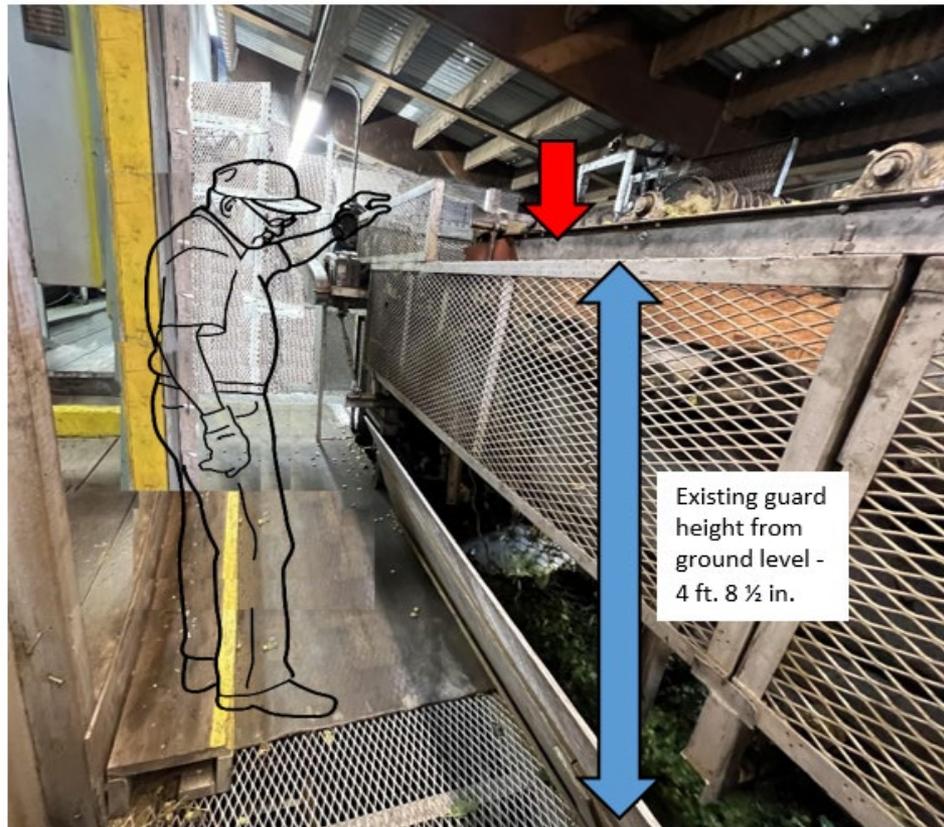
Photo 3. Photo shows outline of a worker standing next to hop harvester arm picker where incident occurred. Red arrow shows approximate location where worker reached his hand when it was mangled by the chain and sprocket drive behind the steel mesh guard. Blue arrow shows height of the existing guard. Note machine's lack of hazard warning and LOTO procedure requirement signage.
