INCIDENT FACTS

71-238-2023

Operator Crushed between Backhoe Boom and Stabilizer

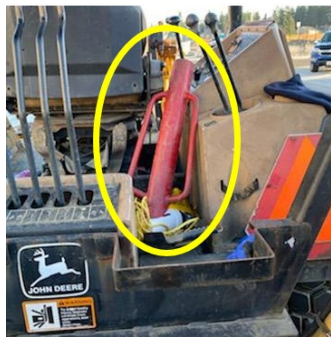
The post pounder (circled), which caused the boom to swing and crush the operator.

He first used the backhoe to excavate around an electrical junction box. After doing this, he used the backhoe's loader to place gravel around the box. He then moved the backhoe to the street where he parked it. He left the engine running and the backhoe boom elevated. He exited the cab and walked to the rear of the backhoe. No one saw what happened next, though investigators determined that as he was standing at the rear of the cab where the backhoe boom attached, he reached into the cab to retrieve a metal tool called a post pounder. As he was doing this, he apparently dropped the post pounder on one of the two foot pedals that controlled the backhoe boom swing. This caused the boom to swing sideways toward him, pinning and crushing him between the boom and one of the machine's two retracted stabilizers.

- Lower the boom to a safe position with the bucket on the ground and turn off the machine before stepping off for any reason.
- Never place tools, parts, or other objects in the cab that have the potential to activate the foot pedals or other controls.
- Never stand in the pinch point of the boom of a running or operating backhoe.

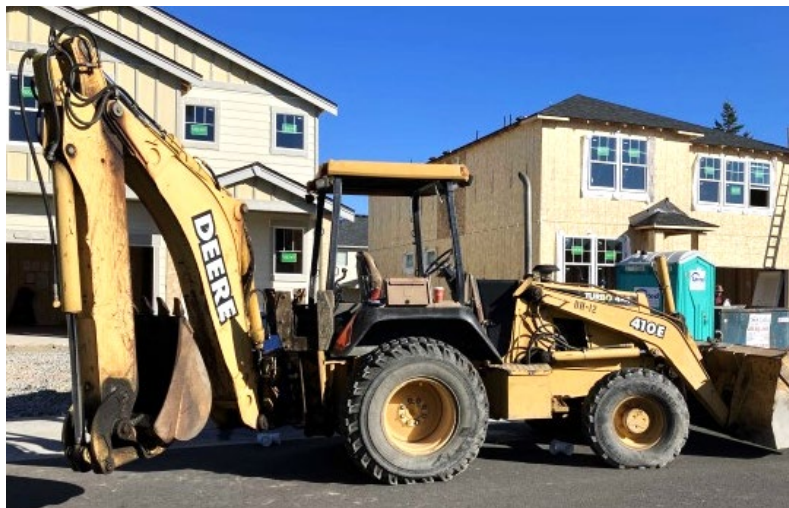
A 54-year-old operator died when the raised boom of a backhoe loader swung and crushed him against one of the machine's retracted stabilizers.

The backhoe loader at the incident scene.
