INCIDENT FACTS

71-242-2023

Excavation site

Spotter Loses Fingertips in Excavator Quick Coupler

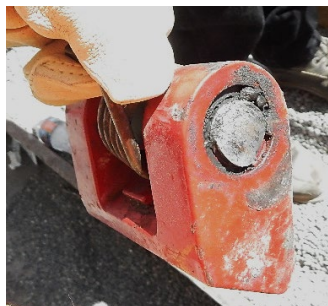
The safety knuckle that detached from the quick coupler.

The young worker was part of a crew setting up a shoring system. He was spotting for an operator who was using the bucket of a rented excavator to pound in a steel piling. When finished, the operator lowered the bucket to the ground. Just then, the spotter noticed the safety knuckle of the quick coupler on the ground. It had detached from the coupler where it connected the bucket to the excavator. He picked up the knuckle and moved in front of the bucket where he used his hands to feel around inside the coupler and tried to reattach the knuckle. Suddenly, the wedge of the coupler locked into place crushing his fingers between the wedge and the bucket. The incident evolved into a 3-hour, multiple agency technical rescue. The spotter lost the tips from the first three fingers of his right hand.

- The operator inspected the quick coupler earlier that day, confirmed the wedge was locked in place and there were no hydraulic leaks, and used the excavator for seven hours prior to the incident.
- The operator nor anyone else on site heard a detachment alarm when he lowered the bucket or when the safety knuckle detached from the coupler.
- No evidence of exactly what caused the knuckle to detach.
- The spotter did not communicate to the operator when he attempted to reattach the knuckle.

- Train equipment operators and workers on the ground to:
 - Never place hands inside the quick coupler or anywhere near the linkage mechanism while the hydraulic system is pressurized or the machine is on.
 - Never attempt to repair failed equipment and to notify site supervisors when issues with equipment are suspected or noticed.
 - Always communicate intentions and wait for confirmation before proceeding.
- Use an excavator-mounted pile driver instead of a bucket to drive piles.

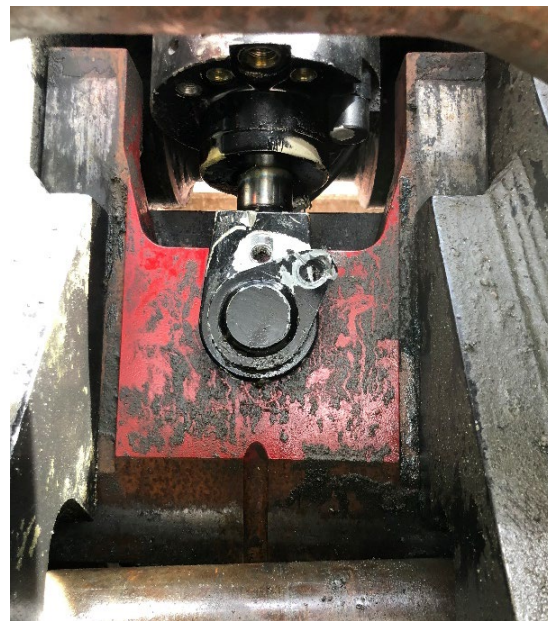
A 20-year-old worker lost three fingertips from his right hand when a quick coupler connecting a bucket to an excavator failed. He had been with the employer for 5 months, working as a ground person.

The wedge lock of the quick coupler that crushed the worker's fingers.
