Inexperienced Framers Falls 22 Feet from Upper Floor

INCIDENT FACTS

REPORT #: 71-253-2024s

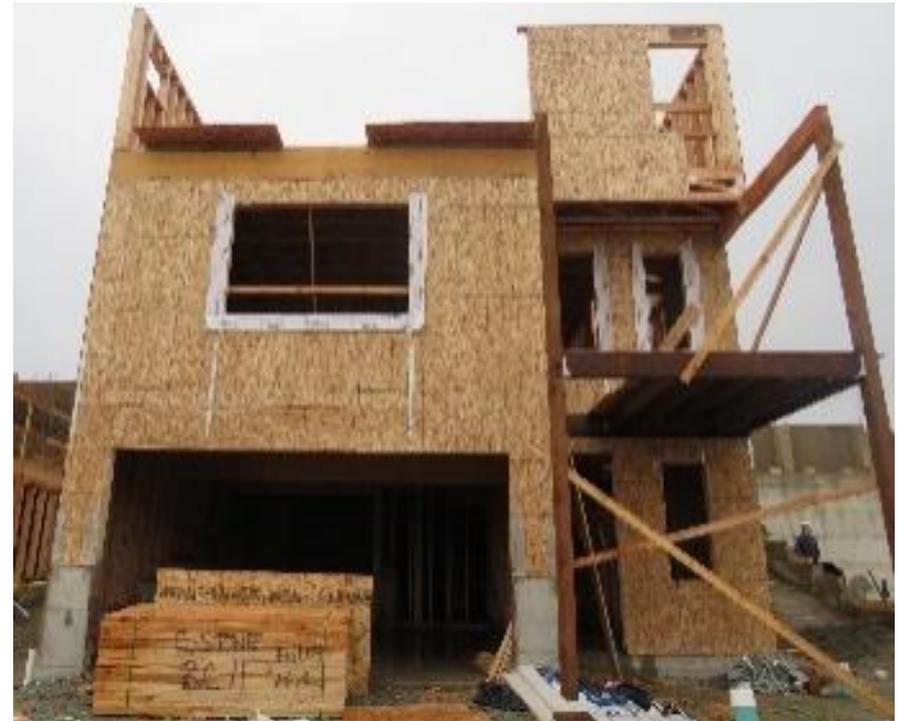
The framer was working with a supervisor on the unfinished, open-sided floor. The floor was still being framed, and the supervisor removed fall prevention guardrails in an area where a wall assembly was going to be installed.

The supervisor instructed the framer to cut out a window opening in a piece of wood sheathing being prepared for the wall assembly. After making the opening, the framer went to drop the cuttings down to a scrap pile on the ground. He walked on the wall assembly, which was laying on the floor, and then onto a small piece of attached sheathing that extended past the edge of the floor.

The sheathing was not properly nailed down and gave way under his weight, causing him to fall 22 feet to the ground. The supervisor witnessed the fall, ran downstairs, and called 911. The emergency dispatcher guided him in giving first aid. When first responders arrived, they could not save the framer, who died of severe head injuries

- Employers with employees exposed to fall hazards must have and enforce policies in their accident prevention program (APP) that meet the Unified Safety Standards for Fall Protection. See [WAC 296-880](#)
- The employer must develop and implement a written fall protection work plan including each area of the work place where the employees are assigned and where fall hazards of ten feet or more exist. See [WAC 296-880-10020](#)

- Ensure a competent person trains each affected employee to know at least the following::
 - (a) The nature of fall hazards in the work area; (b) When fall protection is required; (c) What fall protection is required; (d) The correct procedures for erecting, maintaining, assembling, disassembling, and inspecting the fall protection systems to be used; (e) The use and operation of fall protection systems used; (f) Limitations of fall protection systems used; (g) Proper care, maintenance, useful life, removal from service; and (h) The requirements of this chapter. See [WAC 286-880-10015\(2\)](#)

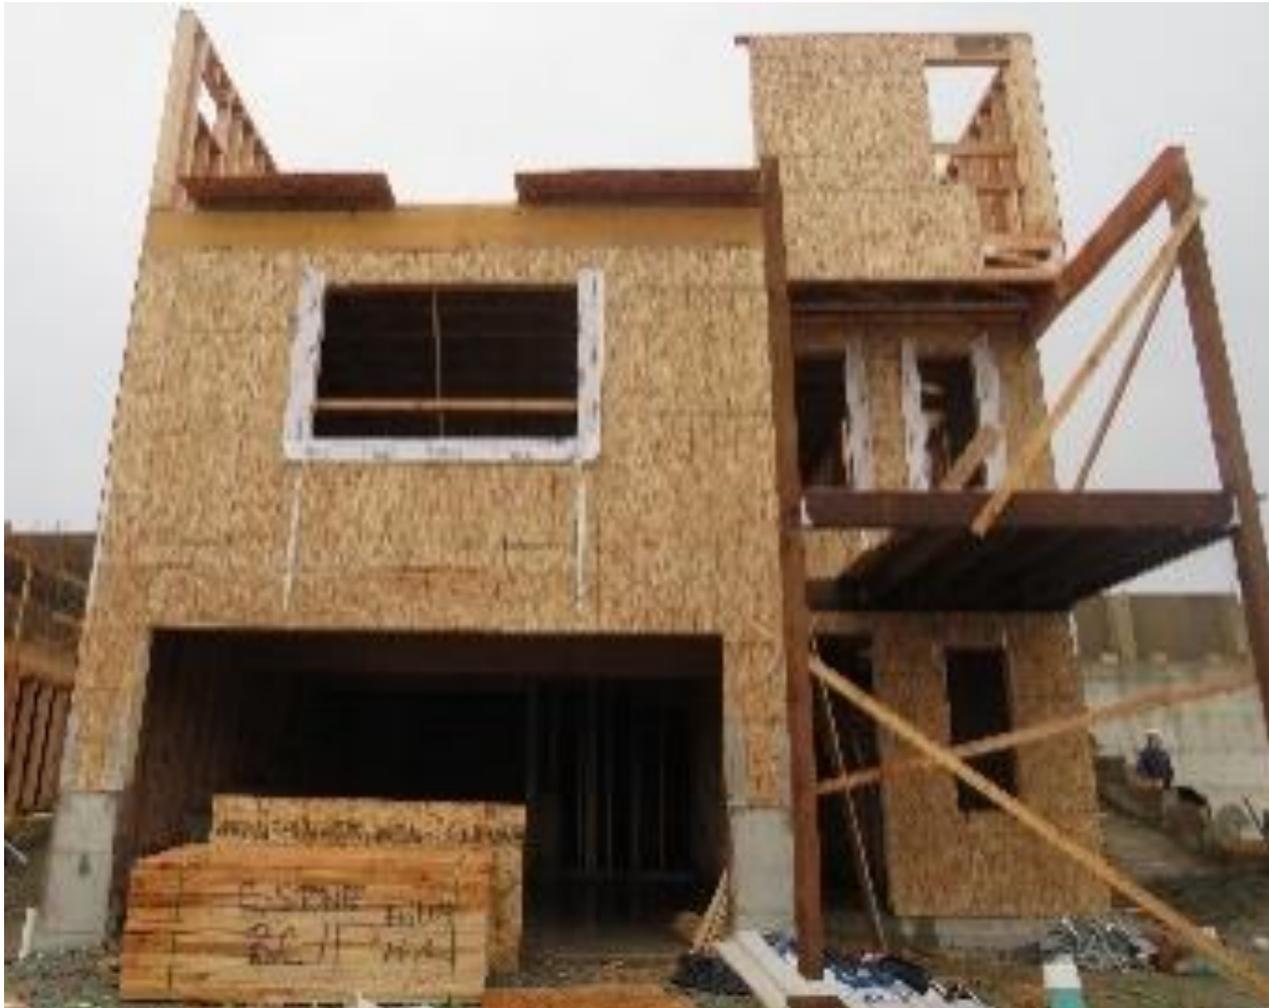
Photo 1. Open-sided upper floor where guardrails were removed.

- Develop APP policies to use PFAS when fall prevention guardrails are not in place on open-sided floors.
- Discuss fall protection policies at crew meetings, monthly safety meetings, and annual stand-downs.
- Conduct recurring hands-on fall protection training and ensure workers show proficiency in practice.
- Require all levels of management to spot check workers and enforce fall protection policies and practices.
- Use a project timeline to communicate task schedules with workers and suppliers to avoid rushing.

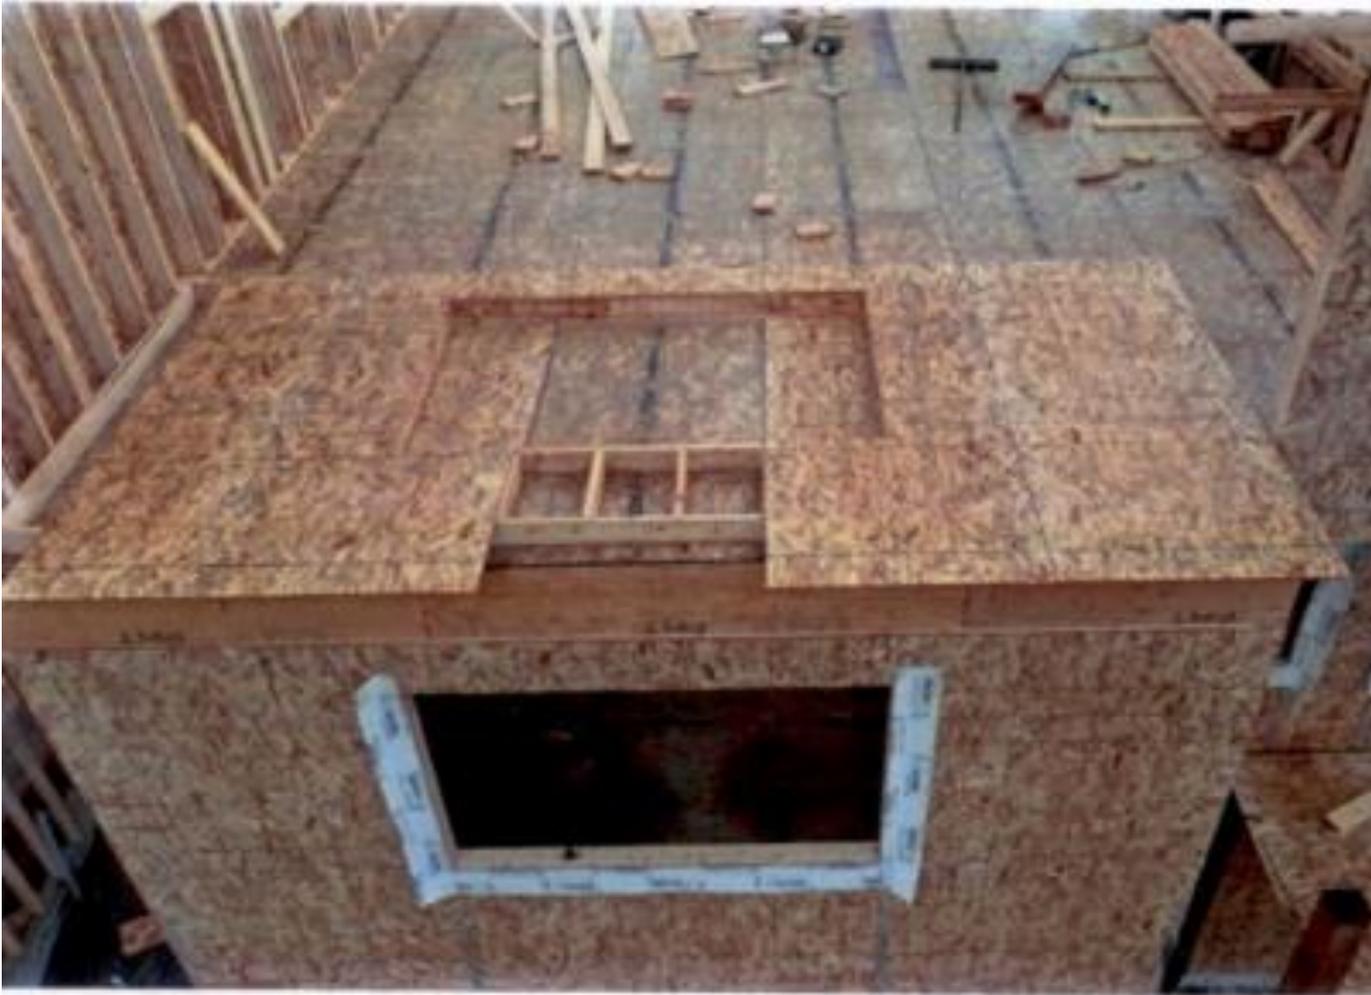
Photo 2. Unprotected floor where the framer fell.

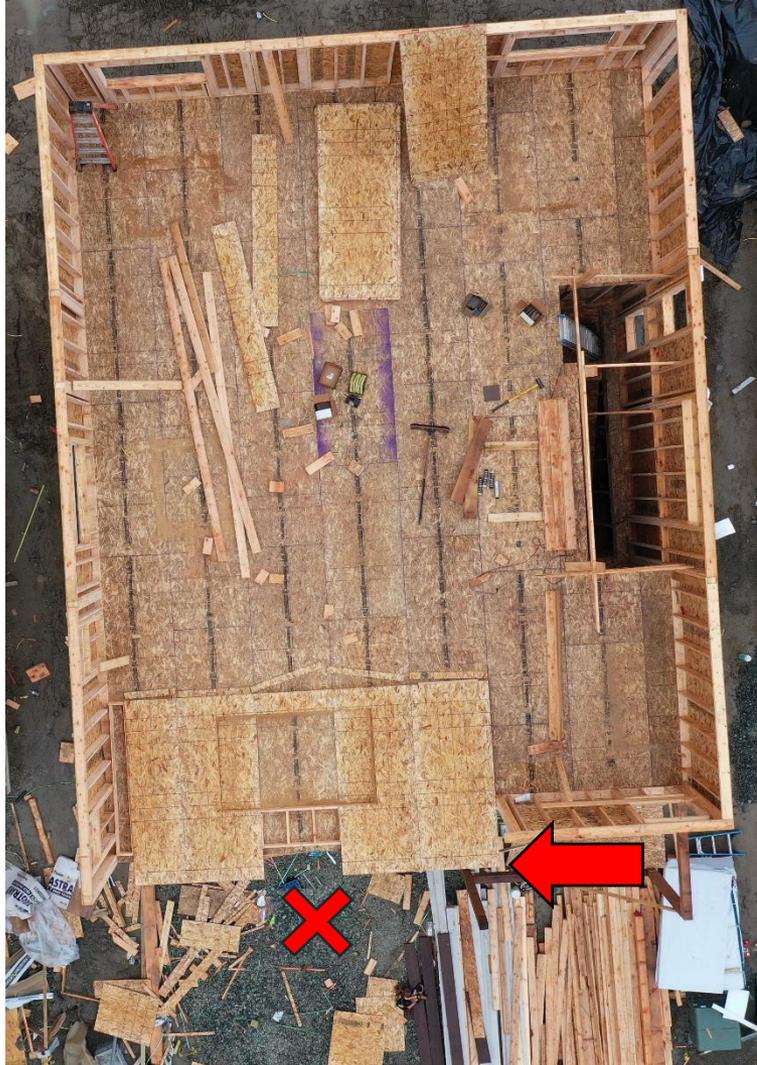
Photo 3. Aerial view of upper floor with arrow showing wall sheathing extending over unprotected edge.

The X marks the ground-level area where the framer landed after falling.
