Welder Fell 32 Feet from Storage Tank Roof

REPORT #: 71-260-2024s

SCENE: Storage tank construction site

EVENT TYPE: Fall from elevation

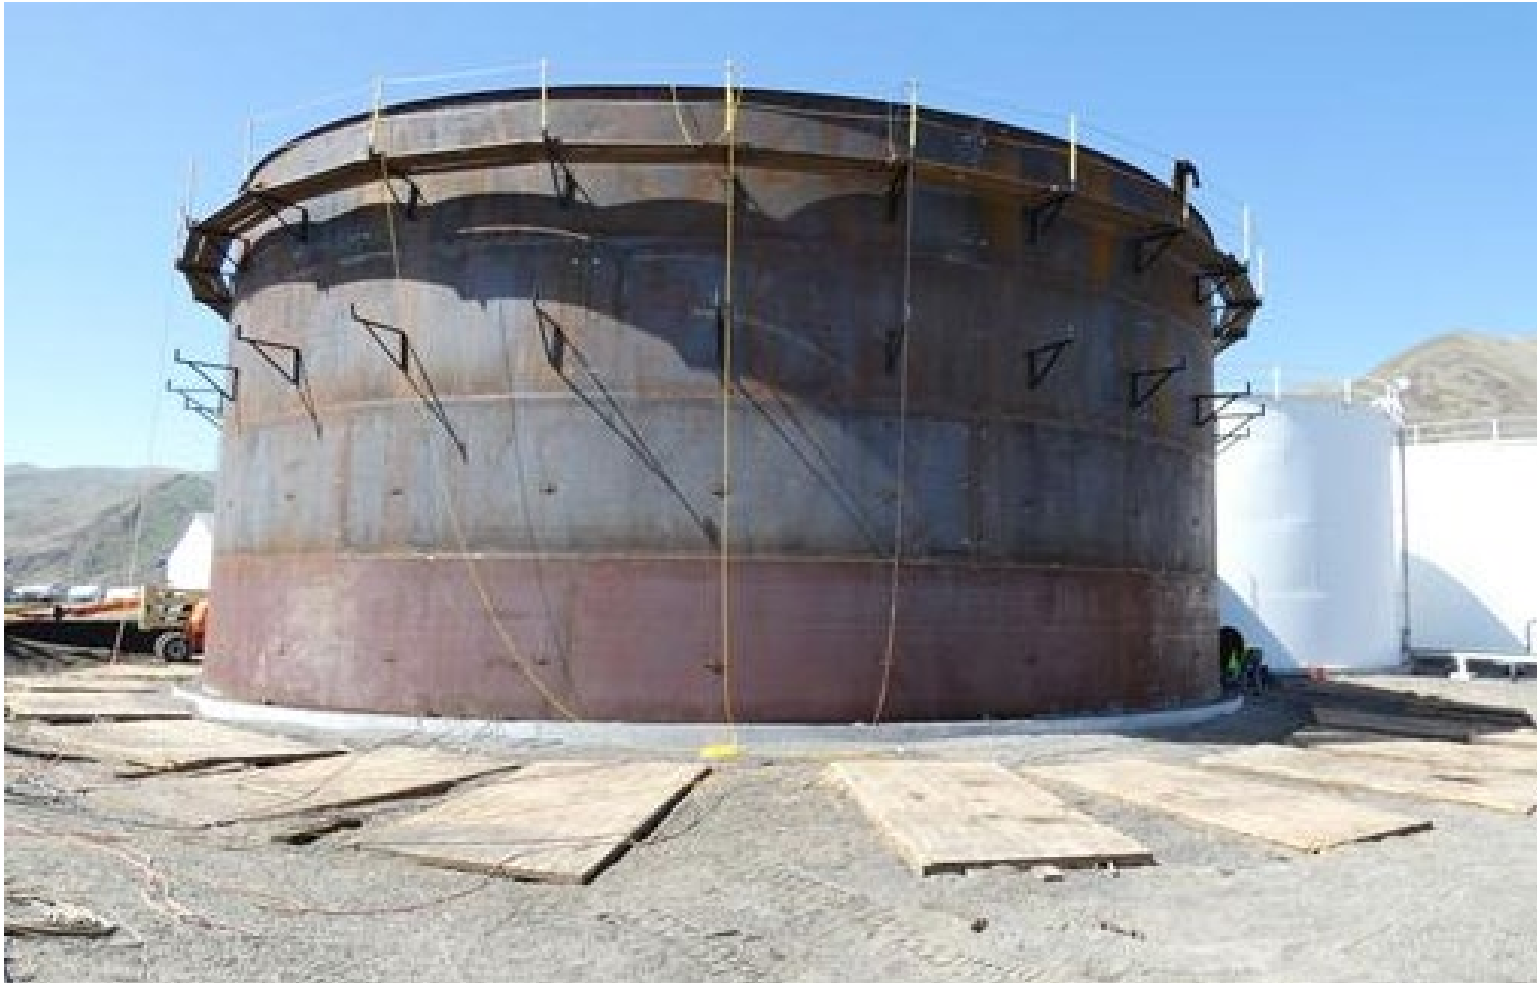
Photo 1. Storage tank at incident site.

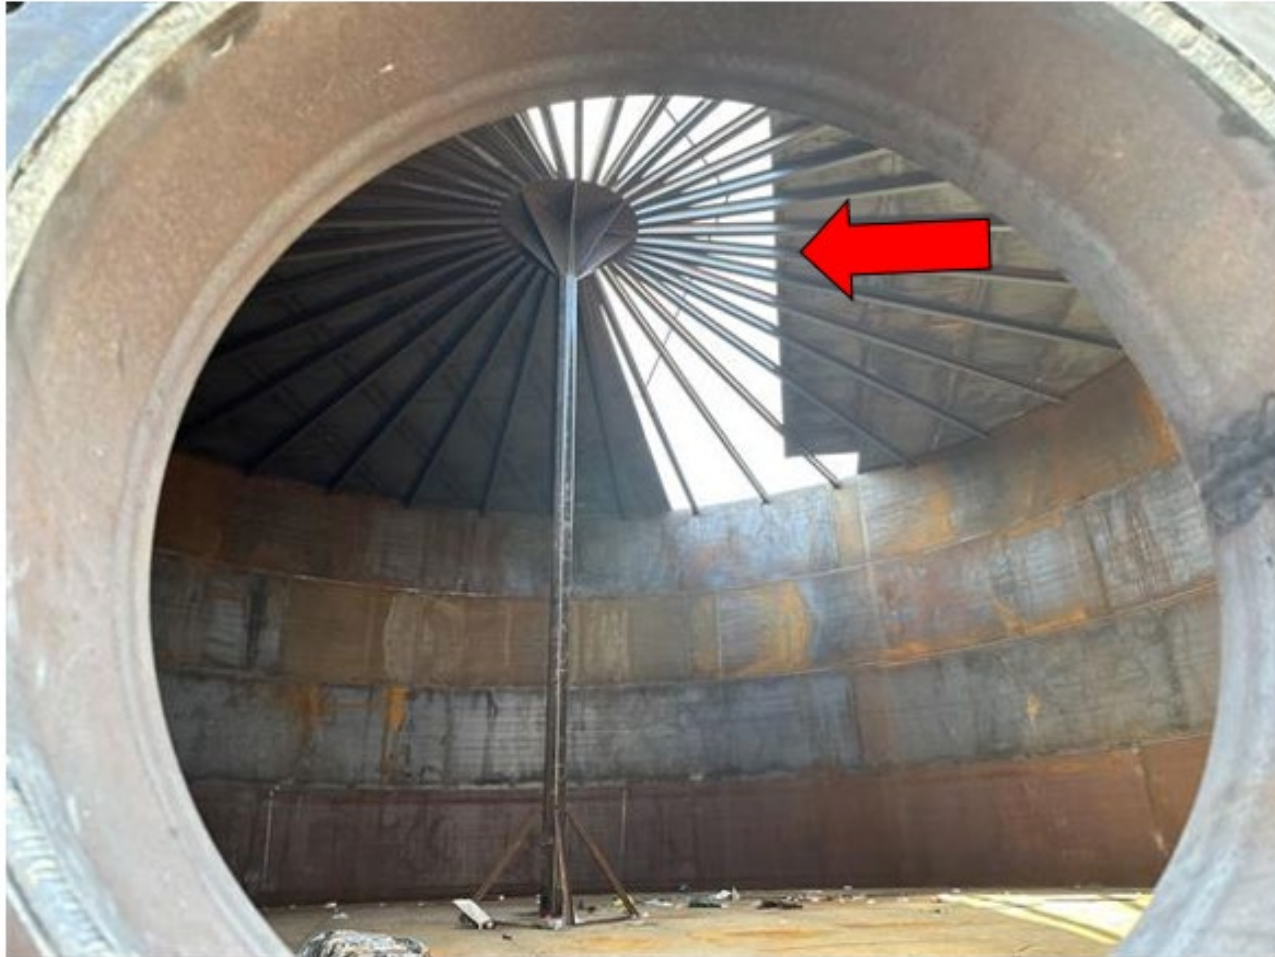
While sitting on the rafter, he used a pry bar to bend and move the sheet into place for welding. As he pried, he fell backward through the hole between the rafter and leading edge. After landing on the ground, he was badly hurt but still conscious and breathing. Emergency responders arrived and had a critical care helicopter airlift him to the hospital. He died the next day.

Photo 2. Hole in top of tank roof where the welder fell through.

- Use a crane instead of workers to move sheathing near roof leading edges.
- Develop FPWP and PFAS policies in their accident prevention program (APP). Policies should require pre-planning the use, training, and inspection of site-specific fall protection to meet the needs of different work environments.

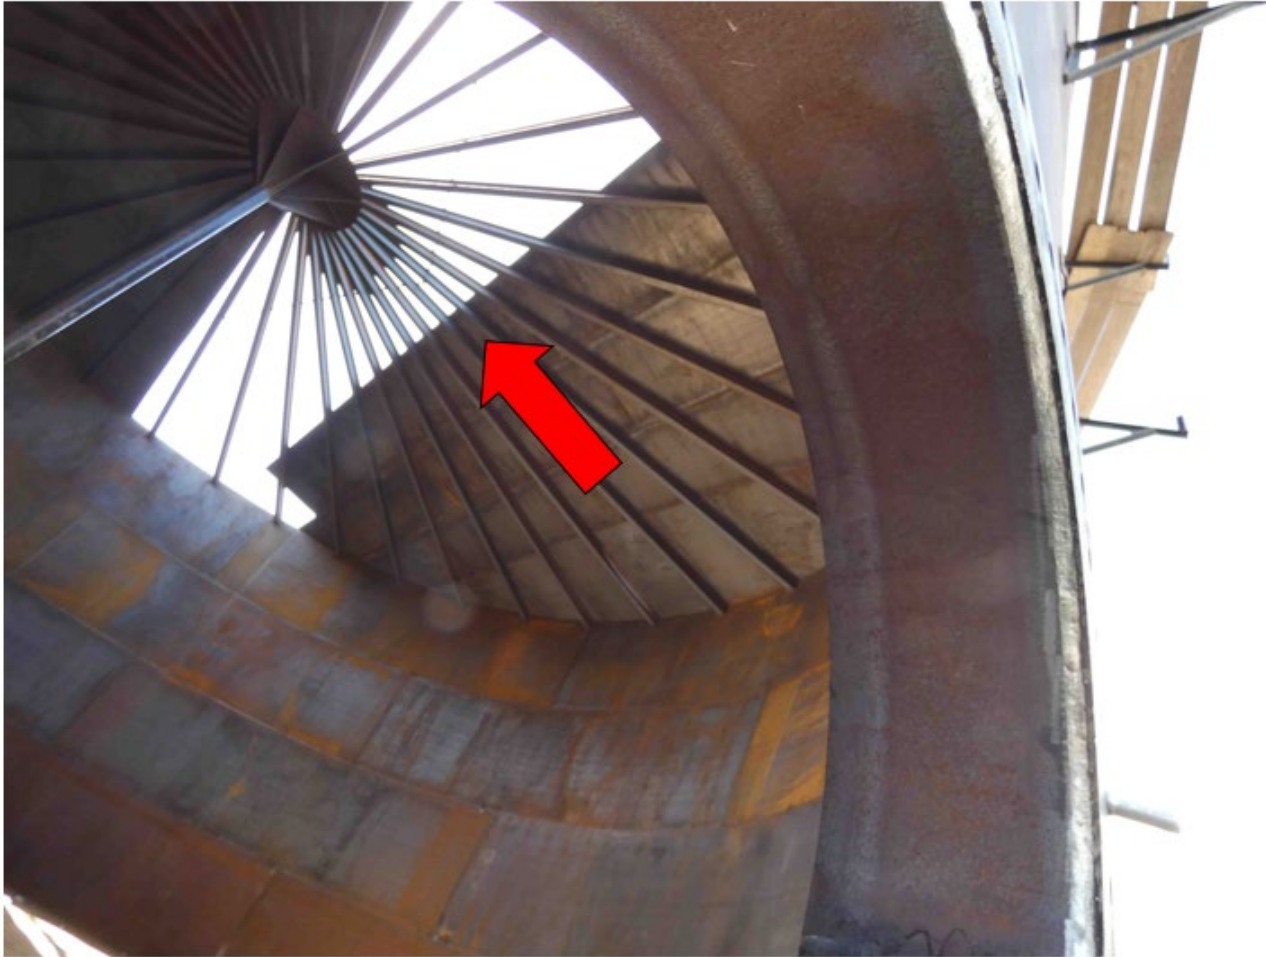
Photo 3. Alternate view of hole in tank roof where the welder fell.

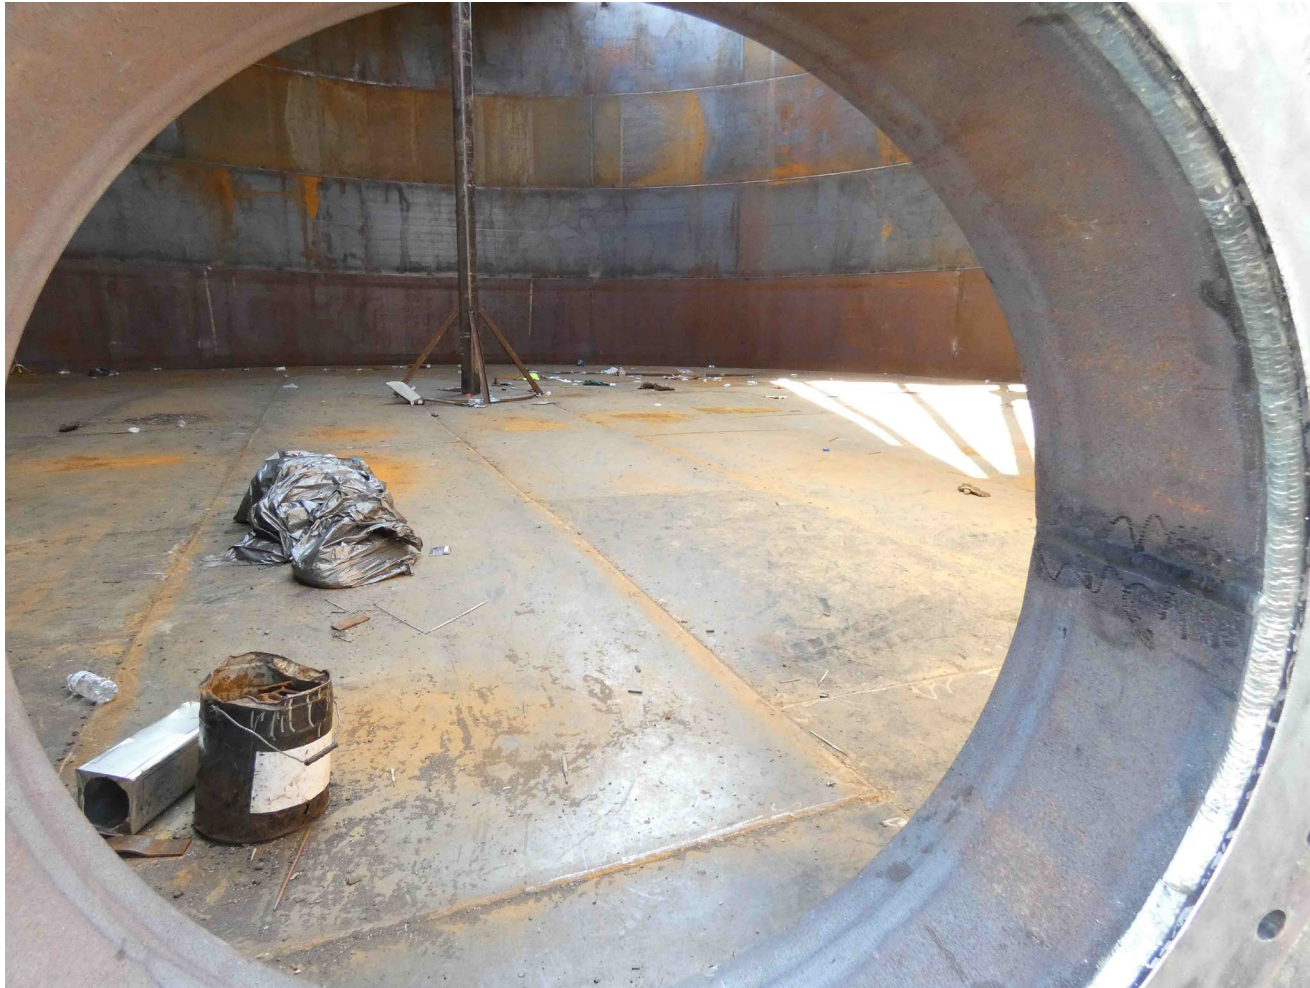
Photo 4. Floor at base of tank where the welder landed.
