# FATALITY NARRATIVE

## Foreman and Laborer Fall when Aerial Lift Struck by Vehicle

**Task:** Installing retaining rods on bridge

**Type of Incident:** Fall

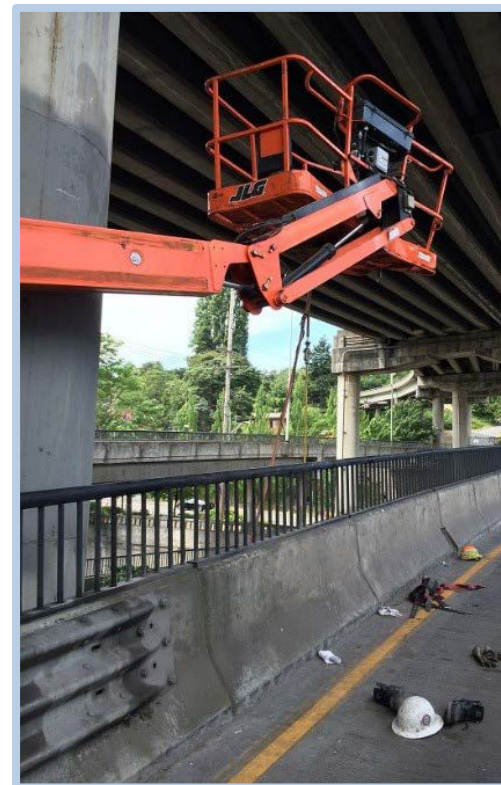
In July 2016, a 40-year-old construction foreman died and a 57-year-old laborer was injured when a truck struck the elevated aerial lift platform they were working in, ejecting them from the platform.

Their task that day was to install replacement retaining rods underneath the bridge. Also known as seismic restrainers, these rods prevent excess movement of bridge elements. They were using a self-propelled telescopic boom-supported elevating work platform or aerial lift. They positioned the lift underneath the bridge in a dirt median between two roadway ramps.

After loading equipment, they both stood on the platform while the foreman raised it and boomed out so that they could access the work area between girders on the bridge above. The work area was about 30 feet above a single lane of an elevated exit ramp.
