Orchard Tractor Operator Dies when Run Over by Trailer-Mounted Water Tank Towed by Tractor

Investigation: # 08WA053
Release Date: November 18, 2013
SHARP Report: # 52-29-2013_summary

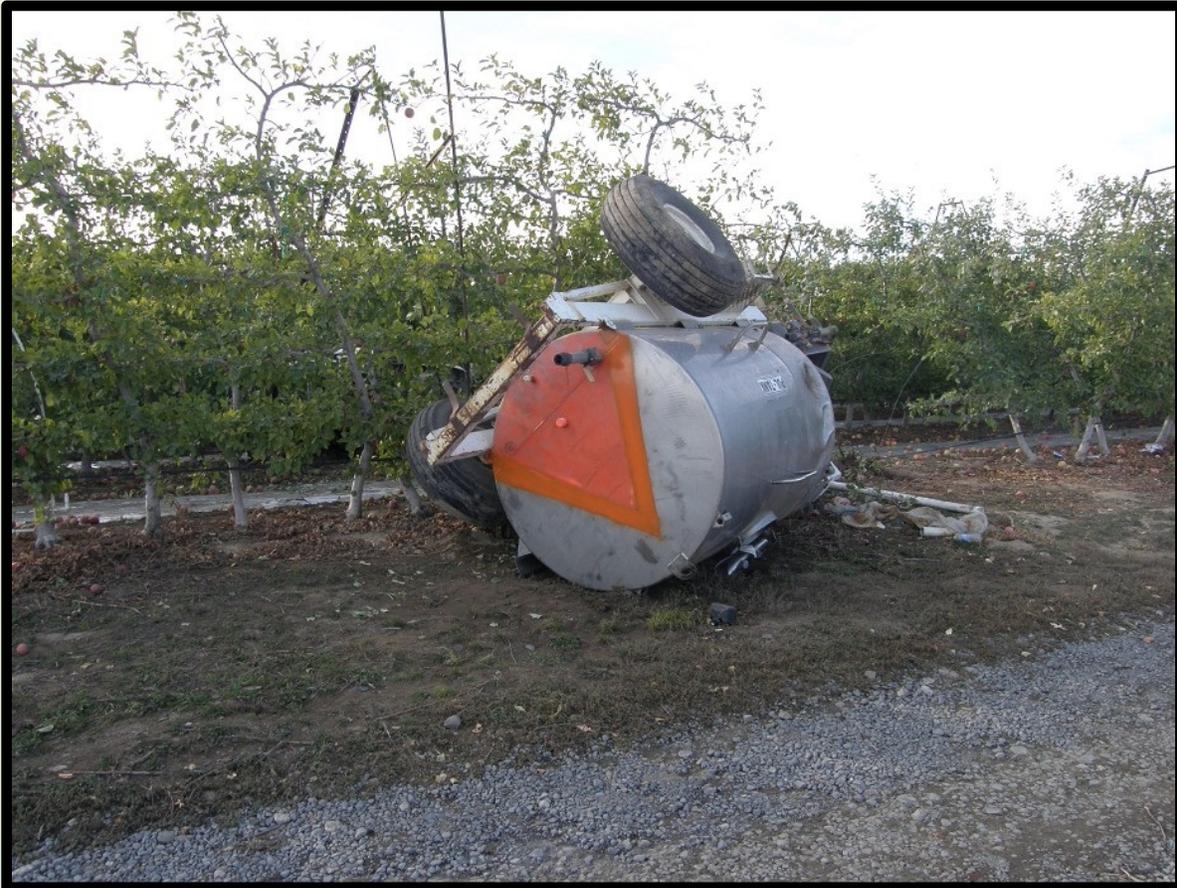
Investigators found the water tank trailer separated from the tractor and lying on its side. The tractor was found resting upright against trees in the orchard. A piece of wire was used instead of a locking safety bolt on the trailer's coupler to hold it on the tractor's hitch. This piece of wire failed just before or just after the victim came off of the tractor. The use of the wire in place of the locking safety bolt allowed the water tank trailer to separate from the tractor. The tractor was determined to be in neutral (out of gear) when examined in the orchard after the accident. Investigators also noted that the tractor did not have a seat belt or rollover protective structure (ROPS).
