Worker Hospitalization Alert

May 2021

Worker Hospitalized After Fall from Mobile Scaffold

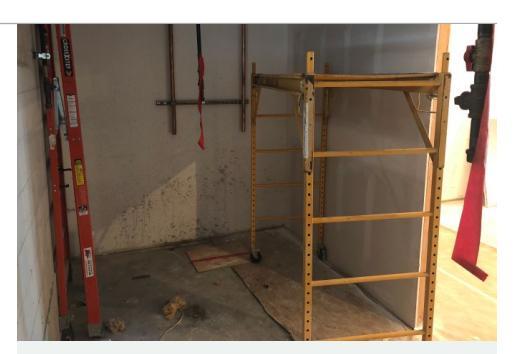
An experienced carpenter was standing on a mobile scaffold in a small mechanical room. He was sealing up insulation around a vent pipe in the ceiling. The 5-foot by 3-foot scaffold was raised to its maximum height of approximately six feet. The caster wheels on the scaffold were not locked.

Photo 1: Six-foot mobile scaffold set up in the small mechanical room. The room's door is to the right of the scaffold.

Position scaffolds safely. Avoid moving mobile scaffolds while workers are on them—get off and reposition in the needed location. Keep wheels locked while workers are on scaffolds.

- Manual force to move the scaffold must be as close to the base as practicable. See <u>WAC</u> <u>296-874-40012(2)(a)</u>.
- Employers must make sure mobile scaffold wheels and casters are locked, or equivalent means are used, to prevent movement when the scaffold is being used. See <u>WAC 296-874-40006(5)(b)</u>.

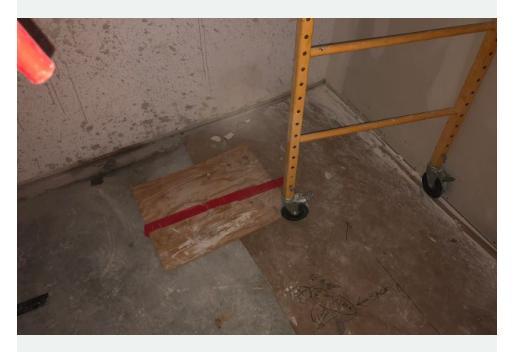
On the floor was the 12-inch square hole of a steam blow-off pit that was part of the new construction. The open hole was covered only by a 18 by 20-inch piece of unsecured 1/2-inch thick plywood.

Photo 2: Unsecured plywood cover over the open floor hole.

The open hole in the floor was covered with an unsecured piece of plywood.

Cover and mark holes. Cover and secure all open holes with sturdy material. Mark the outside of the cover with the word 'HOLE' to notify others in the area they are stepping on a hole cover.

- Employers must guard holes into which an employee can trip, step into, or step through by a cover of standard strength and construction. See <u>WAC 296-880-10010(2)</u>.

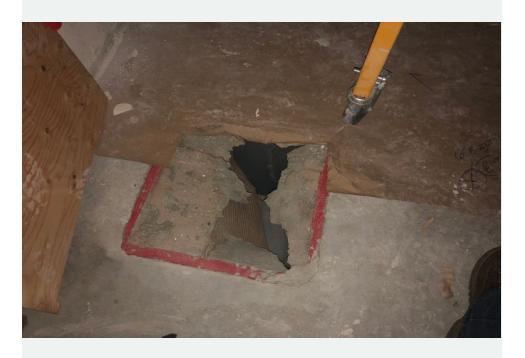
As the scaffold moved, its wheel pushed the plywood cover off of the floor hole and rolled into it, causing the scaffold to tip over.

Photo 3: The scaffold's wheel pushed the unsecured cover off of the hole and rolled in, causing scaffold to tip.

The wheels on the mobile scaffold were not locked while the worker was working from it.

The worker was moving the scaffold while on it, and did not notice that the scaffold wheel was pushing the unsecured hole cover.

- Employers must make sure a scaffold is not moved with employees riding on it unless the surface on which the scaffold is being moved is free of pits, holes, and obstruction. See WAC <u>296-874-40012(6)(a)(ii)</u>.
