# TRUCKING FATALITY NARRATIVE

# Driver Run Over by Semi-Trailer at Truck Stop

**REPORT #: 71-252-2024s**

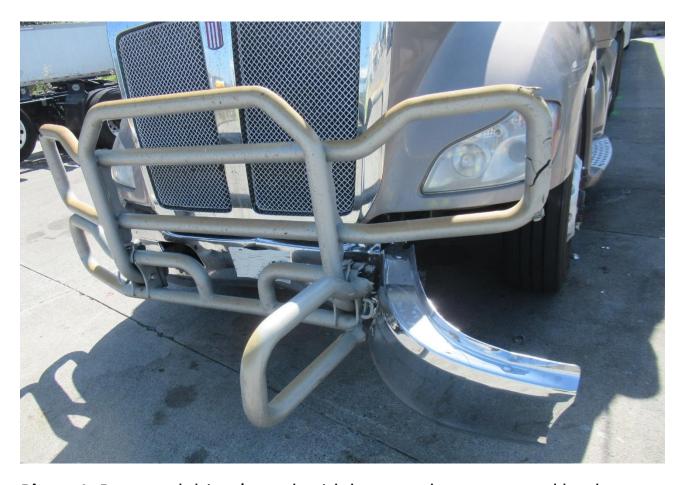
The driver returned from the store a few minutes later and walked between the trucks to get to his cab. The truck parked next to his suddenly pulled forward and turned left, which made the rear of its trailer pivot and sweep into the space where the driver was walking. The moving trailer struck the driver, pinned him against his trailer, and ran over him with its rear right wheels. First responders pronounced him dead at the scene.

**Photo 1**. Deceased driver's truck with bumper damage caused by the trailer that ran over him.

- Assist drivers with pre-trip planning, including finding truck stops and rest areas with safe truck parking.
- Develop a clearly written accident prevention program (APP)
  with truck parking area safety policies and training. The policies
  and training should instruct drivers, whenever possible, to:
  - Park in brightly lit areas, wear a hi-visibility reflective vest, and use a flashlight or blinking light pendant during hours of darkness.
  - Put away phones and electronic devices and always maintain situational awareness in parking areas.

- Avoid unnecessarily walking between parked trucks, especially when the space between them is less than 8 feet wide.
- Inform drivers in adjacent parking slots before doing a walk-around vehicle inspection.
- Walk as far away from traffic as possible, especially near parking lot entrances or at the end of the rows where there is a greater risk of being struck.

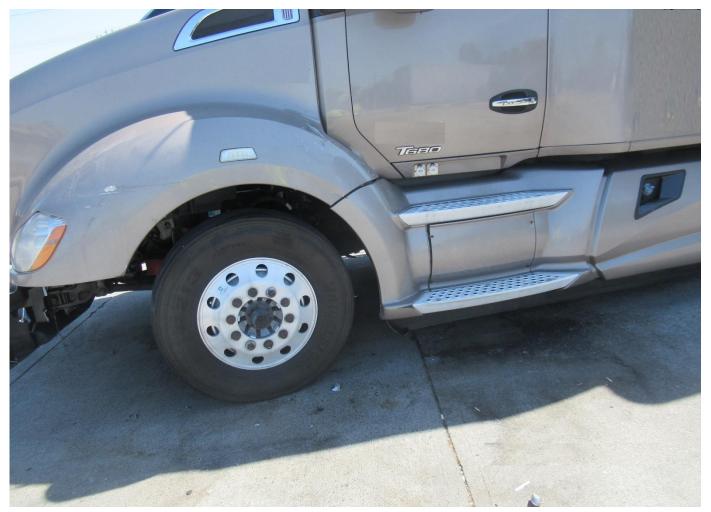
- The employer did not have an accident prevention program (APP).
- The driver was not provided safety orientation training specific to the types of workplace hazards.
- The truck stop had only straight back-in parking slots that limited visibility and space between trucks.

Photo 2. Area where driver was run over.

- O Use 45-degree angle herringbone drive-through (HDT) parking slots instead of straight back-in slots (SBI). HDT slots allow trucks to enter and leave without having to back up. This lets drivers see the entire parking slot and the edges of adjacent slots. By contrast, SBI slots limit maneuvering visibility at the rear of the slot, creating a hazard for drivers on foot.
- Only use designated parking areas, which often have lighting, security cameras, fencing, controlled access, and other drivers that make them safer and more secure than undesignated areas.
