Hay Buyer Fractures Skull, Breaks Shoulder Falling off Feed Table

Industry: Agriculture
Task: Compacting Hay

Release Date: July 12, 2011
Occupation: Hay Buyer

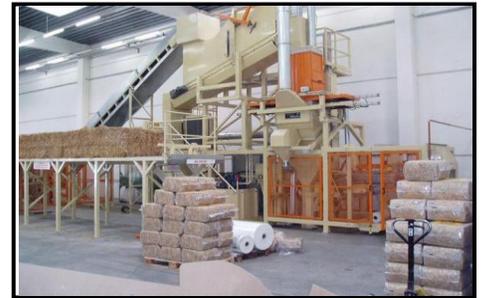
A 22-year-old hay buyer fractured his skull and broke his right shoulder when he fell seven feet off a feed table. The victim was working a hay press when a forklift bumped a stack of hay bales knocking them over. The worker went onto the feed table to manually restack the hay bales. While restacking, one of the pieces of twine holding the 110 lb hay bale together broke. Two bales of hay immediately fell onto the victim's legs, pushing him backwards over the edge of the feed table. The victim landed on his head and right shoulder, injuring both. The victim had been asked to help a shorthanded crew because he had over eight years experience in the industry. He had been employed seven months in this workplace at the time of the incident.

- The employer is required to provide safety education training programs. See [WAC 296-307-018\(6\)](#).
- Platforms or working surfaces greater than four feet above the ground must have guardrails. See [WAC 296-307-25015](#)
- Railings can be removed when they impair operation. However, railings must be re-installed as soon as the operation is complete. See [WAC 296-307-25006](#).

- Work on elevated surfaces only if there is a fall protection system in place.
- Use machinery designed to lift and move heavy materials.
- Make sure you are trained on how to recognize and minimize job hazards.
- Make sure you are trained on what to do if a problem arises.
