Question of the Month

Ugly Installations

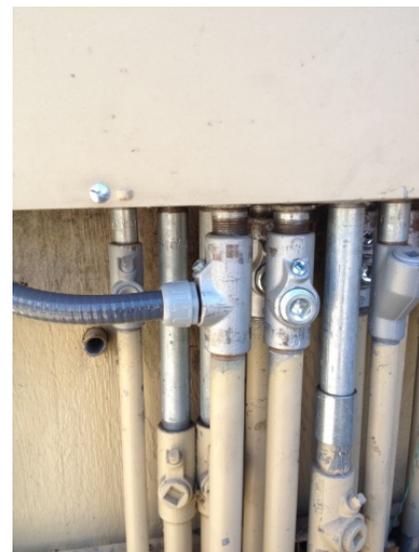
Online readers - click on the picture to open a larger image in another window.
Violations: NEC 110.3(B) - Improper use of conduit sealing fitting. (This circuit does not serve a hazardous location)
