ERGONOMICS DEMONSTRATION PROJECT

Trucking

January 2002

Demonstration Project

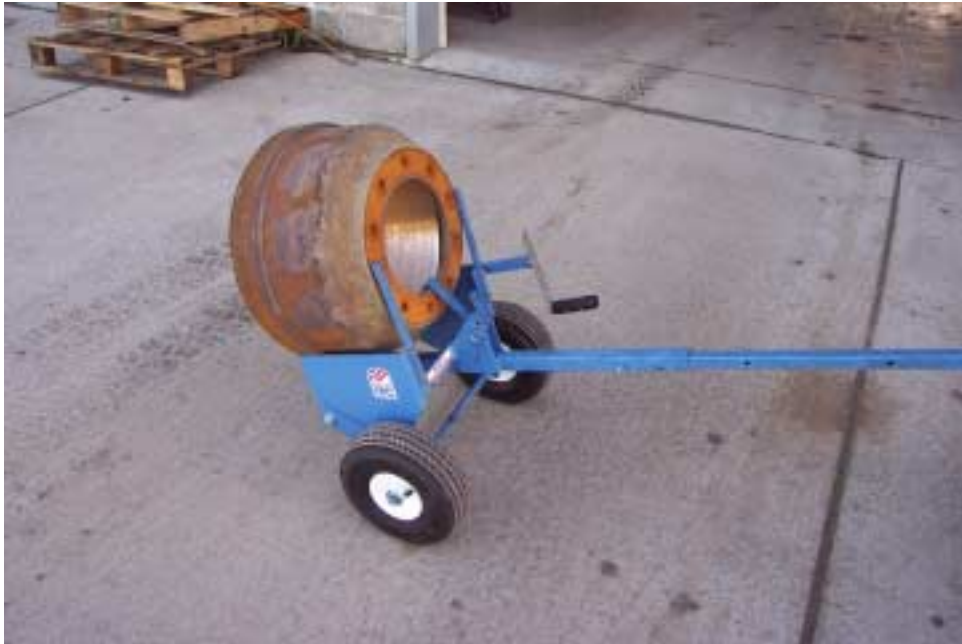
Drum dolly with hand crank can lower or raise the drum dolly to the proper level.

- A complete analysis was conducted of shop mechanics in their duties related to truck maintenance. Risk factors and a hazard were identified. Mechanics must lift brake drums that weigh up to 110 lbs. This was identified as a hazard. The team identified a brake drum dolly, which alleviates this heavy lifting.

- An affordable brake drum dolly (\$480) was purchased to eliminate the 110 lb. lift required when changing drums.

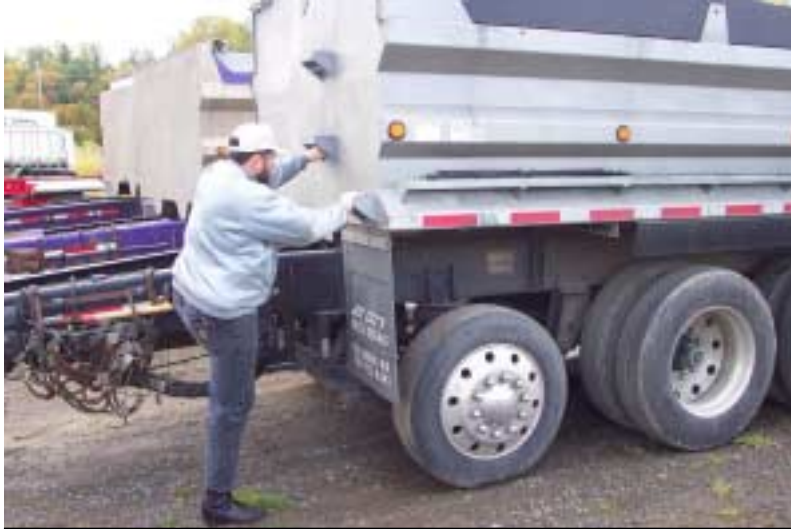
Worker uses handholds that were installed to reduce the risk of injuries from falls.

- Ludtke installed additional steps, and handholds and a foot rail on dump trucks and trailers to facilitate climbing up onto equipment more safely.

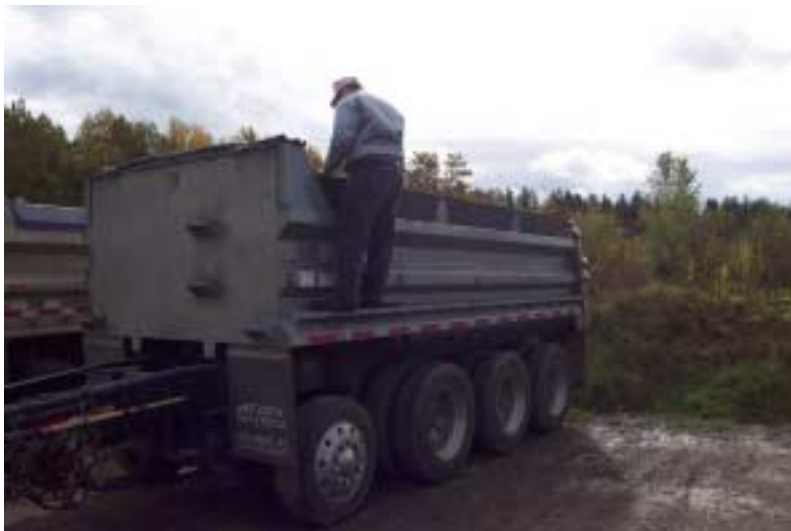
Employee stands on running toe rail installed on side of truck to reduce the risk of slip and fall injuries.

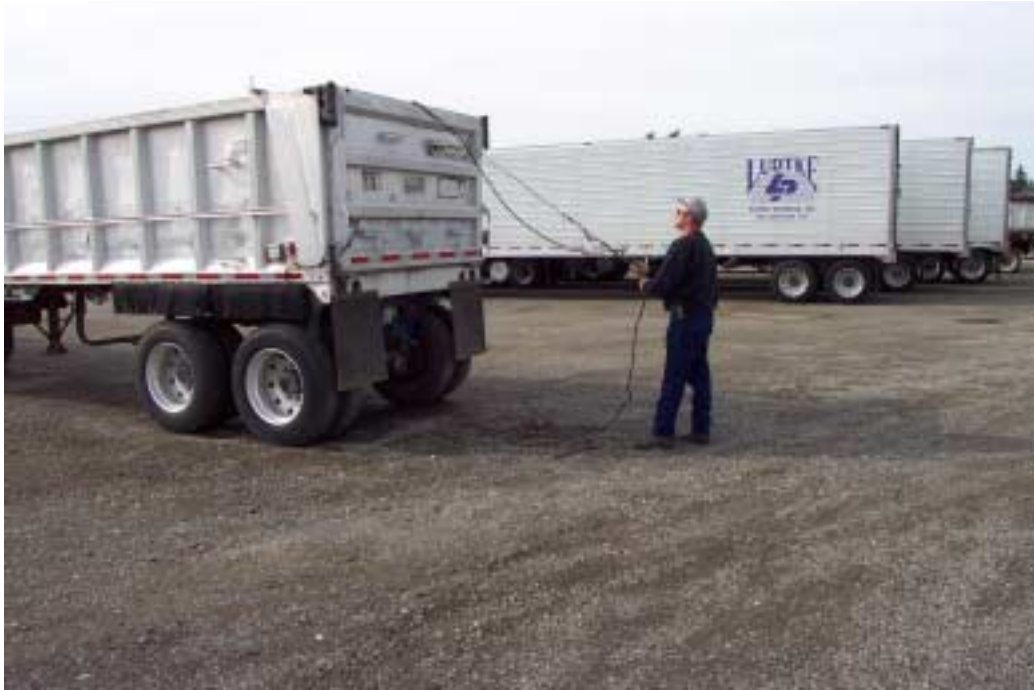
Employee uses an electric tarp device to deploy the tarp across the top of the container while pulling on the tie-down ropes.

The automatic tarping device which is operated from the ground eliminates the need to climb the truck bed to tarp a load.

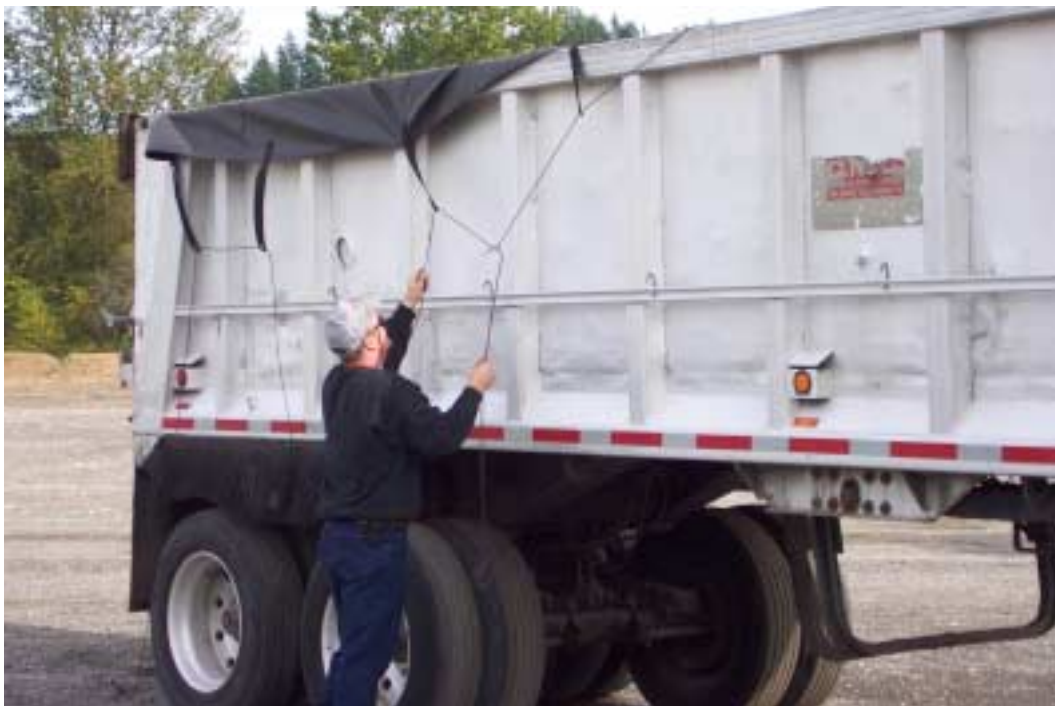
Employee hooking down the sides of the automatically deployed tarp.

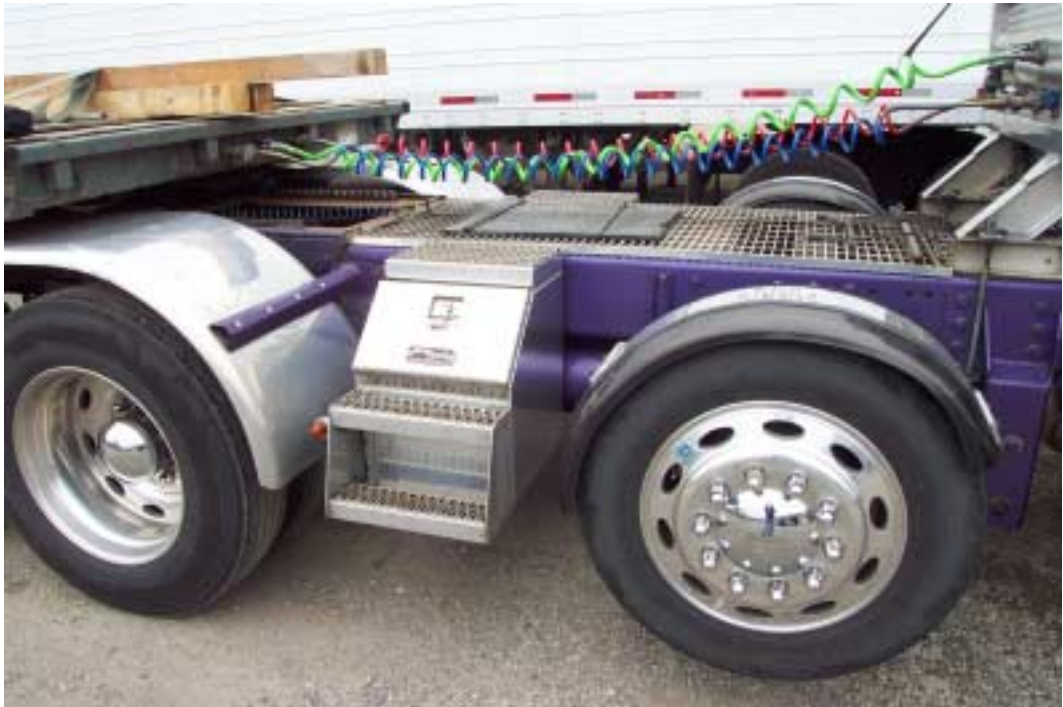
Metal decking, additional storage and steps were installed behind the truck cab to reduce the risk of slip, trip and fall injuries.

- Additional decking was installed behind the truck cab to reduce the risk of slips and trips.

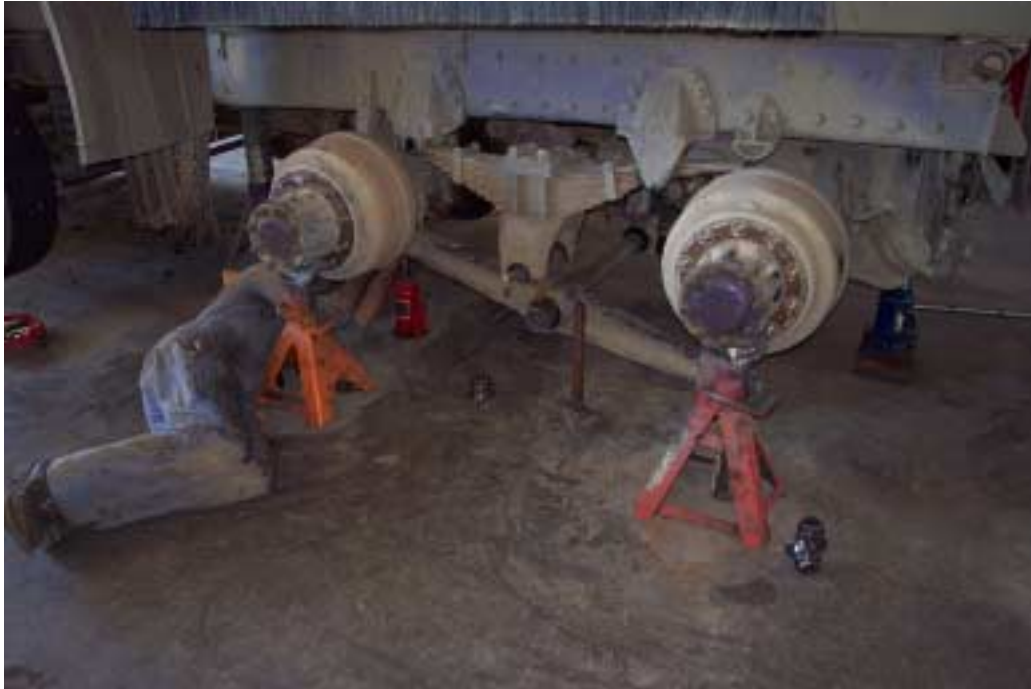
Employee using hydraulic jack to lift one end of the walking beam before securing it to the truck underbody. This is an alternative to two employees manually lifting the assembly.

- During a spring changing job, hydraulic jacks were used to lift the walking beam (a component weighing 183 lbs) to eliminate an awkward team lift. The rear of the truck is also supported by the shop overhead crane.
