## Elevator Industry Bulletin

### Safety Alert!

**Many 1970s-era Dover elevators use an unstable and unsafe shut-off valve.**

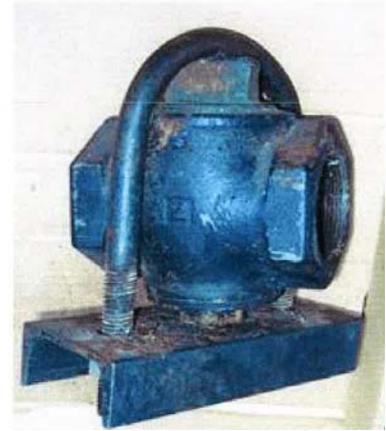
HSSV Valves look like this. ►

They are located in the “pit,” at the base of the elevator shaft and are commonly referred to as “knock-style cut off valves” because technicians typically strike them with a hammer in order to loosen the valves.

If an HSSV Valve is loosened too much, then the stem and hydraulic fluid will be released, causing a loss of pressure, and that loss of pressure will cause the elevator car to fall. Anyone working in the elevator shaft would almost certainly be killed by the falling car, unless proper safety precautions were taken.

If your L&I elevator inspector finds an HSSV valve, you will be directed to replace it within 90 days, as required by current code: (RCW 70.87.120 3a) For this reason, if you know you have this type of valve, L&I encourages you to take the initiative and get the work done right away, to avoid receiving a citation in your next inspection. Note: Current code permits you to replace it with a rupture valve with a self-contained shut-off valve.

- Placing pipe stands in the coil springs at the bottom of the elevator shaft.
- or*
- Securing the elevator car with rail clamps.
- or*
- Using a similar method required by your company’s safety program.
