**Attention** businesses, supervisors, and employees who use **Pro-Pak Model JN-ZK1 bagging machines** to package onions, potatoes, and other produce:

Bag-line employees were injured in 2 separate incidents because of pinch-points hazards created by exposed moving parts on onion bagging machinery.

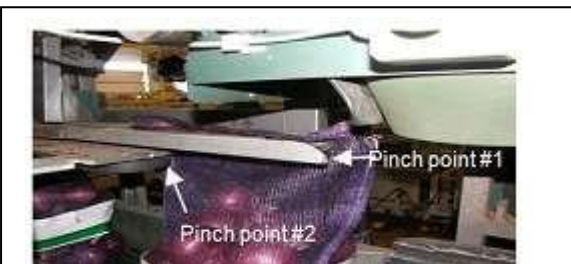
Each employee had their fingers caught and injured by a retracting metal clamp which grabs the top of bags after filling and pulls them through a set of rollers toward a stitcher. (see photos).

Photo 1. Unguarded and dangerous: metal clamp arms extend and come together (pinch point #1) to grab the bag and pull it through rollers (pinch point #2) and on towards the stitcher.

Machine safeguarding and employee training on safe work practices are essential to prevent injuries to bagging machine operators. Possible safeguarding ideas include using a light curtain, barrier, pressure sensitive or restraint device to prevent employees from contacting the clamp. Check with equipment manufacturers for information about these safety features and make sure any modifications won't create other safety hazards.

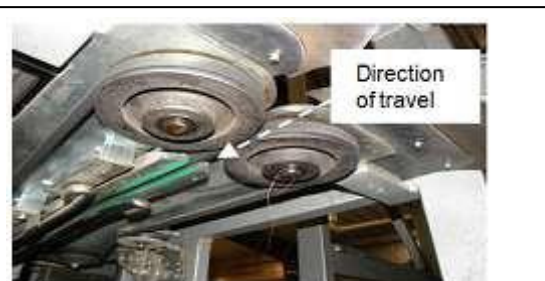
Photo 2. The metal clamp (underside shown without an attached bag) has moved from the extended position shown in Photo 1 to a fully retracted position on the other side of the rollers.
