# FATALITY NARRATIVE

## Painter Falls from Stepladder\*

**Industry:** Painting contractors  
**Task:** Spray painting ceiling  
**Occupation:** Painter  
**Type of Incident:** Fall from ladder

**Release Date:** May 21, 2012  
**Incident Date:** October 12, 2010  
**Case No.:** 11WA00801  
**SHARP Report No.:** 71-110-2012

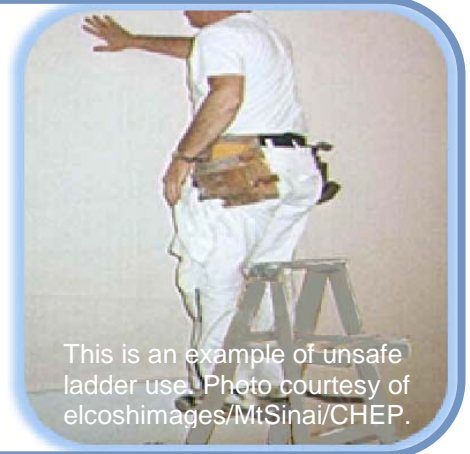
On October 12, 2010, a painter died when he fell from a stepladder. The 57-year-old self-employed painter was working alone at a newly constructed house. He was standing on an aluminum stepladder spray painting the ceiling. The incident was unwitnessed, but according to the police report, he apparently fell from the ladder down into a stairwell, where he landed about 25 to 30 feet below. He was taken to a hospital, where he died.

- Ensure that stepladders are fully opened with the spreaders locked. See WAC 296-876-40050.
- Do not stand or step on the top cap and top step of a stepladder. See WAC 296-876-40050.
- Train employees to recognize ladder hazards and how to minimize these hazards. See WAC 296-876-15005.
- Keep ladders in good, usable condition and remove from service any ladders with structural defects. See WAC 296-876-30005.
- Workers conducting a task from a ladder greater than 25 feet must either use fall protection or find another method of access if the work requires the use of both hands. See WAC 296-876-40040.

- Choose the right equipment for the task:
  - Select an appropriate ladder length, type, and strength.
  - A scaffold or elevating work platform, such as a scissor lift, may be a safer alternative to a ladder.
  - Consider using a spray gun extension pole when painting a ceiling or areas over a stairwell.
- Place a stepladder on a solid, level surface.
- Before using a ladder, inspect it to make sure it is in good condition.
