Timber Harvester Operator Killed Following a Chain Shot Incident

Investigation: # 10WA04801
Release Date: 02-24-2014
SHARP Report: # 52-30-2014_summary

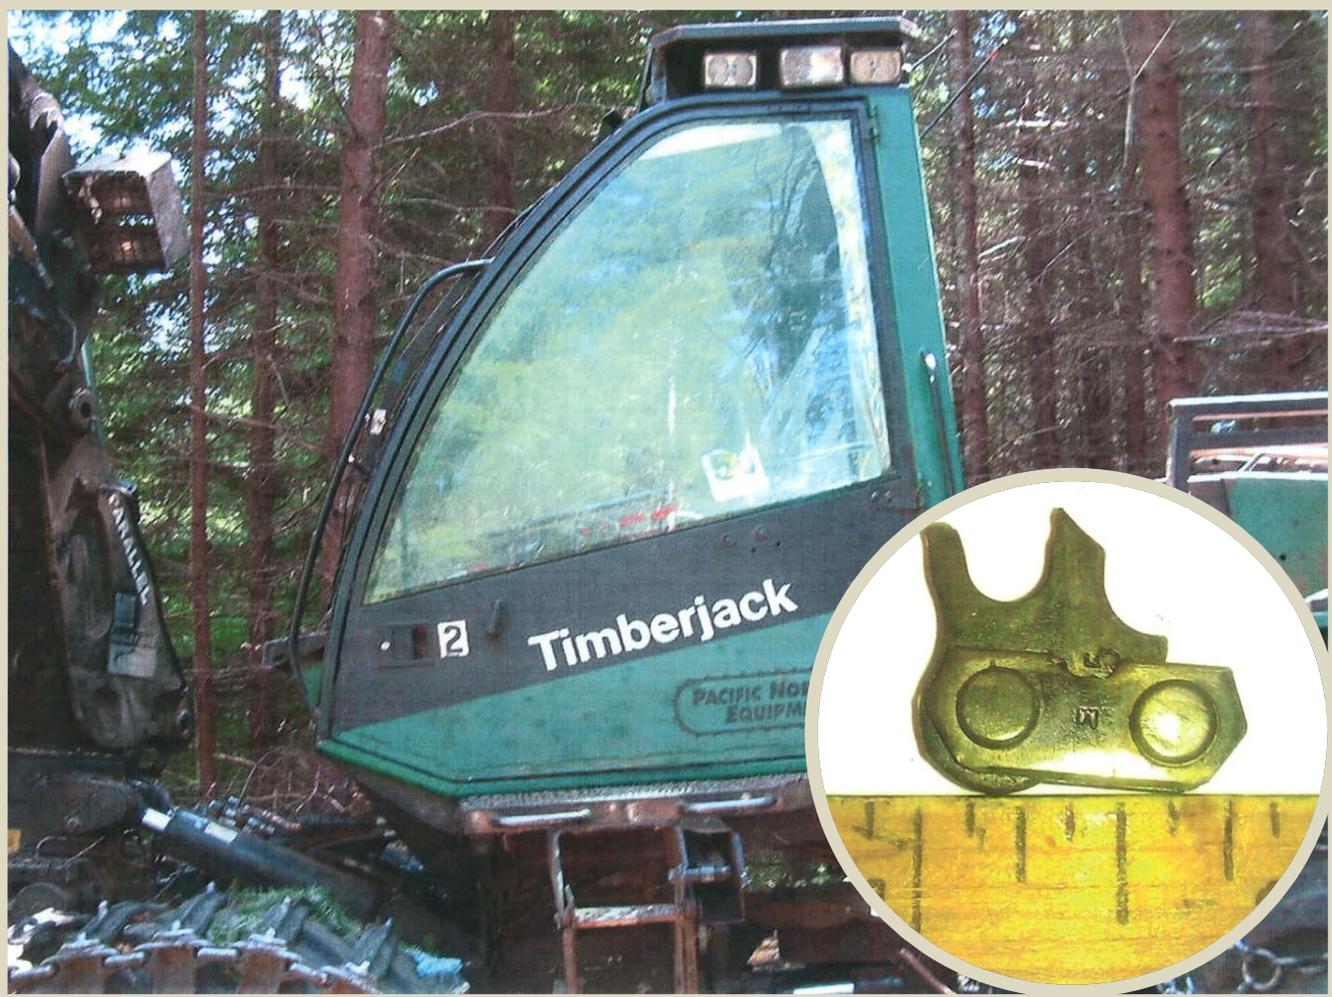
On August 12, 2010, a 47-year-old timber harvester operator, employed by a logging company, was fatally injured when he was struck in the neck by a broken saw chain link while processing a Douglas-fir tree and the cutting chain experienced chain shot. Chain shot is the high velocity separation and ejection of a piece or pieces of cutting chain from the end of a broken chain.

The operator was using a Timberjack harvester equipped with a Timberjack cutting head to thin a stand of trees. Prior to the chain shot incident, the operator used the harvester to cut the Douglas-fir stem and move it to the left side of the operator's station for processing. When the operator started the cut-off saw to cut the tree into shorter lengths, the chain broke. It is believed by the employer and DOSH inspector, that when a portion of the broken chain hit a snow hole on the cutting head, chain shot occurred. Three pieces from the chain struck the operator's cab. One of the pieces penetrated the 12 millimeter (approximately 1/2 inch) polycarbonate window made by Lexan and struck the operator in the neck. The injured operator contacted a co-worker in the area, who contacted emergency responders and the employer. The harvester operator was pronounced dead on the scene.

- **Should create maintenance and guarding systems that reduce the chance of chain shot and protect workers.**
- **Train all workers who might encounter chain shot on standard operating procedures (SOPs) used for the prevention of chain shot.**

- **Should whenever possible avoid processing trees when the processing saw is in line with the operator's cab.**

- **Should be aware of and in frequent communication with harvester operators regarding their proximity and alignment relative to timber harvesters and the location of safe zones.**

- **Should equip mechanized logging equipment with multiple safety systems to prevent chain shot and related injuries.**
