## Carpenter Saved From Potentially Fatal Fall

### *Incident:*

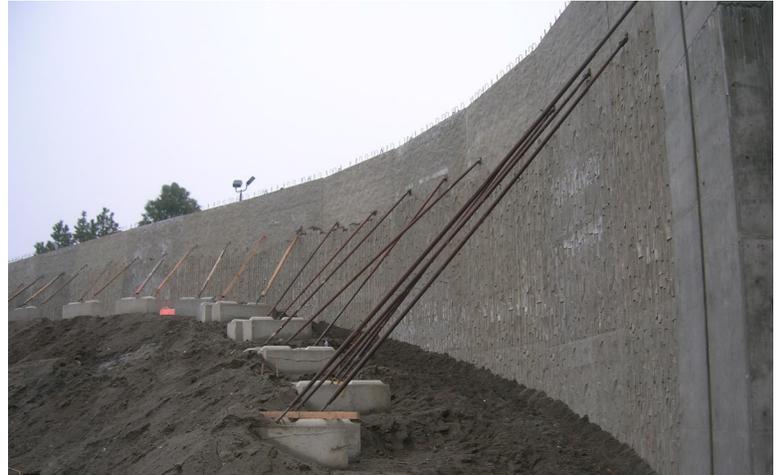
Retaining wall before plywood forms were placed and concrete caps were poured.

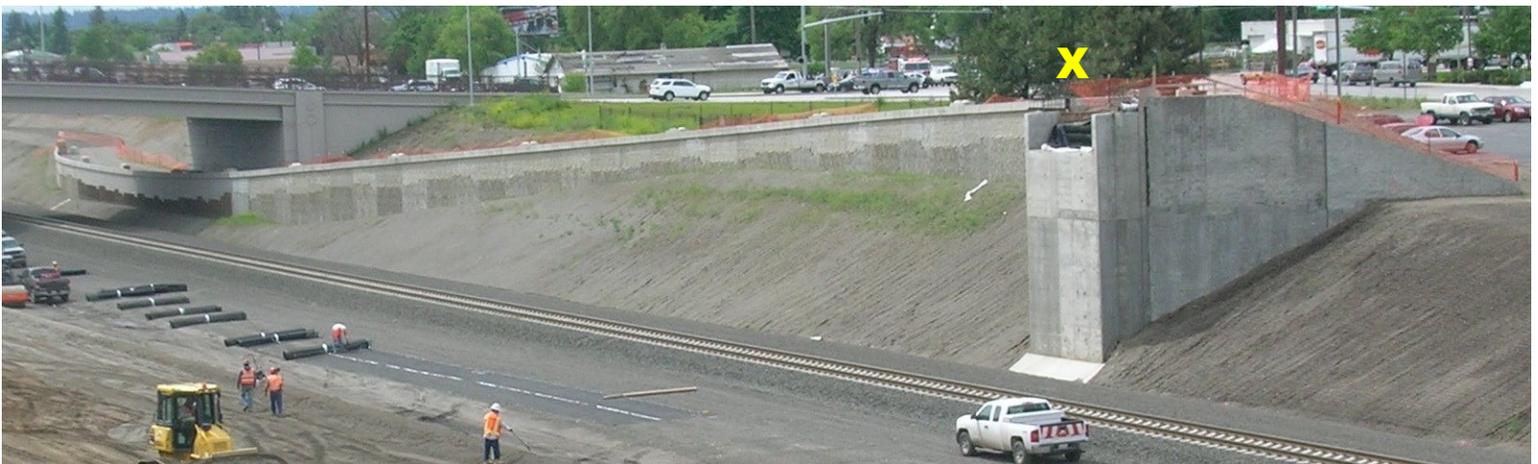
The carpenter and a coworker were removing plywood forms that were 2 feet tall and 12 feet long from around the concrete caps on top of a series of 24-foot retaining wall panels. The carpenter was using a 5-foot crowbar to pop the plywood off of the concrete, a job that can only be done manually. He had been on the jobsite for about a month, but had over 15 years of experience in the industry. His coworker was an apprentice.

By around 3:30 in the afternoon, they had already removed the forms from 300 feet of wall and were working on the last form of the day. The carpenter was attempting to remove the plywood, but when he pulled back on the crowbar, the form didn't come off. Instantly, the bar sprung back with enough energy to catapult him over the side of the wall, exposing him to a more than 25-foot vertical drop.

A fall from this height would have been catastrophic, or even deadly. Thankfully, the carpenter was using a fall-protection system that was rigged to stop his fall at just 2 feet over the wall. He was even able to self-rescue by pulling himself back up onto the top of the wall.

Retaining wall where the carpenter was removing plywood forms from the concrete caps on the top of the wall on the day of the incident. The "X" indicates the area where he was working when he fell.

- Employers must ensure that the appropriate fall protection system is provided, installed, and implemented when employees are exposed to fall hazards of 10 feet or more to the ground or lower level when working on any surface that does not meet the definition of a walking/working surface. See [WAC 296-155-24611\(1\)\(c\)](#)

- Employers must develop and implement a written fall protection work plan including each area of the work place where the employees are assigned and where fall hazards of 10 feet or more exist. See [WAC 296-155-24611\(2\)\(a\)\(i-vii\)](#)
