Asphalt Plant Supervisor Dies after Falling down a Drag Slat Conveyor

SHARP Publication # 52-46-2020_summary. The full version of this investigation report, along with the detailed recommendations and discussions section, can be found at: www.lni.wa.gov/safety-health/safety-research/files/2020/52_46_2020_AsphaltPlantSupervisorFall.pdf

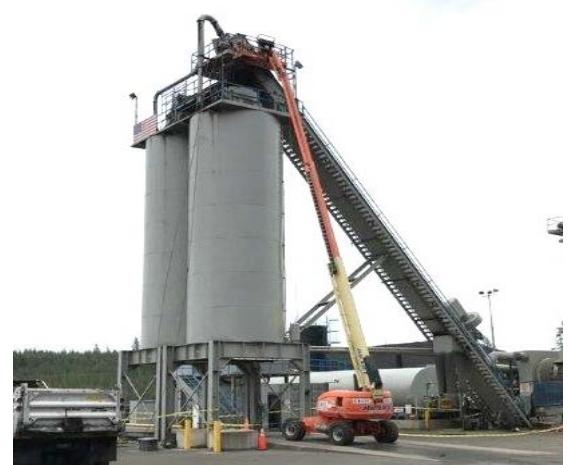
On April 22, 2017, a 58-year-old supervisor/plant operator employed by a hot mix asphalt manufacturer died after he slid down the cover of an inclined asphalt storage silo conveyor and then fell down a stairway, landing 67 feet below on concrete.

Their work area was located above the silos on a 50-degree inclined conveyor 67 feet above the ground. The sprockets were located beneath a hinged lid on the cover of the conveyor box. The workers used an aerial lift to ascend to the work area where they set up their equipment on a work platform adjacent to the conveyor box lid.

The platform did not extend over the conveyor. The coworker opened the lid and then went down to a lower platform to hand up equipment to the supervisor. The supervisor then took off his personal fall protection even though the employer required it for the task. He then climbed over the platform railing onto the inclined conveyor cover. Presumably, he supported himself using the hinges of the lid cover or conveyor slats as foot holds while he prepared to chip-off the asphalt with a pneumatic chisel. An employee working in another part of the plant saw the supervisor sliding down the conveyor. The coworker and the employee who saw him fall rushed to the scene and found him unconscious. He was airlifted to a hospital, where he died four days later.

Asphalt storage silos and the drag slat conveyor down which the supervisor slid and fell while performing maintenance on the upper part of the conveyor.

- Provide a way for workers to safely inspect and maintain conveyors.
- Apply principles of Prevention through Design (PtD) to existing and new facilities, structures, equipment, and procedures to identify and eliminate safety hazards to workers. Ensure that bale storage areas are designated and access limited to authorized employees.
- Provide fall protection and ensure that workers use it when necessary.
- Perform a job hazard analysis (JHA) of conveyor and similar maintenance tasks.
- Evaluate the safety management and safety culture within their organization and make a commitment to injury prevention.
