Chip Truck Driver Struck by Passing Truck

SUMMARY

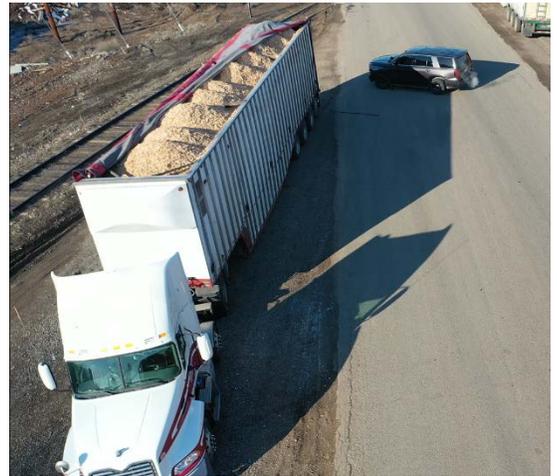
On the day of the incident, the driver had just picked up a load of wood chips from a supplier in his tractor-trailer. The trailer measured 53-feet long by 14-feet high. The trailer was equipped with a manual side roll tarp system to cover loads. After the trailer was loaded, he pulled off the road into a dirt and gravel turnout that was often used by drivers to check and secure their loads. He was wearing a high-visibility safety vest.

Just before the incident, a witness saw the driver attempting to close the tarp that was on the top of his trailer, but the actual incident was unwitnessed. The driver was working at the rear left side of the trailer, which was approximately two feet off the road. Evidence suggests that he was attempting to reach the tarp roll bar or strap with a long reach tool. While doing this, it is suspected he stumbled into the road where he was struck by a passing tractor-trailer. His body was found in the road approximately 10 feet from the rear of his trailer with the long reach tool between him and the rear of his trailer.

Driver's tractor-trailer parked in turnout with rear of trailer closer to the road than truck cab. Trailer is filled with wood chip piles and tarp is not fully closed.

- Ensure trailers are loaded at the proper capacity so tarps can be safely closed and fastened.
- Maintain tarp systems and consider using an automatic tarping system that eliminates the need to manually close a tarp over a load.
- Develop policies for how and where to safely park and tarp trailers.
- Provide warning devices for truck drivers to use when parked on the side of the road. These devices offer visual aids for motorists and alert them to the possibility drivers may be walking or working outside.
