## INCIDENT FACTS

71-223-2022

## Orchard Worker Driving Overloaded ATV Struck on Highway

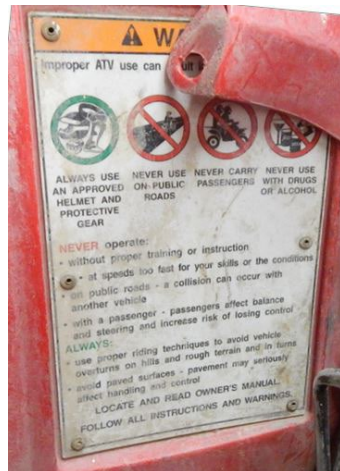
Manufacturer's warning label on ATV showing helmet requirement and public road use restriction.

- The employer did not ensure that workers followed the ATV manufacturer's guidelines to not have any loads that were not secured to the vehicle's front and/or rear cargo racks.
- The employer did not provide helmets nor ensure that workers wore them per manufacturer's guidelines.
- The employer did not prohibit workers from driving ATV on highways and public roads, including shoulders, in accordance with state vehicle and traffic rules and vehicle manufacturer's guidelines.
- The employer did not ensure that workers were provided with proper hands-on ATV safety training.

- Provide DOT-compliant helmets and develop APP requirements and training for ATV, UTV, and other off-road vehicle operators to wear them during vehicle operation.
- As part of their APP, do a job hazard analysis (JHA) of tasks involving farm vehicles and equipment that may pose risks. Workers should be involved in creating the JHA.
- Develop APP policy requirements and safety training for ATV, UTV, and other off-road vehicle operators to follow manufacturer's safety guidelines, including loading procedures, and state, county, and local vehicle and traffic laws and ordinances.

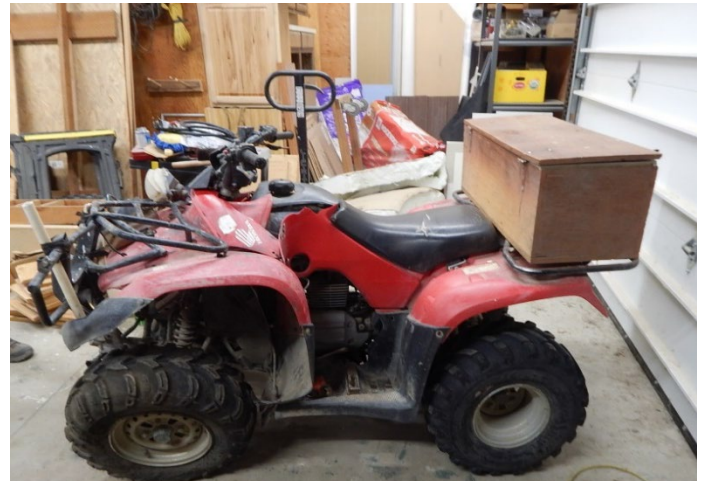
**All-Terrain Vehicle (ATV) with damage from a collision with a horse trailer.**

On the way to the orchard, the two workers drove on a gravel access road to an intersection with a paved state highway. The road had a slight decline where it met the highway. The worker with the pipe was in the lead. He tried turning right from the road onto the highway's southbound shoulder but lost balance and control from the momentum and pipe blocking his steering ability. He rolled across the centerline into the northbound lane where an oncoming passenger truck going the 60 mph speed limit struck the ATV with the left front side of a horse trailer it was towing. The worker was ejected from the ATV and died at the scene.
